BE CIVIL ENGINEERING PROJECT REPORT

Geotechnical and Seepage Analysis of Khanpur Dam and Recommended Measures for its Safety

(2020)

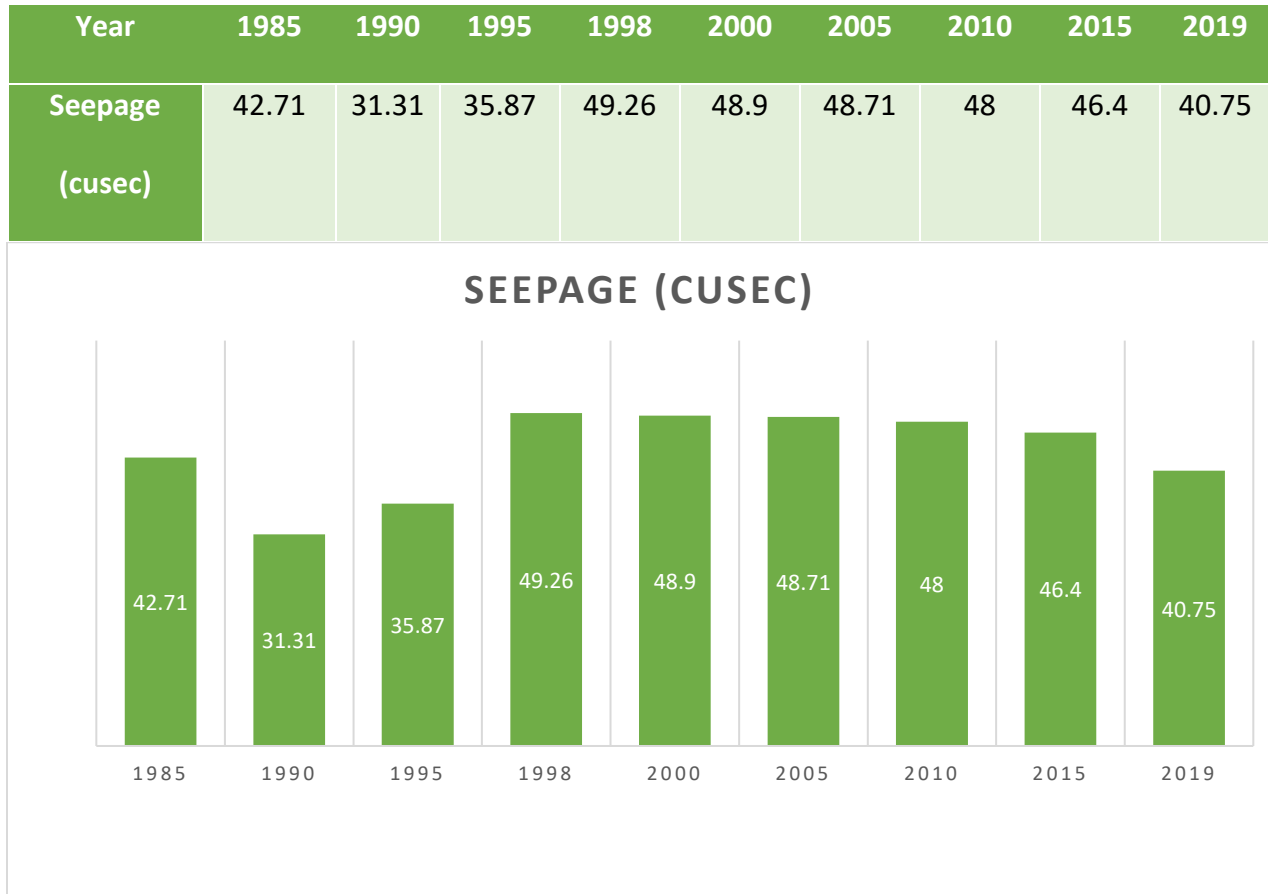
Fig 5.1: Trend of overall seepage through the dam

From the analysis of data it can be concluded that seepage after 2010 has decreased to some extent without taking any additional measures, this may be due to filling of cracks by silt, also known as the self-healing phenomena of dam.

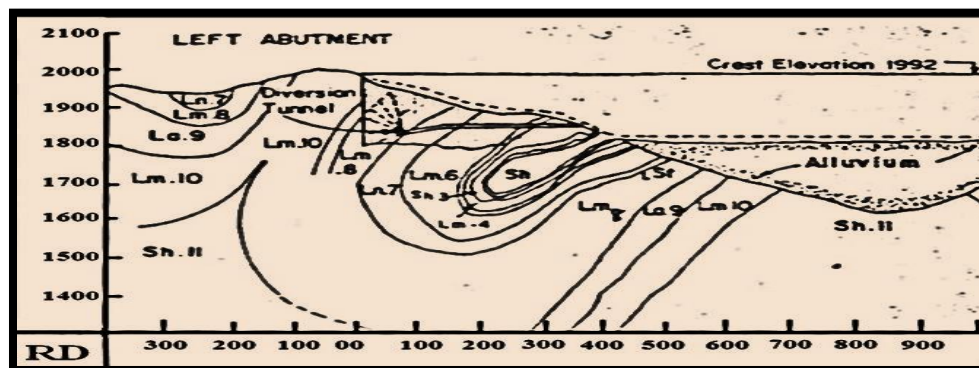
In left abutment, weak beds present in substrata that cause excessive seepage in abutment area. Weak beds include two inverted syncline beds of limestone, Lm-6 & Lm-8 extended from upstream to downstream shown in Fig. These beds present 20-40 Ft. below dead level of dam. Limestone beds present between Elevation Level of 1860-1880 ft. Lm-6 run along upstream side of diversion tunnel b/w Elevation level of 1875-1910 ft. Lm-6 extended about 800ft along upstream.

Fig 5.4: Cross sectional view of Left abutment

Due to accessibility issues, these beds remain untreated, that's why seepage occurs in this part of dam. But seepage is under control as shown in below figures. Left abutment seepage includes diversion tunnel and new seepage area. Diversion tunnel seepage measured at outlet of tunnel while seepage from "new seepage area" is collected and measured separately at downstream. From 1999-2004, remedial measures were taken, dental concreting and grouting was done under supervision of KSW. After remedial work, seepage reduces about 60% in diversion tunnel at RL 1920ft and its percentage reduction decreases as reservoir level increases. These results show that grouting is very effective in diversion tunnel. While in new seepage area, increment in seepage is recorded.

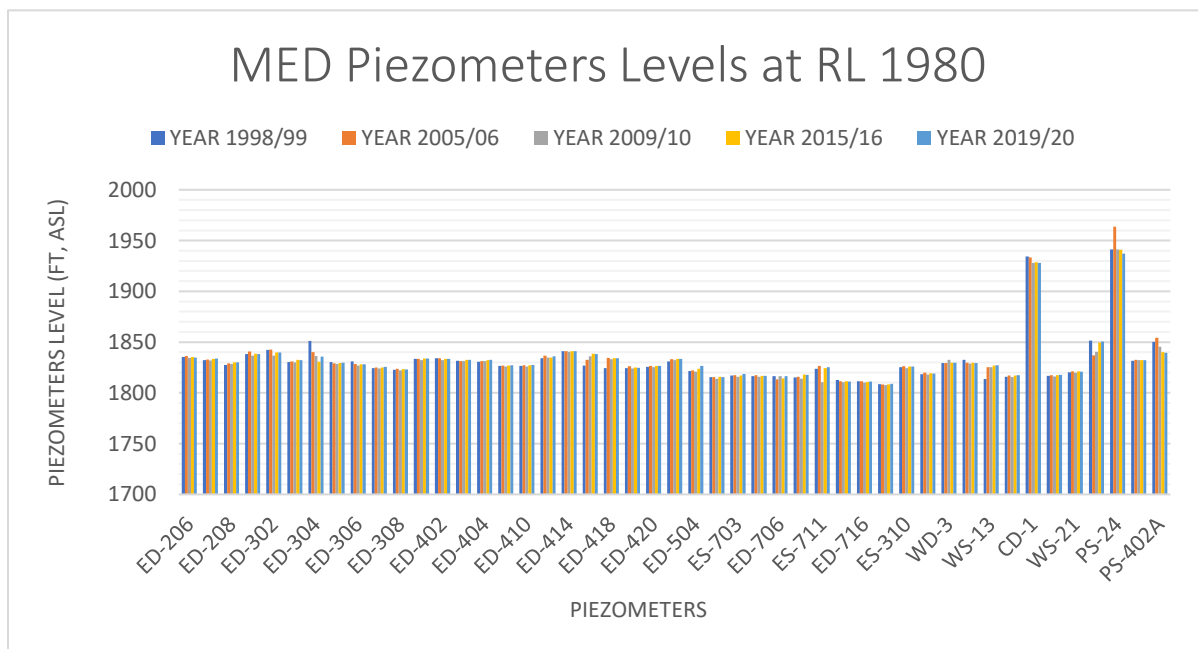
Two instruments CD-1 and PS-24 shows a different behavior than other 45 instruments. Graph illustrate that CD-1 and PS-24 are two weak points of Main Dam. Both these instruments are under special supervisions. That's why CD-1 and PS-24 readings same today as in year 1998 over the period of 23 years.

Fig 5.20: Comparison of Med Piezometers Levels at RL 1980

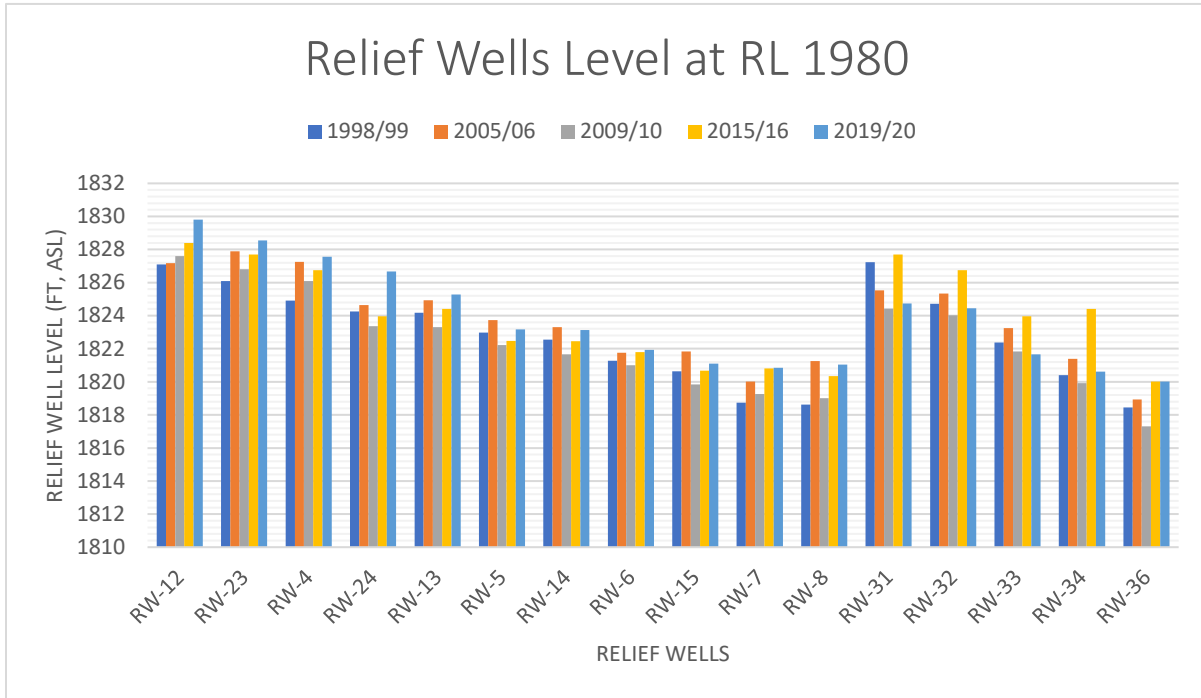
There are total of 16 relief wells. The Relief Well RW-31 showed higher readings in 1998/99. After the seepage control measures were taken the piezometer reading were decreased and the graph remained linear afterwards.

Fig 5.24: Comparison of MED Relief Wells Levels at Reservoir Level 1980

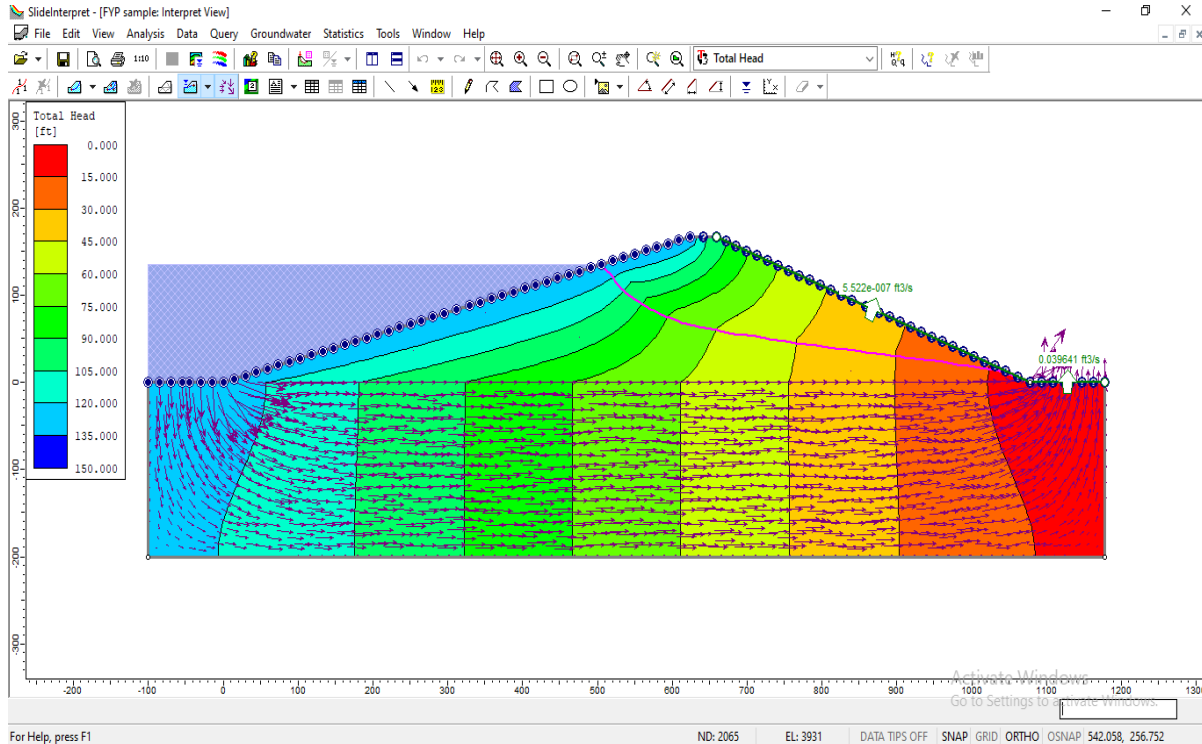
Fig 5.30: Seepage Result at RL 1980
