# **BE CIVIL ENGINEERING PROJECT REPORT**

## ***GEO-FORENSIC DISTRESS EVALUATION OF A DAMAGED BUILDING FOUNDED ON COLLAPSABLE SOIL WITH A VIEW TO FORMULATE A REMEDIAL STRATEGY: A CASE HISTORY***

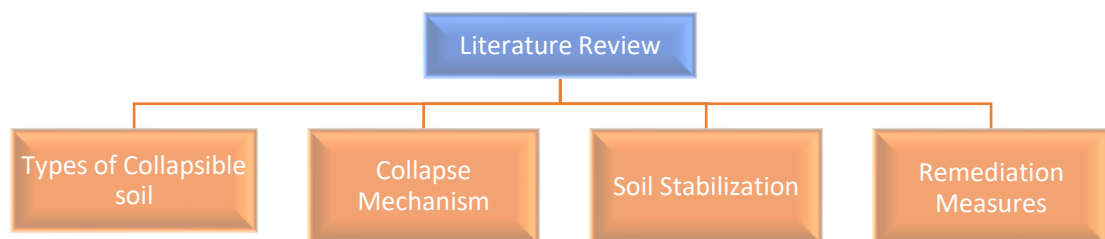
## **2.3 TYPES OF COLLAPSIBLE SOILS**

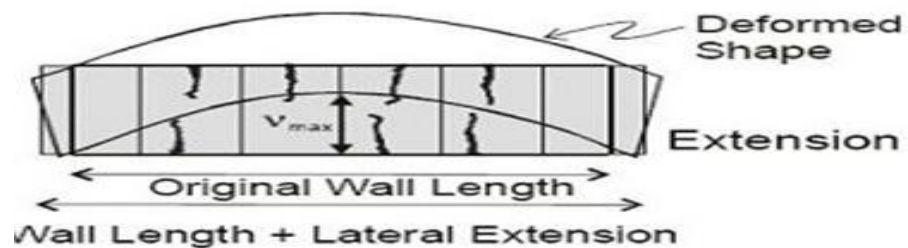
Distress in structure is often linked to foundation failures or displacements. Although after construction every structure undergoes certain amount of deformation, but deformation exceeding safety limits are termed as 'distress'. The crack pattern may indicate the type of distress. Some of common modes are illustrated in figures below (Boone, 2001).

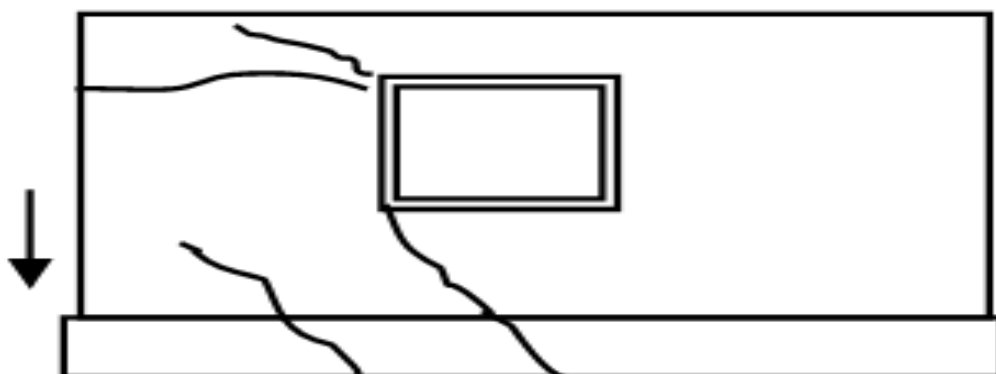
Figure 2.4 Distress in masonry structure due to differential settlements (consolidation)

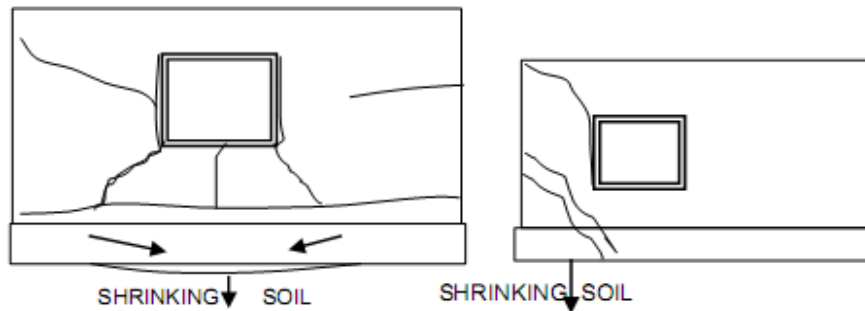
Figure 2.5 Distress in masonry structure due to differential settlements  
(shrinkage in foundation soil)

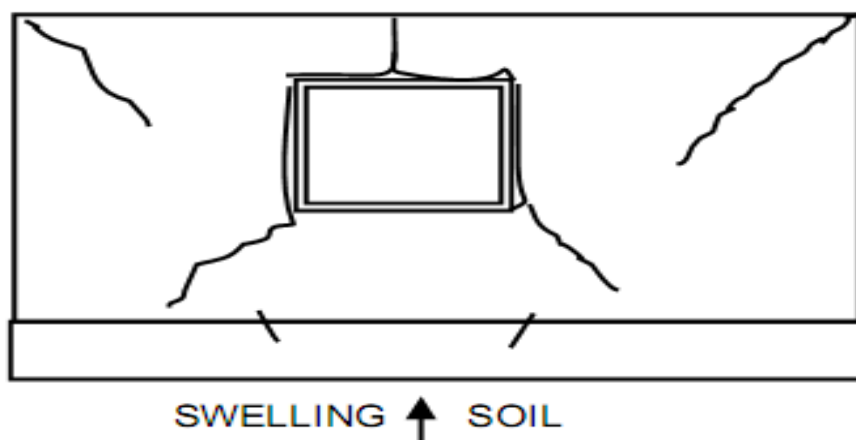
Figure 2.6 Distress in masonry structure due to swelling of foundation soil

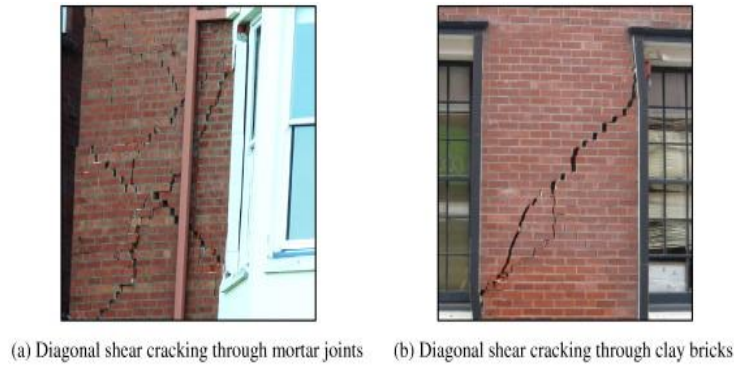
Fig 2.9 failure mode of masonry

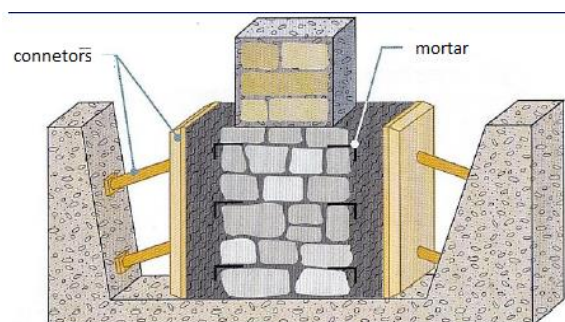
Fig 2.10 Enlargement of foundation

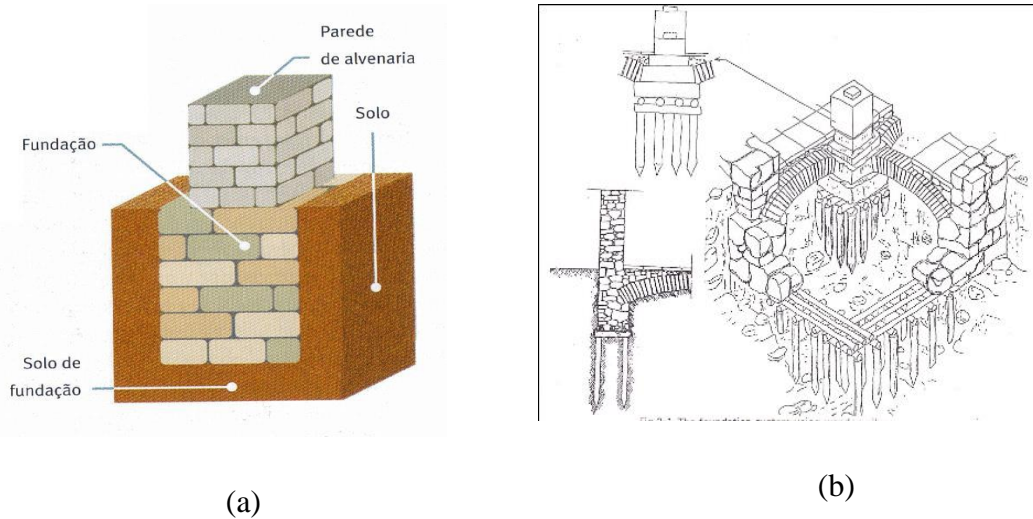
Fig 2.11 (a) Typical foundation of old masonry structures (b) Micro Piles to improve foundation

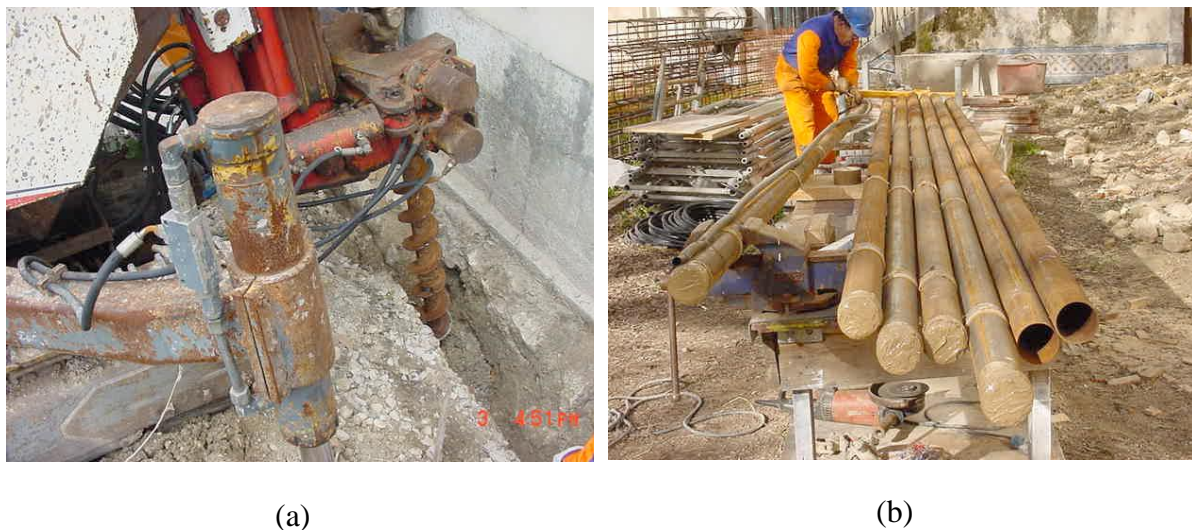
Fig 2.12 (a) Micro pile drilling machine (b) Micro pile casing

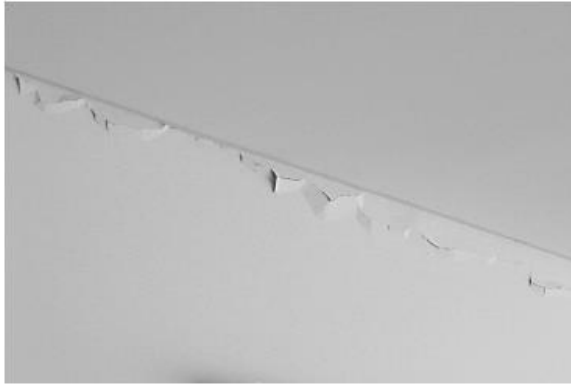
(a) Cracks due to deflection of slab

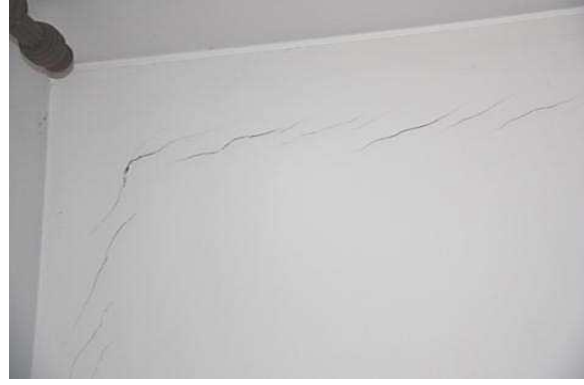
(b) Cracks due to thermal movements

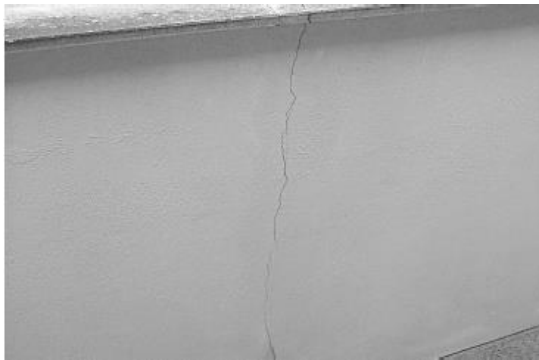
(c) Cracks due to shrinkage

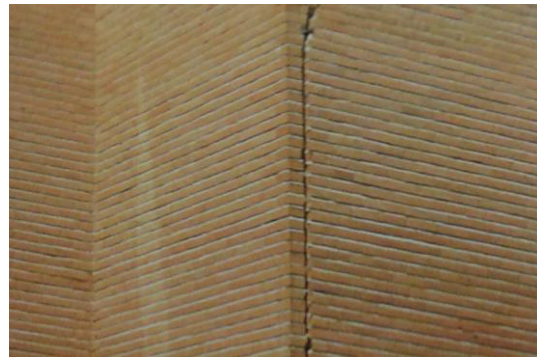
(d) Cracks due to moisture expansion

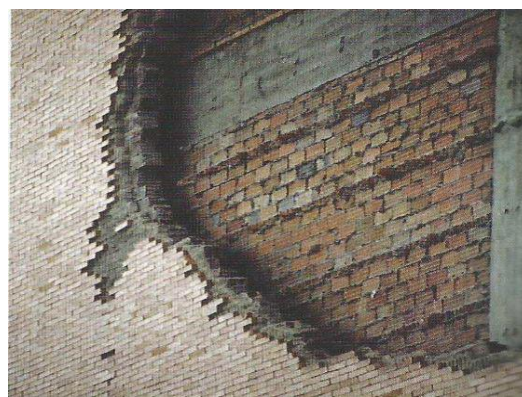
(e) Cladding failure due to moisture/Thermal movement and insufficient ties

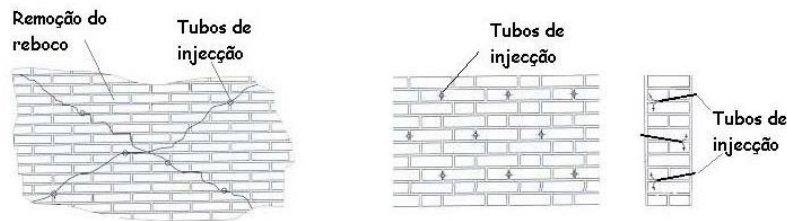
Fig. 2.14 Injection of grouting material to fill internal and external cracks

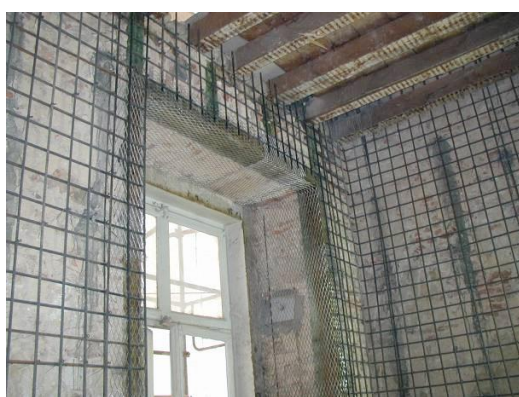
A test experiment conducted on stone masonry reinforced with steel meshes and coated with cement paste and found that the strength increased 3 to 6 times of original strength in compression and shear (Appleton, 2009).

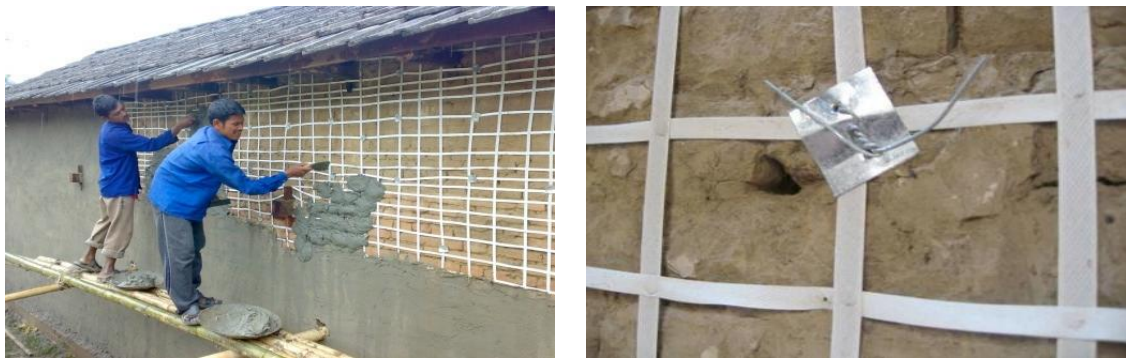
Fig 2.16 Application of PP-meshing

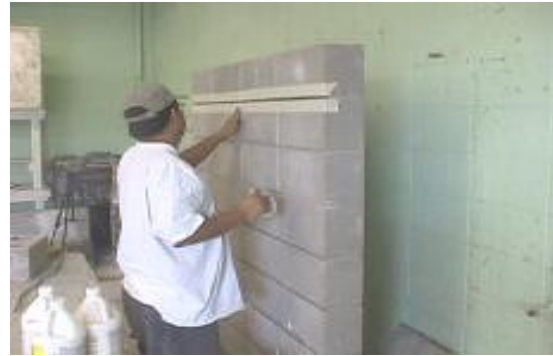
(b) Masking of joints to avoid stains

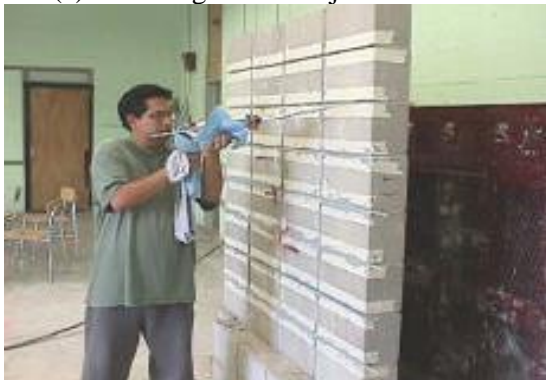
(c) Injection of epoxy paste

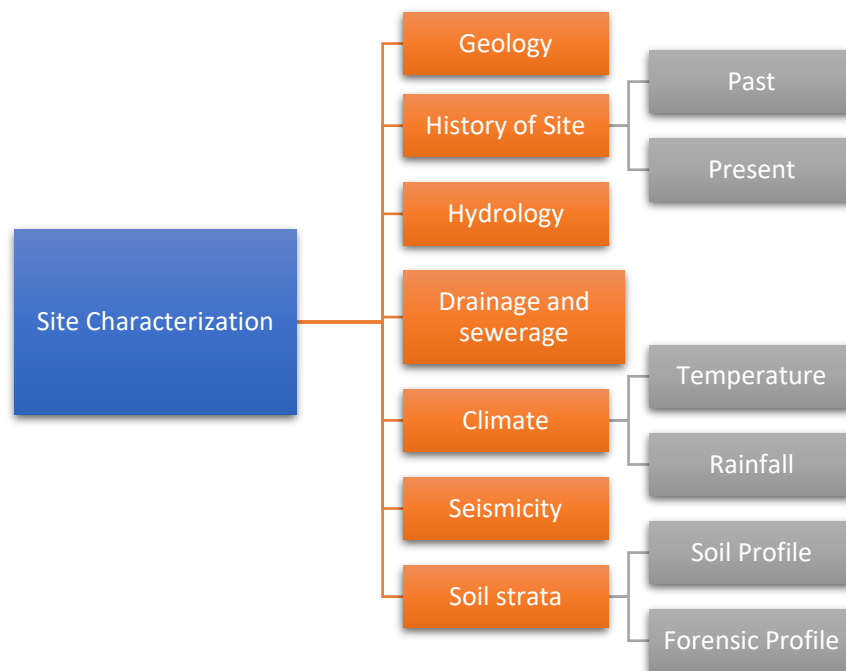
Fig 4.1 Flow chart for site characterization

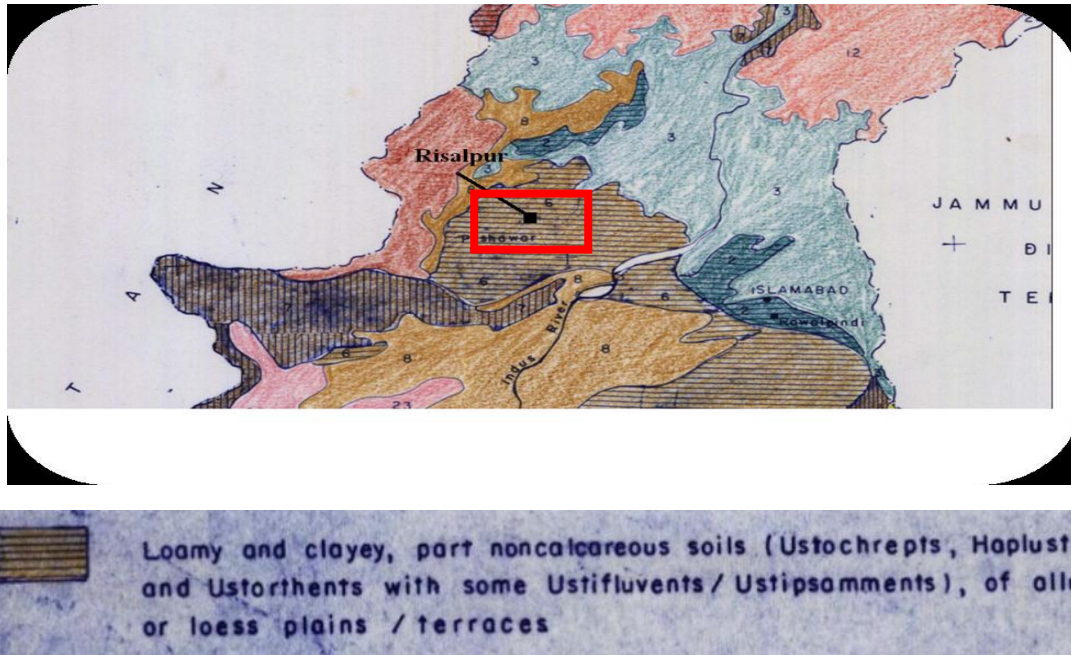
Fig. 4.2 Geological classification of Raisalpur.

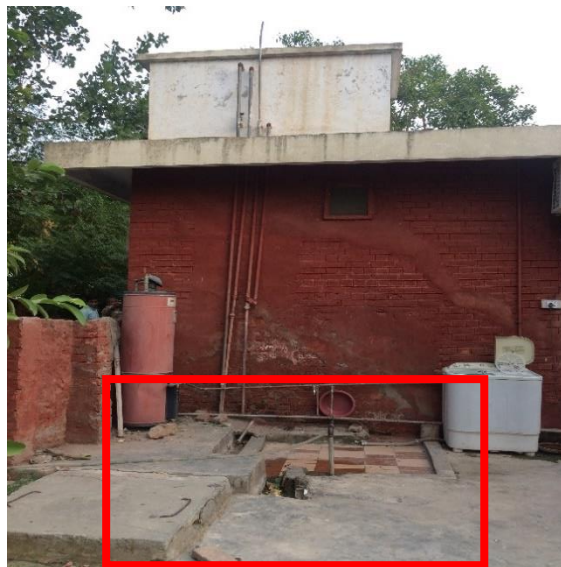
Fig. 4.3 Drainage of overflow water

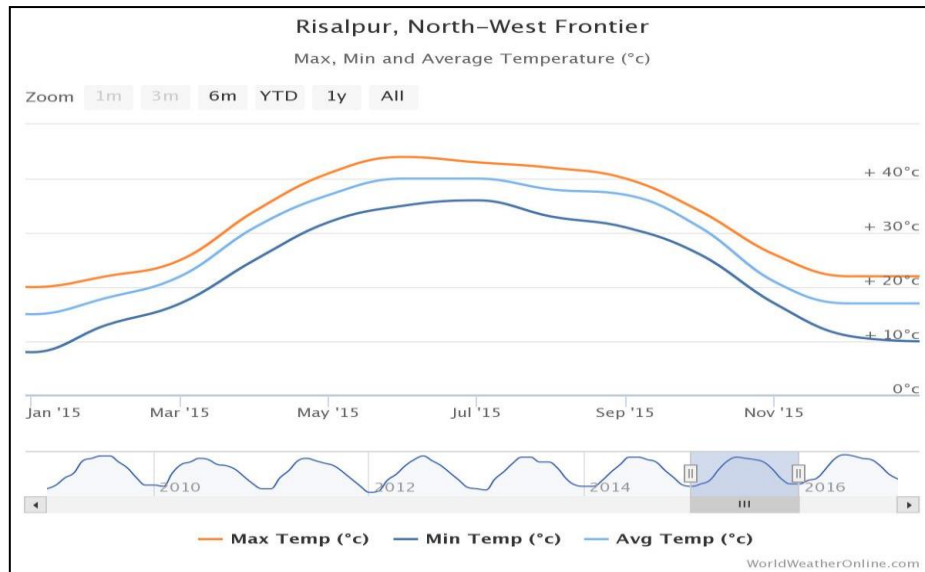
Graph 4.1: 2015 Temperature Graph of Raisalpur

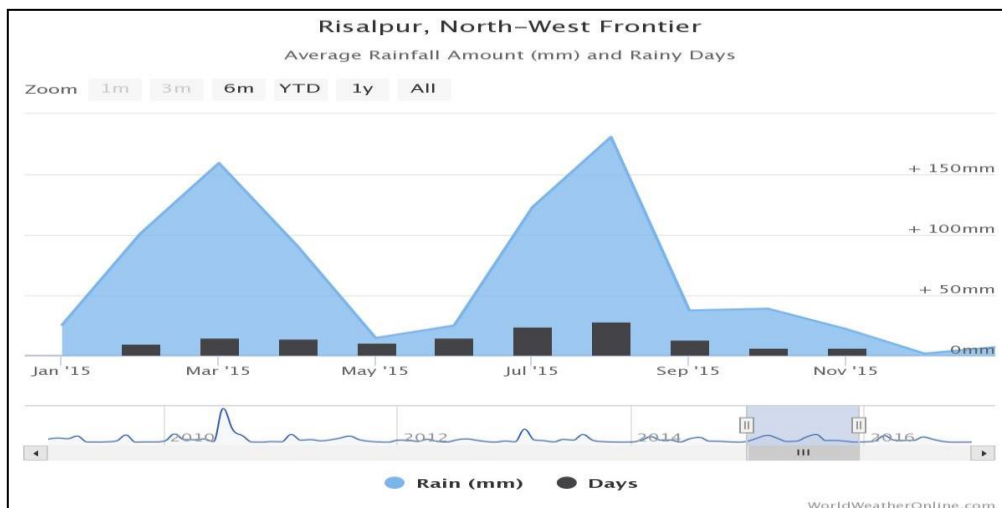
Graph 4.2: 2015 rainfall data of Raisalpur

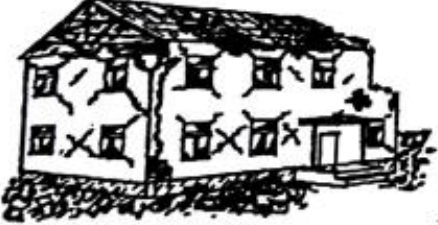
<b>Grade 4: Very heavy damage</b> (heavy structural damage, very heavy non-structural damage) Serious failure of walls; partial structural failure of roofs and floors.

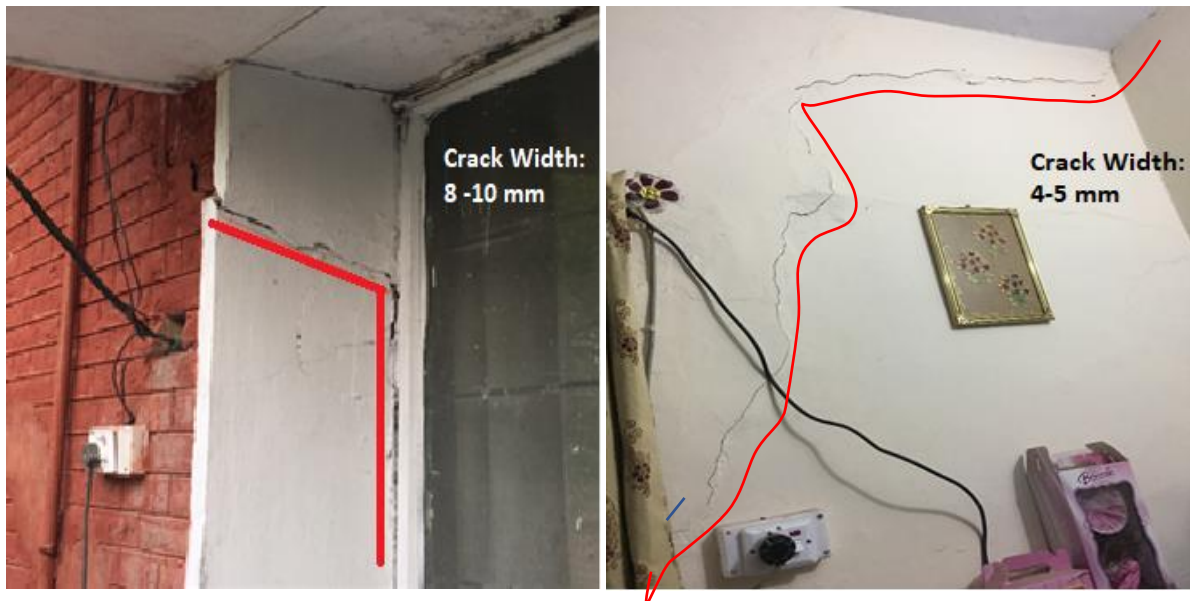
(a) Bedroom 2 exterior wall

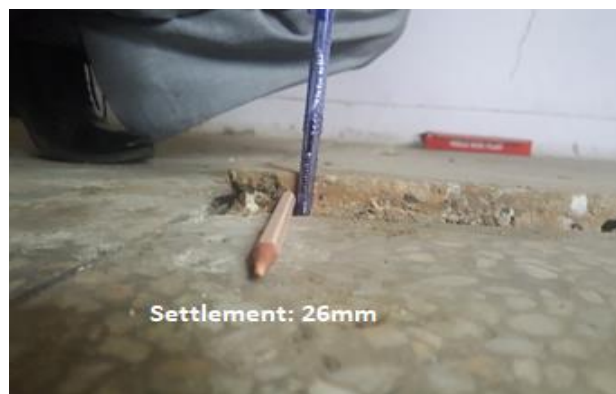
(e) Settlement in floor of Bedroom 2

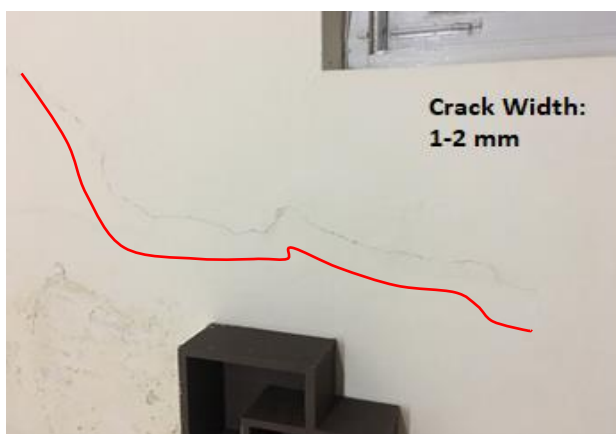
(a) Bedroom 1 interior wall

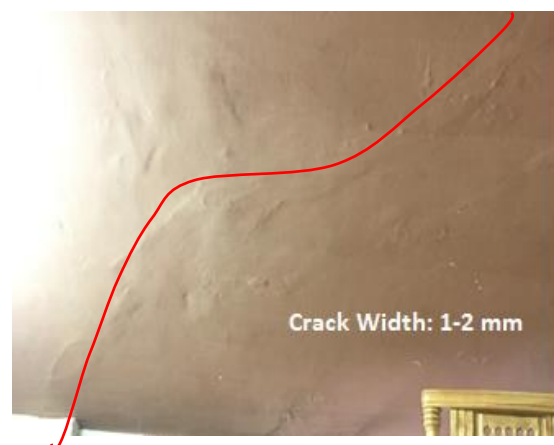
(b) Drawing Room wall

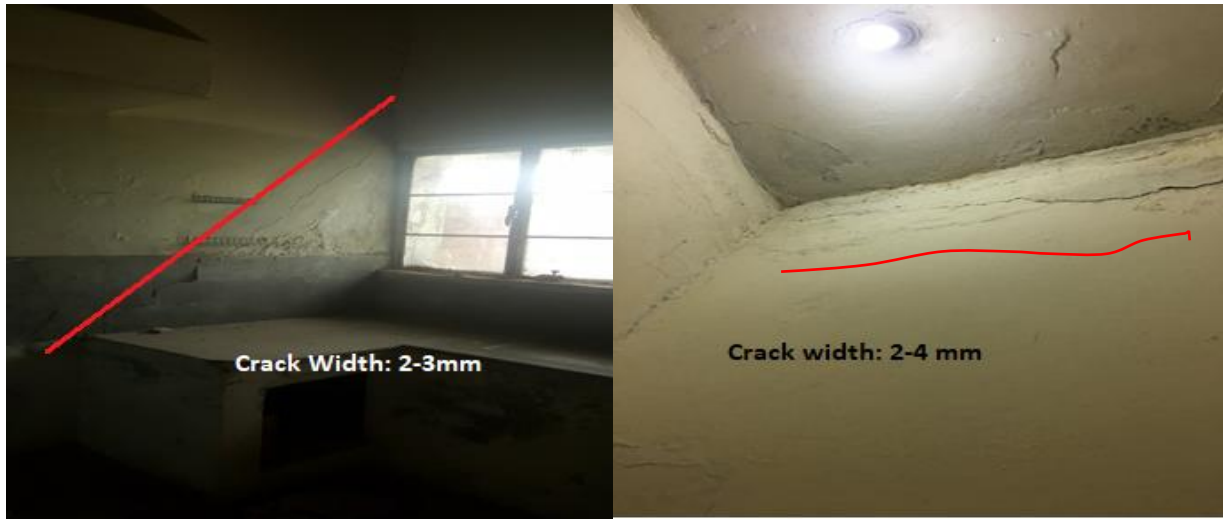
Fig. 4.8 Slightly damaged areas of the House

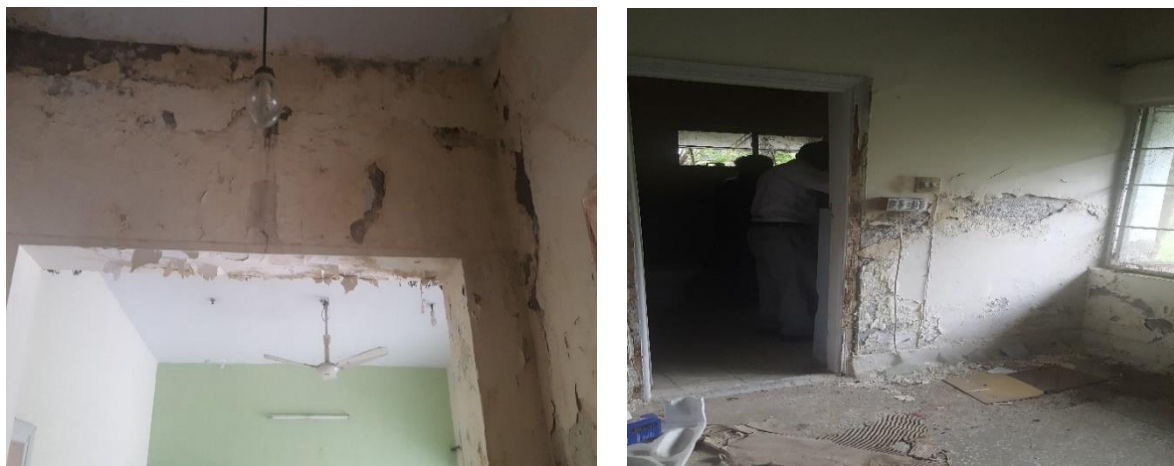
Fig 4.10 Seepage in walls

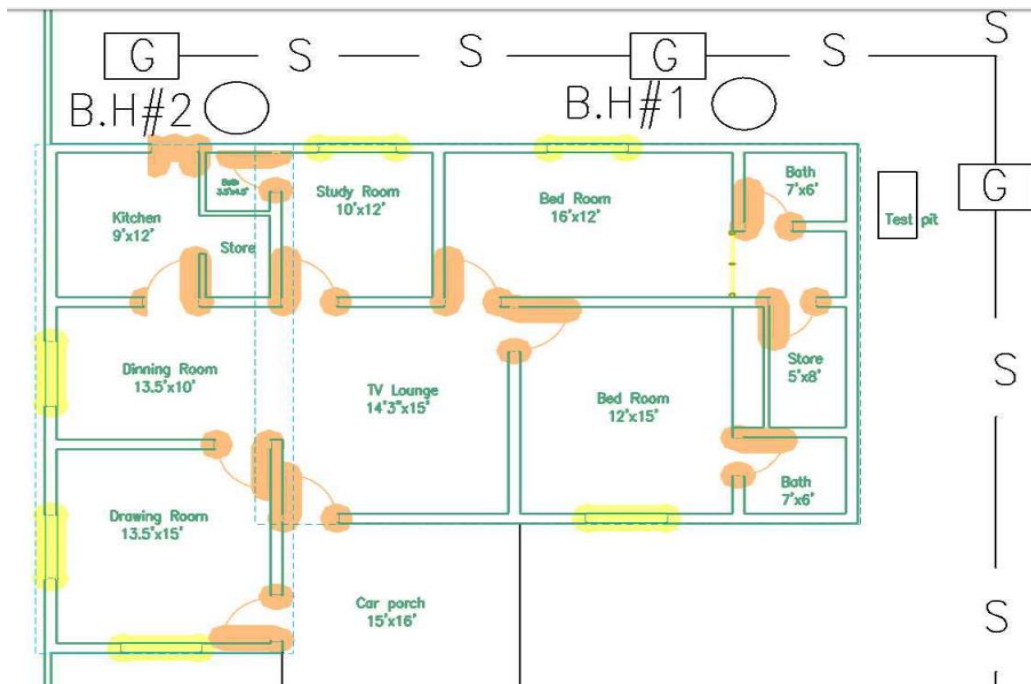
Fig 5.1 Location of boreholes

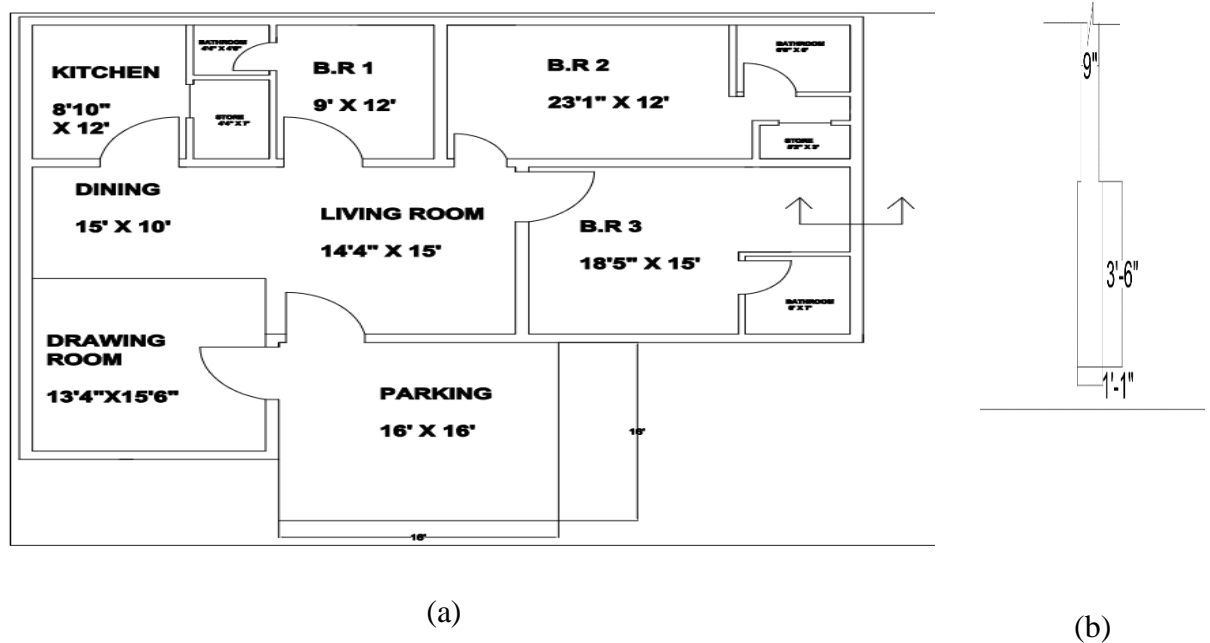
Fig 6.1 (a) Plan view of test house (b) Foundation width

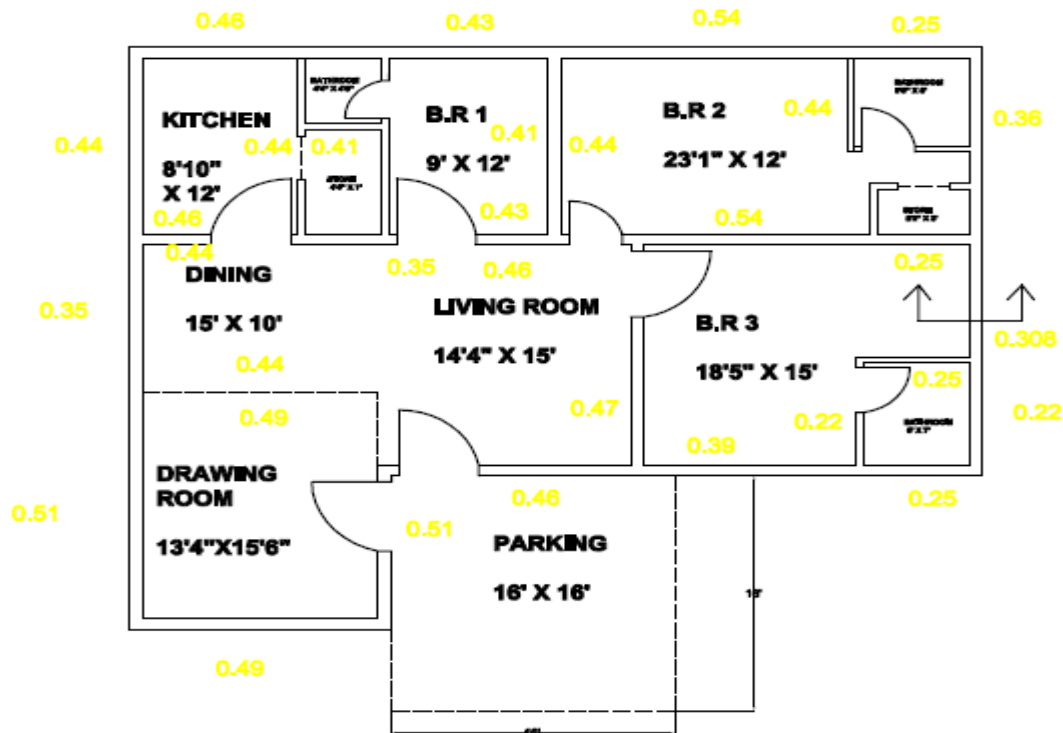
Fig 6.2 Load Distribution of slab on walls

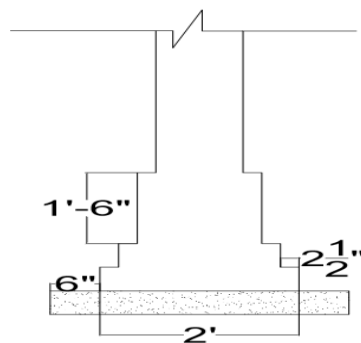
Fig 6.3 proposed Foundation.

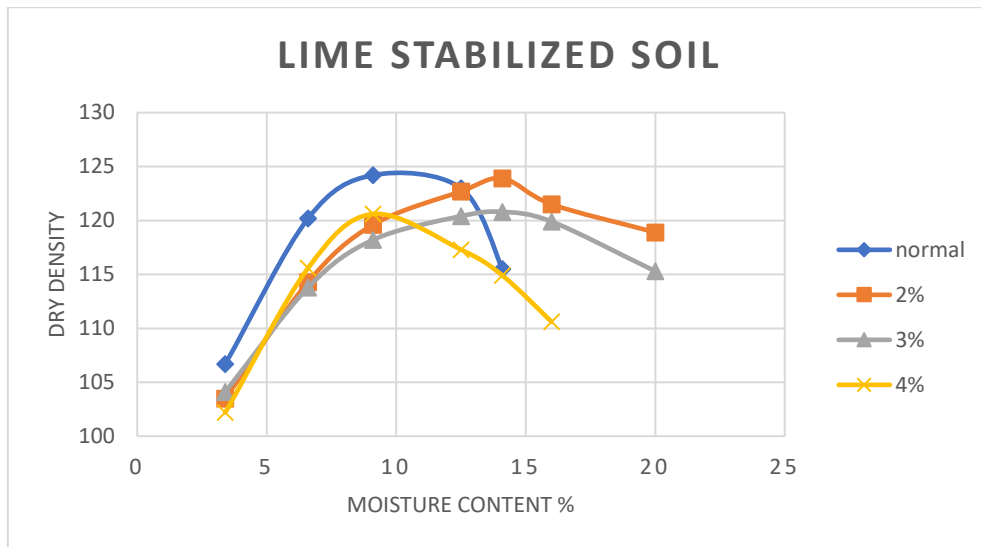
Graph 6.1 Effect of Lime Stabilization

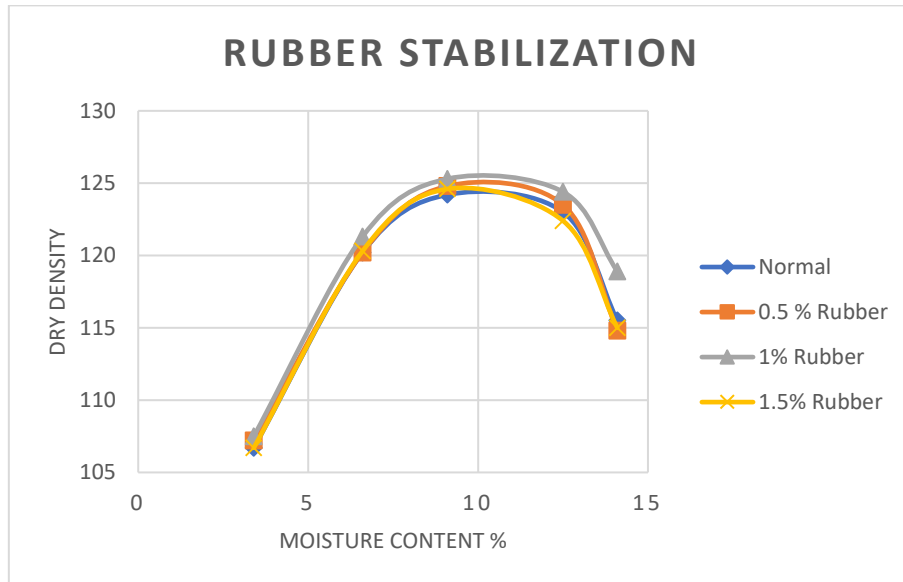
Graph 6.3 Effect of Rubber Stabilization

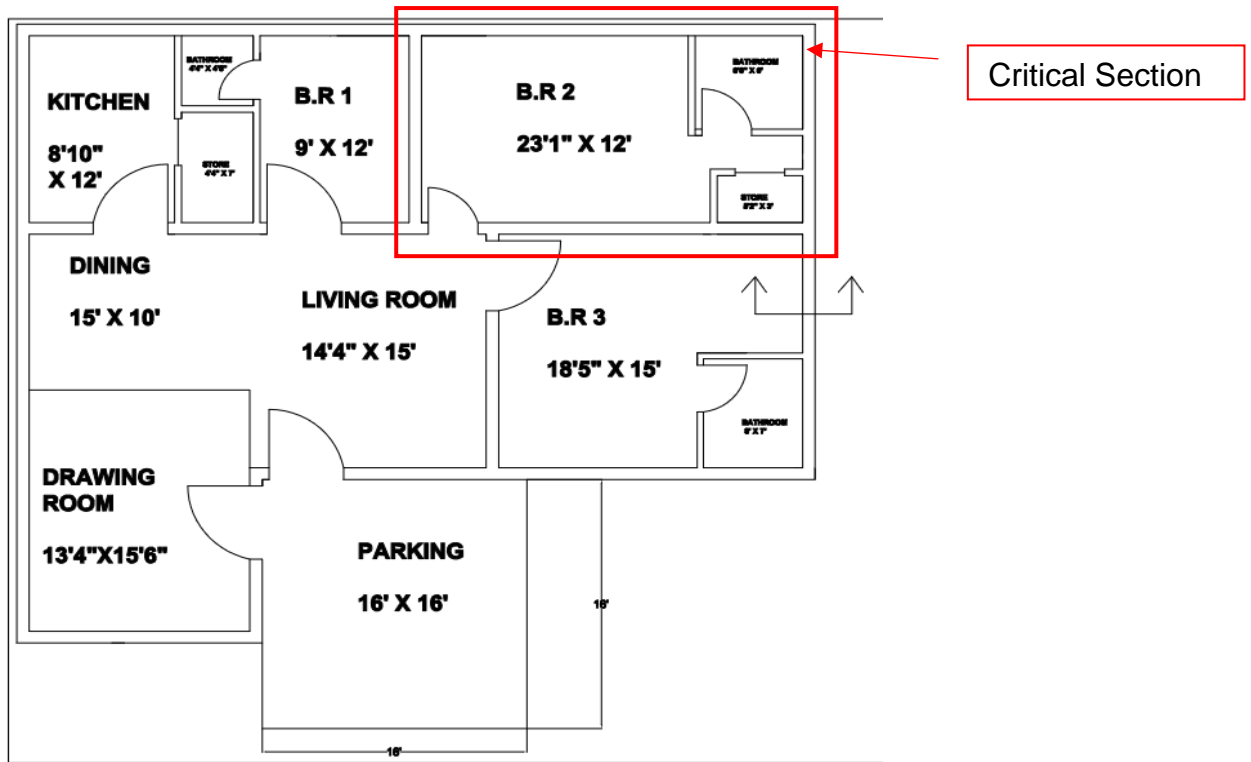
Fig 6.9 Critical section of House

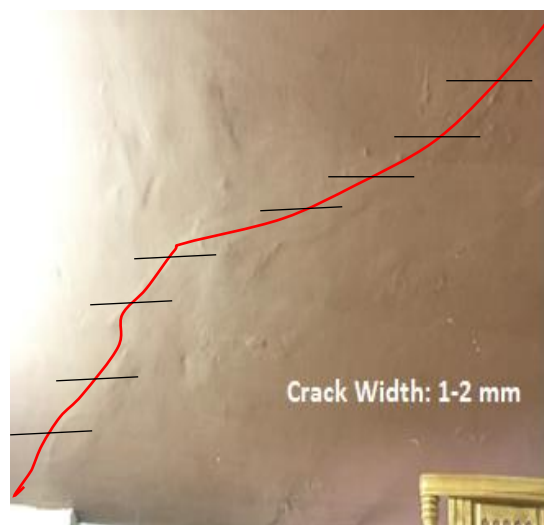
Fig 6.10 Strengthening of walls using structural repointing technique

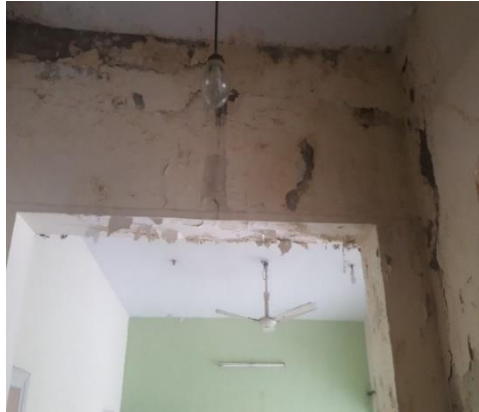
Fig 6.11 Section needed to be reinforced
