REHABILITATION OF DAMAGED CONCRETE USING ECO-FRIENDLY BACILLUS SUSPENDED GROUT

Final Year Project UG 2016

NUST Institute of Civil Engineering
School of Civil and Environmental Engineering
National University of Sciences and Technology, Islamabad
Pakistan
2020

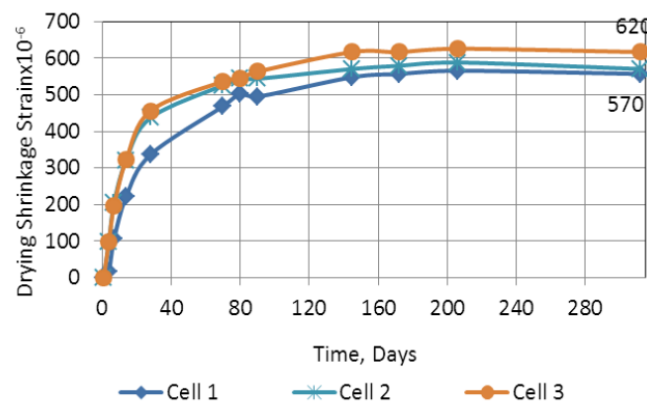
Figure 1: Free shrinkage of PCC with time

So the shrinkage induced in different repairing agents with time were studied by Stefanus Kristiawan (2016) and showed below.

It can be seen that both repair materials show similar trend of free shrinkage behaviour that is shrinkage is generally increased with time at diminishing rate. The shrinkage is relatively faster at the beginning of drying so proportional to the lost of water during evaporation and decrease as the time increase. There is differential shrinkage which generate crack again. And again, repair is needed.

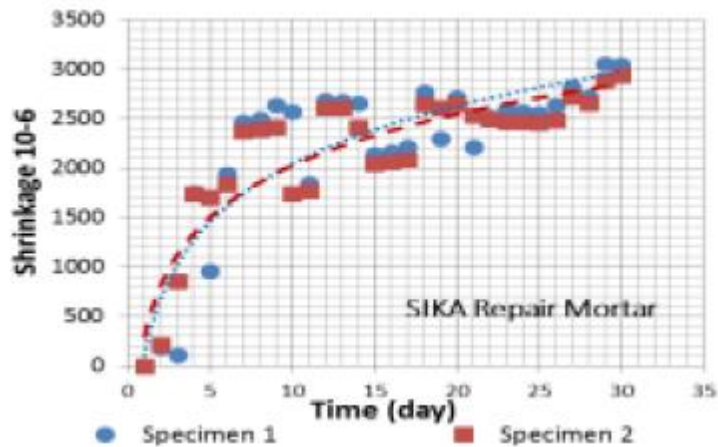
Figure 2: Free shrinkage of Sika Repair Mortar with time

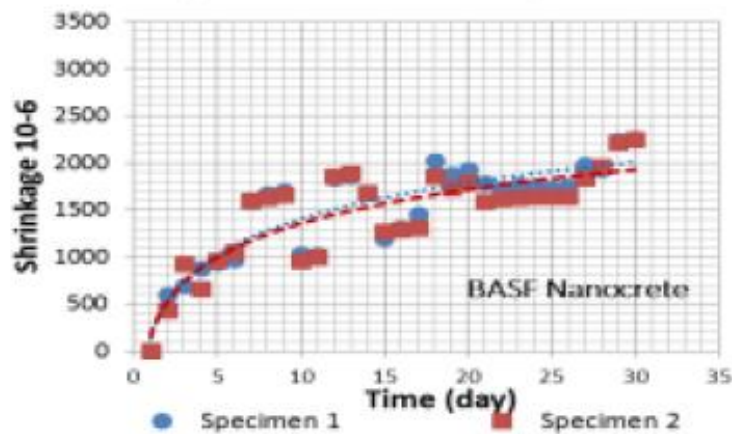
Figure 3: Free shrinkage of BASF Nanocrete with time

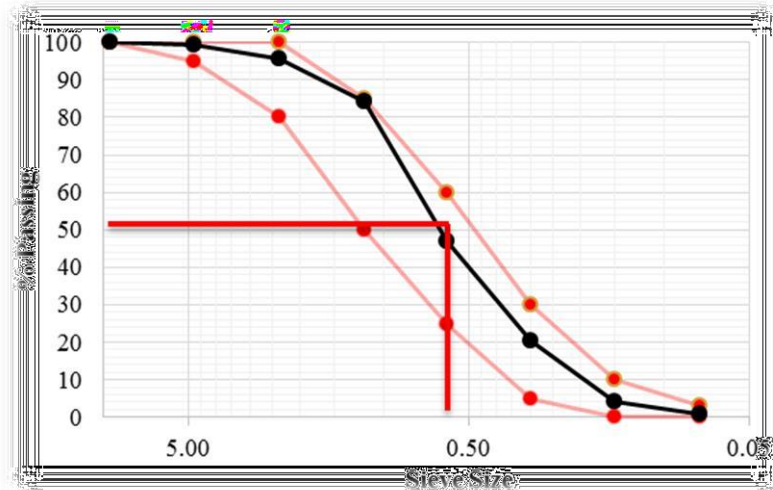
Figure 12: Particle size distribution of sand

Lawrencepur sand was used in our research bearing a fineness modulus of 2.55 which is well within the prescribed limits (2.2 to 3.2) of ASTM. The gradating curve shown in the figure below was obtained by performing the sieve analysis according to ASTM C33.

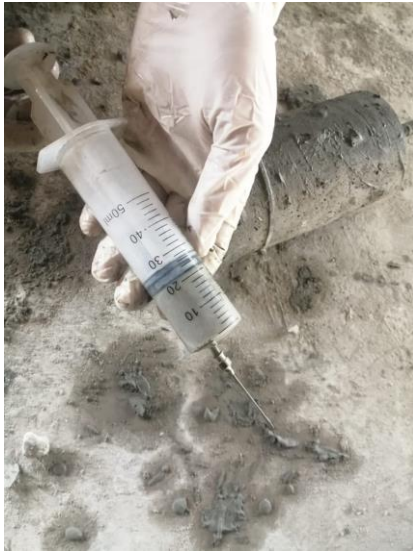
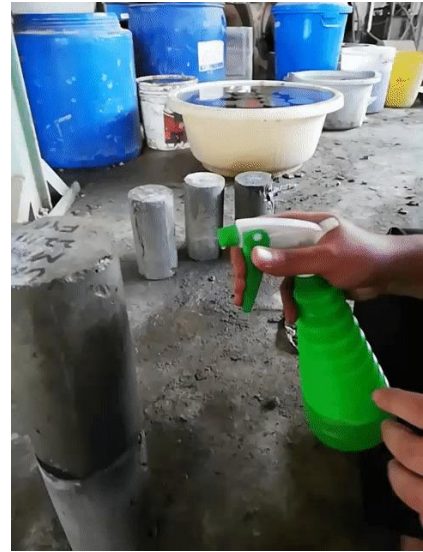
Figure 13: Pictorial representation of Application

We had five formulations. NBG, BS, BG, BZ and BSAP, out of these five formulations, four are grout while BS is suspension. In order to apply these formulations, we used injection for grout and spray bottle for BS, injection selected was based on its nozzle size and for our suspension we used a normal spray bottle, their figures are given below:

The grout was applied between the cracks of the cracked samples. The suspension was sprayed over the cracked samples using spray bottle.

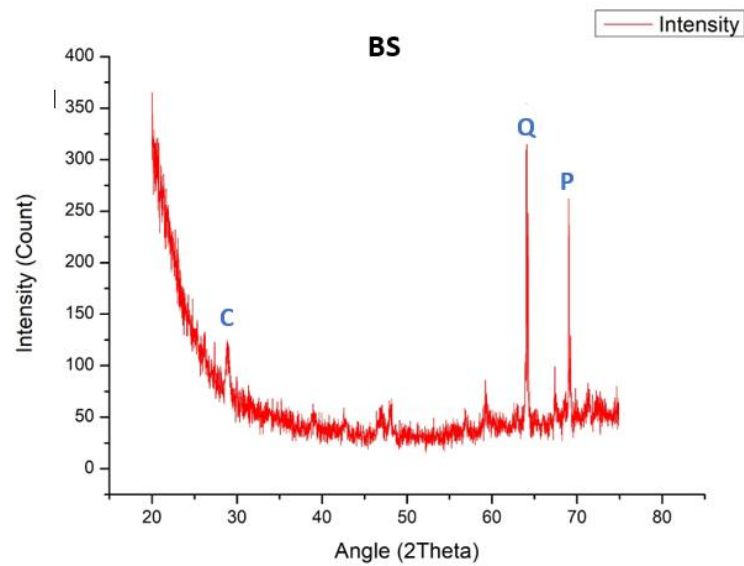
Figure 16: XRD of BS

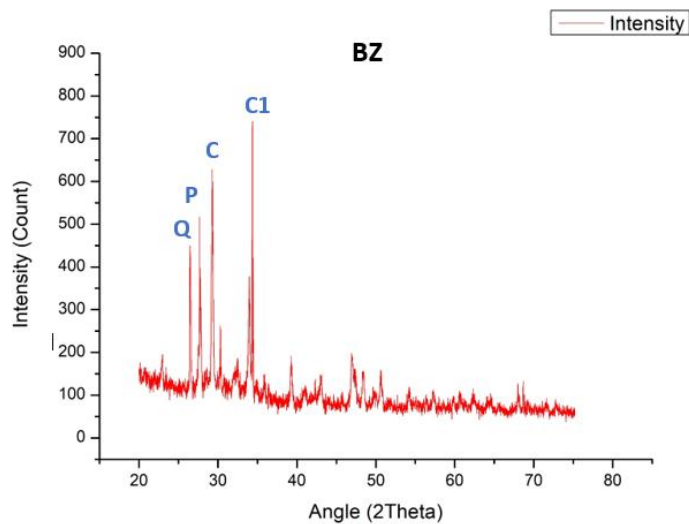
Figure 18: XRD of BZ

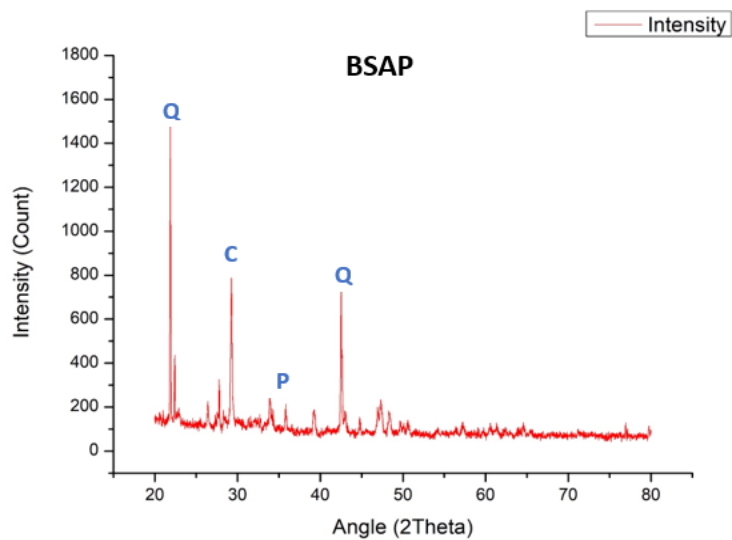
Figure 19: XRD of BSAP

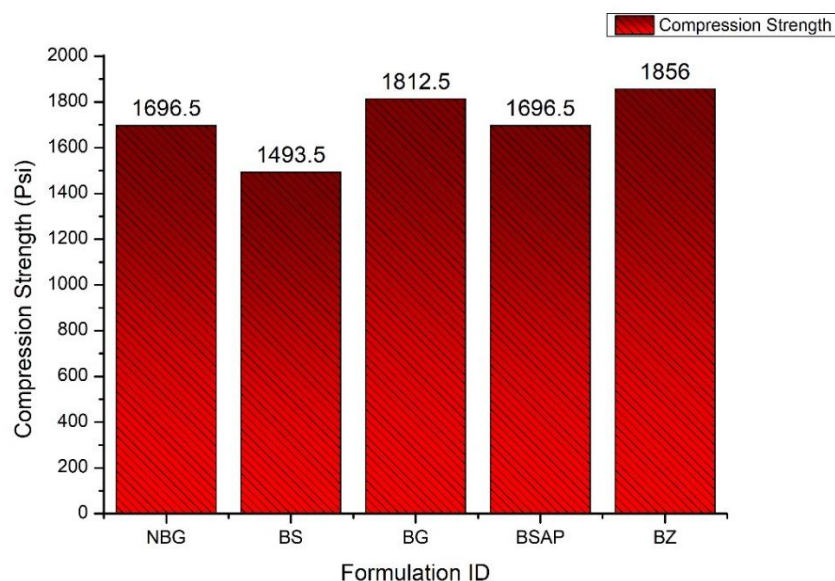
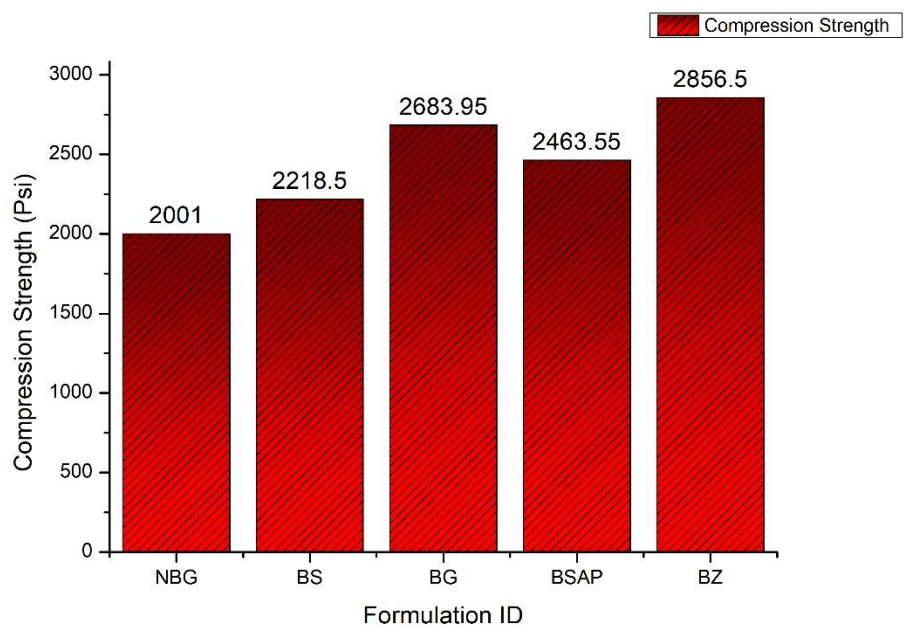
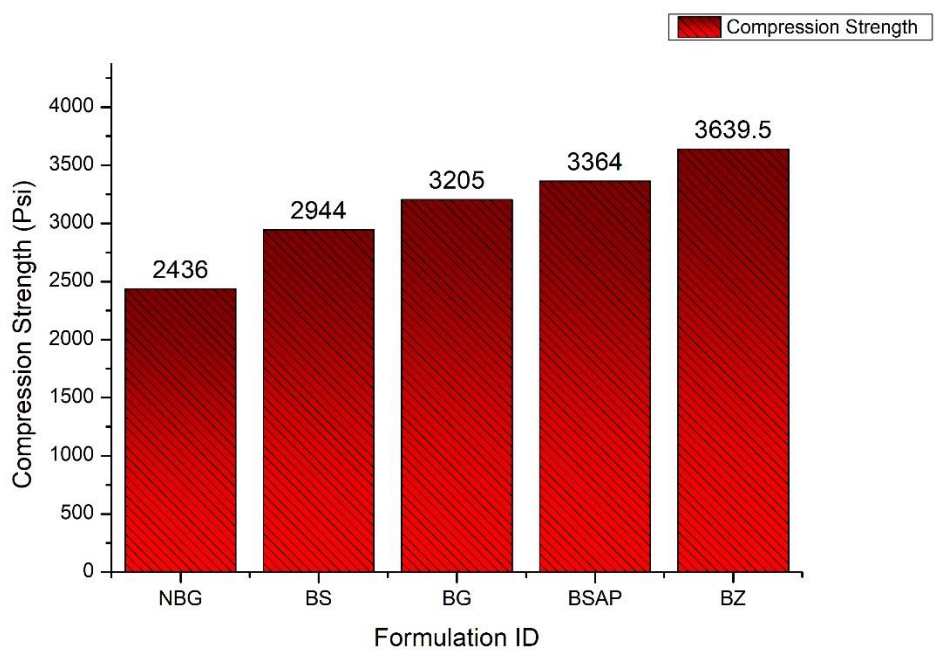
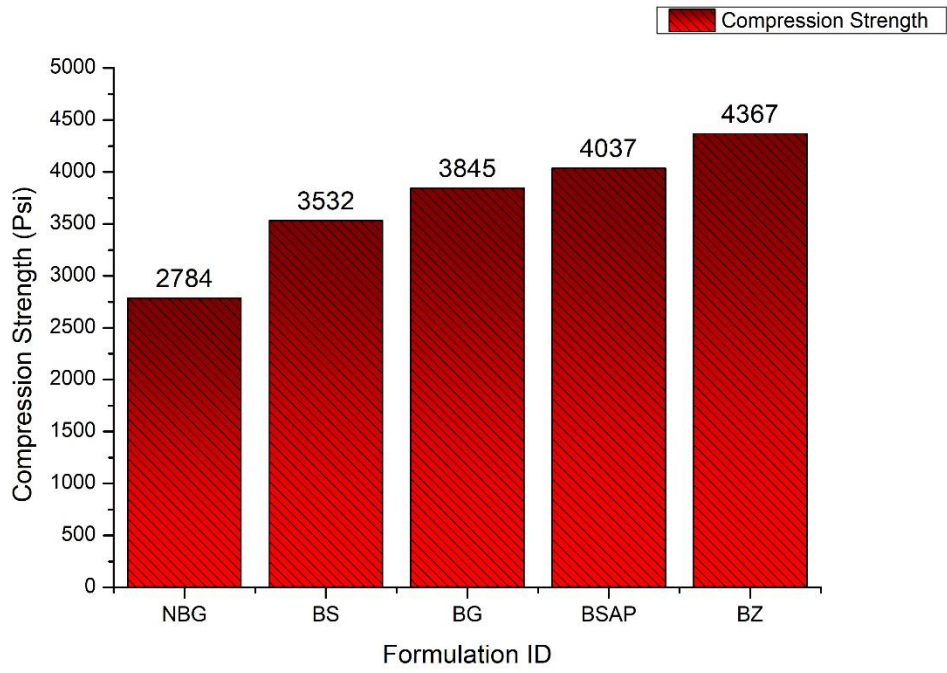
Figure 21: Compressive strengths at (a) 3 days (b) 7 days (c) 14 days (d) 28 days, of cured samples

Start with the compression strength, the graphs below show the compressive strengths of the healed concrete samples at curing periods of 3, 7, 14 and 28 days, respectively. It was observed that with introduction of our suspensions the healing efficiency has improved that results in densification of concrete matrix enabling it to withstand increased loads with maximum regain strength for BZ.

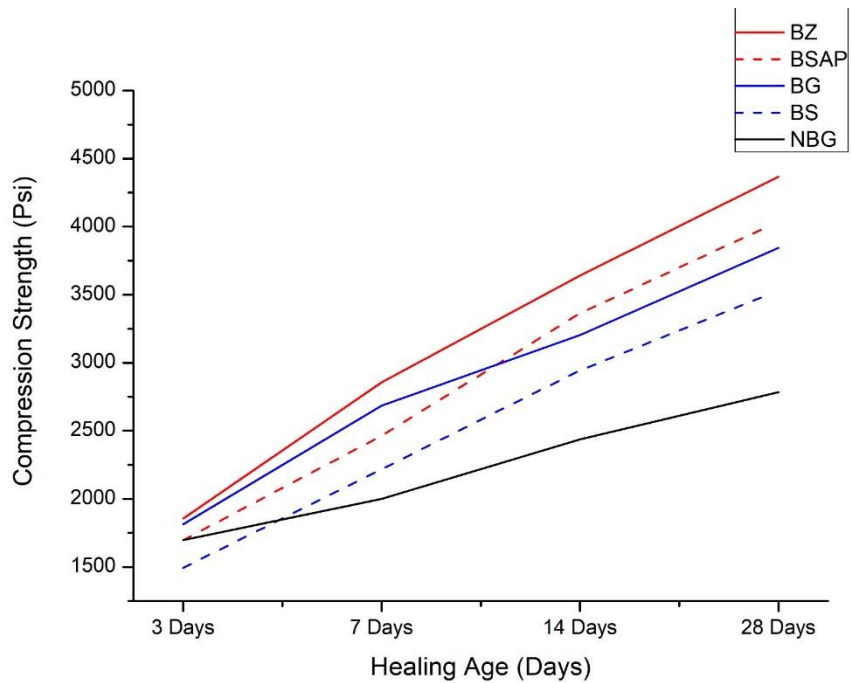
Figure 22: Compressive strengths recovery rate with healing age, of cured samples

Generally, if we analysis the results we can see that the compression strength recovered in the healed samples ranges from 60 to 90 % of its initial strength. The matrix figure below shows strength recovered against respective cured periods. The maximum of 96.7% strength recovery was observed for BZ.

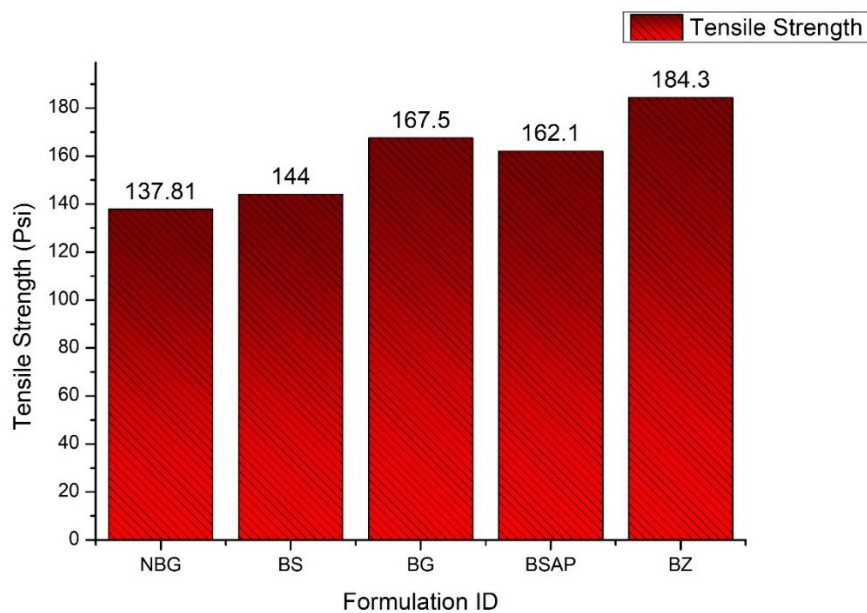
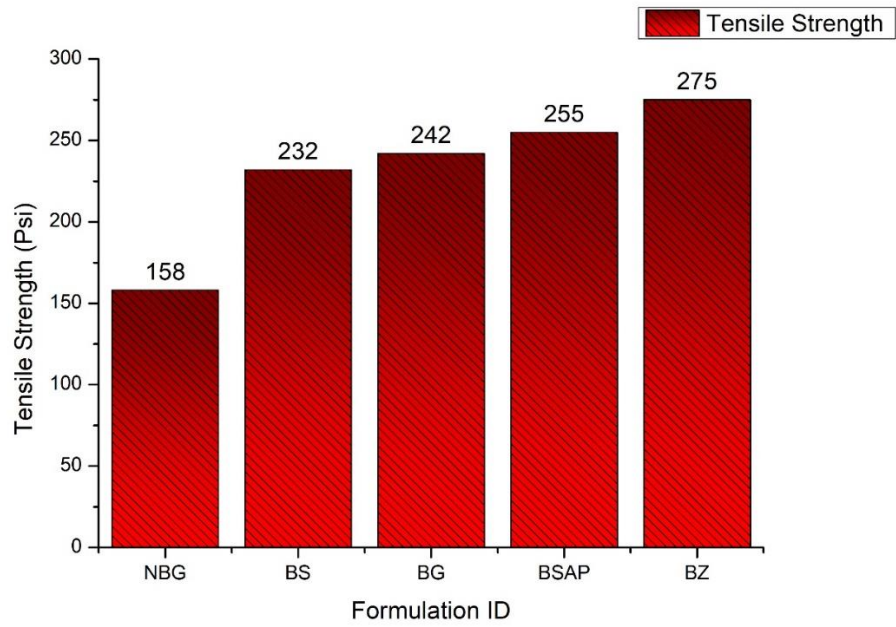
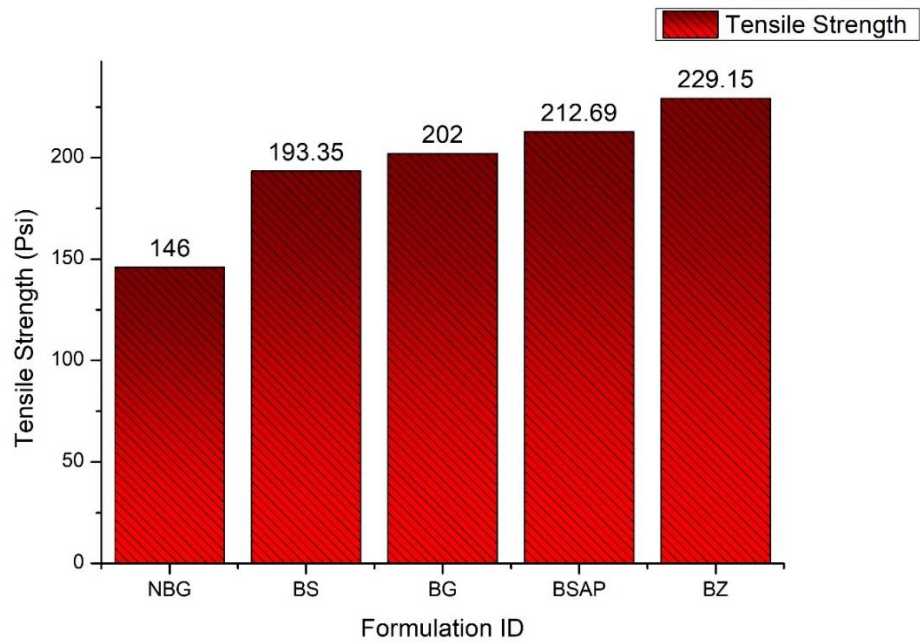
Figure 24: Tensile strengths at (a) 3 days (b) 7 days (c) 14 days (d) 28 days, of cured samples

Now SRI for the tensile strength, the graphs below show the tensile strengths of the healed concrete samples at curing periods of 3, 7, 14 and 28 days, respectively. Here also it was observed that with introduction of our suspensions the healing efficiency has improved that results in densification of concrete matrix enabling it to withstand increased loads with maximum regain strength for BZ.

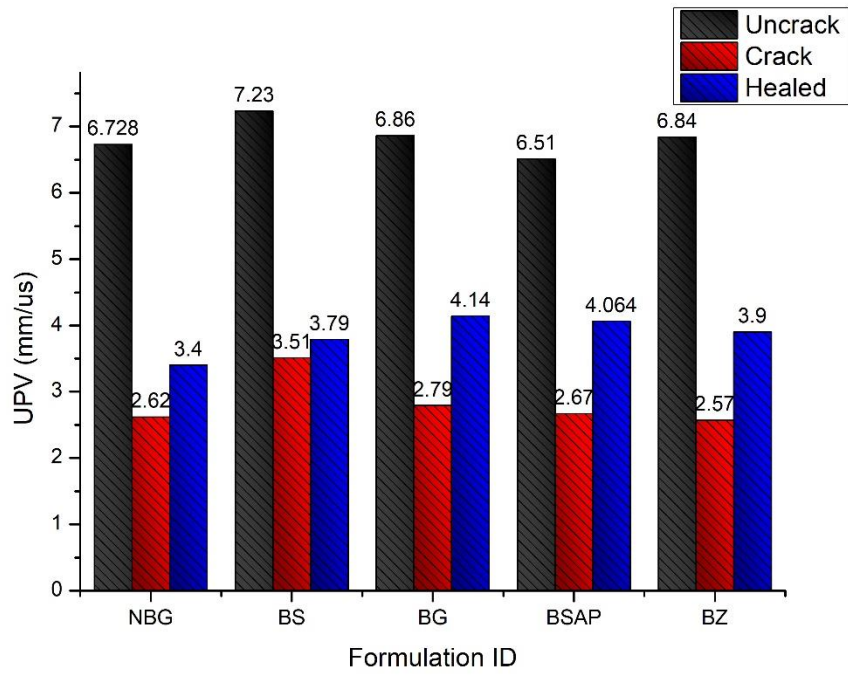
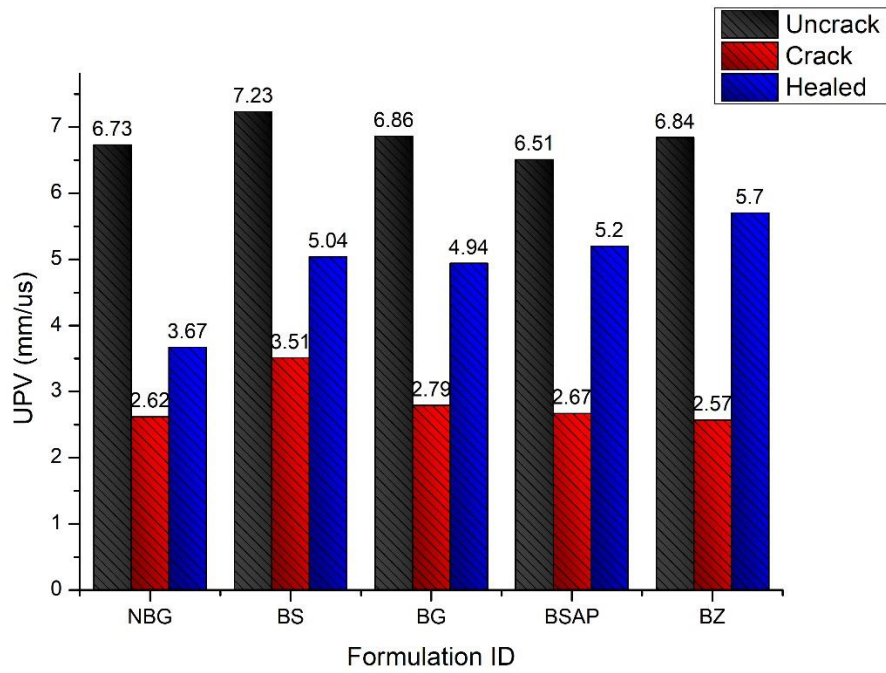
Figure 27: UPV on (a) 3 days (b) 7 days (c) 14 days (d) 28 days, uncracked, cracked and healed samples

The results of UPV compliment the previous test results that were performed to check the healing capability of our suspensions. It can be seen that with increase in healing age, the UPV velocity increases indication that healing is taking place in samples on with our bacterial suspensions were applied as compare to NBG. Among all of them BZ gives the best results with the UPV of healed sample is 83.3 % of uncracked sample.

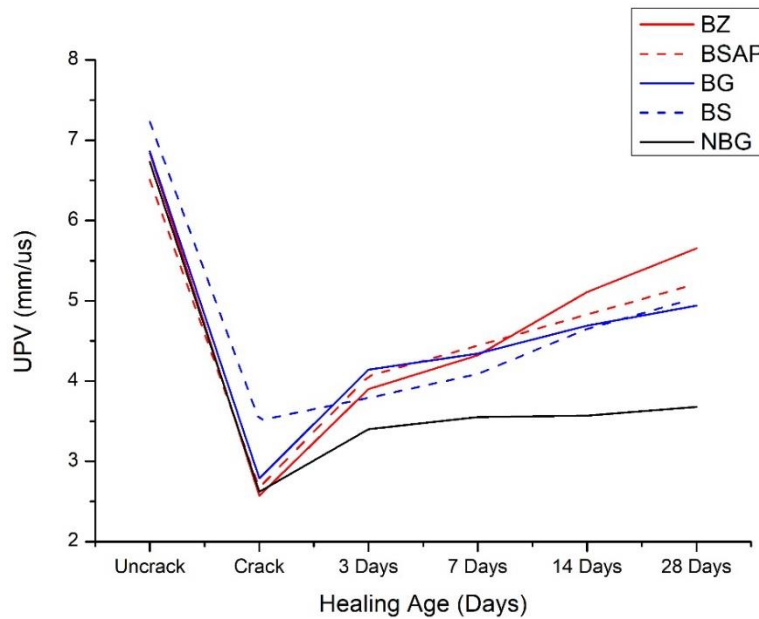
Figure 28: UPV recovery rate with healing age, of cured samples

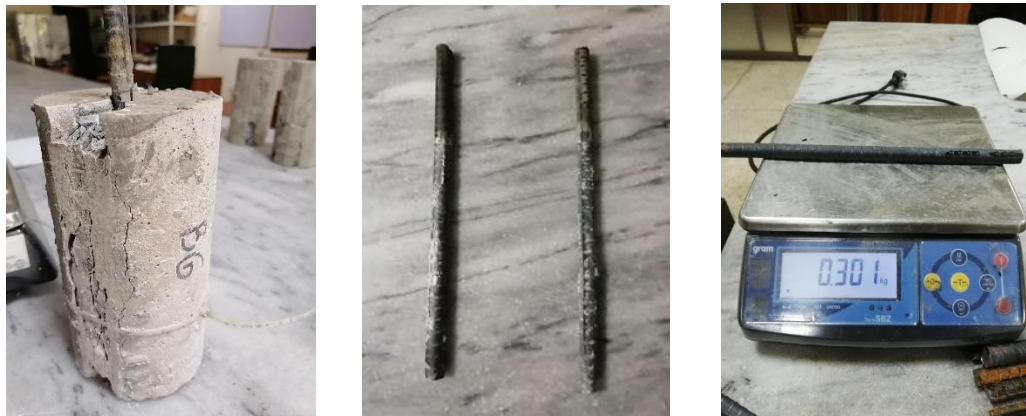
Figure 29: Pictorial description of weight loss measurement test

Weight loss measurement is a classical technique to determine the corrosion rate of the rebar in the concrete samples. Weight of the rebars before casting was noted using balance with accuracy of up to 0.1 g. The same cylindrical samples with rebar at its center were casted and were placed for curing. After the 28 days curing period, the samples were dipped in 3.5% NaCl solution and a DC supply of 12 V was applied for 12 hours. The Samples were then broken down and the corroded bars were cleaned using both mechanical and chemical methods.

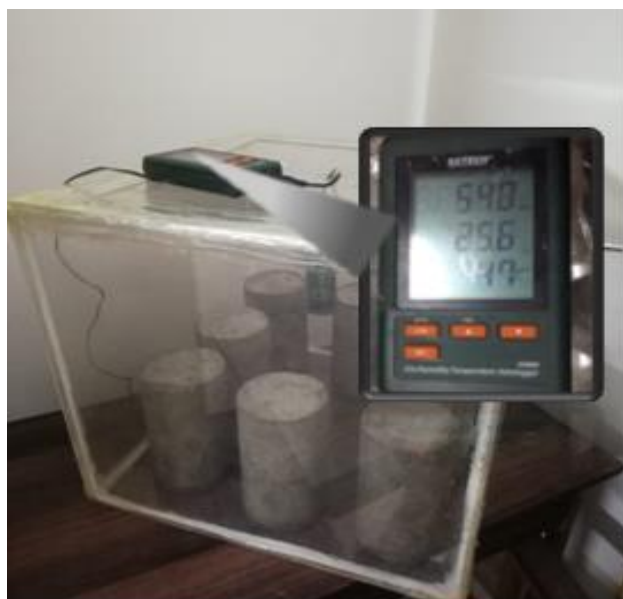
Figure 32: Real time CO₂ monitoring in the climate control chamber

As seen, chamber is a cuboid having a length, width, and height of 1.5 feet made of 6 mm acrylic glass. Mounted on the top is EXTECH sensor that records CO₂, humidity and temperature with time. The sensor can be time calibrated with minimum stage of 1 minute with its probe suspended inside the chamber. The sensor was set at a stage of 10 minutes. The sensor comes along with a data logger that continuously records the readings, as per the stage set, in an excel file which can be retrieved through the memory card fitted inside the sensor.

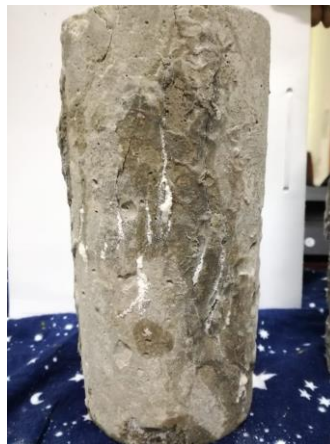
Figure 38: Autonomous healing of BZ repaired sample in 2nd cracking cycle

In order to investigate the performance of optimum formulation against multiple crack healing cycles, the concrete samples that was repaired with BZ was cracked again until noticeable cracks were formed. It was then left into water tank for water curing for 28 days. Visually almost all the cracks were repaired through autonomous healing. Visual evidence of this autonomous crack healing is given below
