Repair of Damaged Strip and Stirrup Confined Beam Column Joints Using Carbon Fiber Reinforced Polymer

MILITARY COLLEGE OF ENGINEERING
NATIONAL UNIVERSITY OF SCIENCES AND
TECHNOLOGY, RISALPUR
AUGUST, 2018

A thesis submitted in partial fulfillment of the requirements for the degree of
MS Structural Engineering

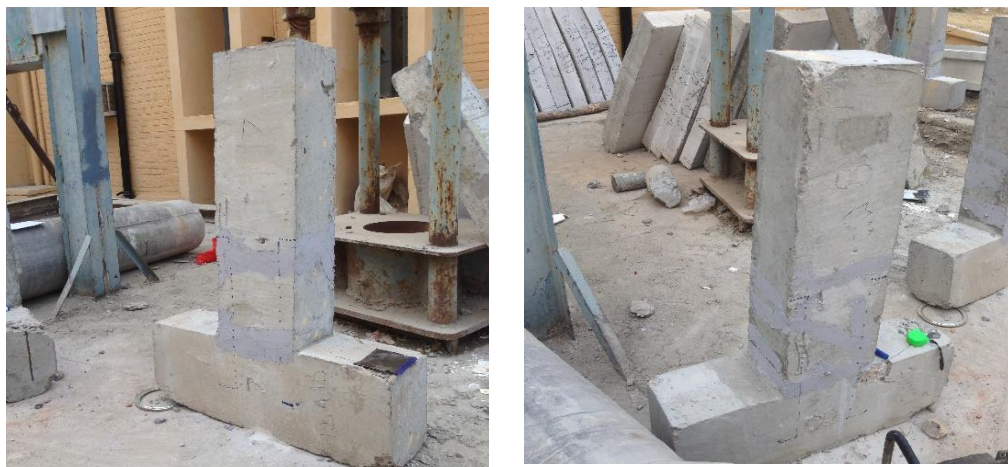
Figure 3.2 Joints repair work using non-shrink grout Chemdur-31

- i. First of all, joints surfaces with cracks were washed with the help of brush or air pressure.
- ii. When the cracks were washed joints were made completely wet.
- iii. After that resin was made and put it in the cracks so that each crack was completely filled so that no crack space was kept free. And after that these were dried before testing

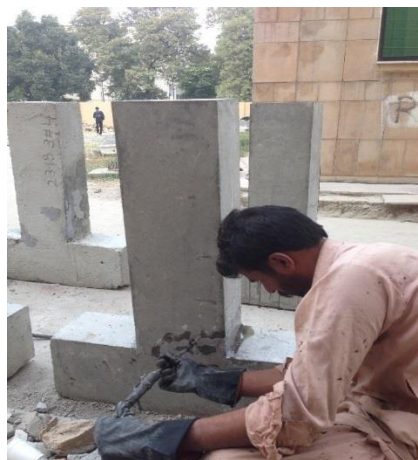
Figure 3.3 Filling of joint cracks using resins

After filing the cracks resins is applied. There are many types of resins but some are described below:

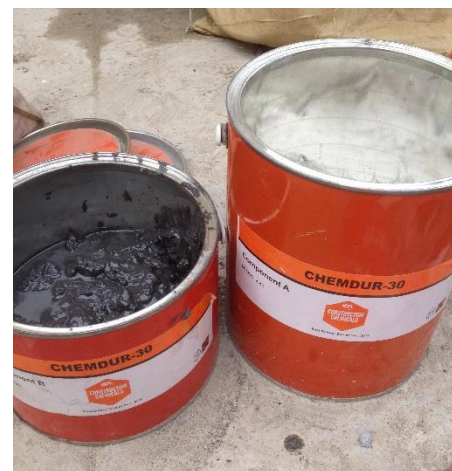
Chemdur -31

It is solvent free, thixotropic, epoxy mortar based on a combination of epoxy resins. It can be used as concrete repairs, blow hole filling, cracks and surface filling, structural adhesive for precast concrete elements, columns.

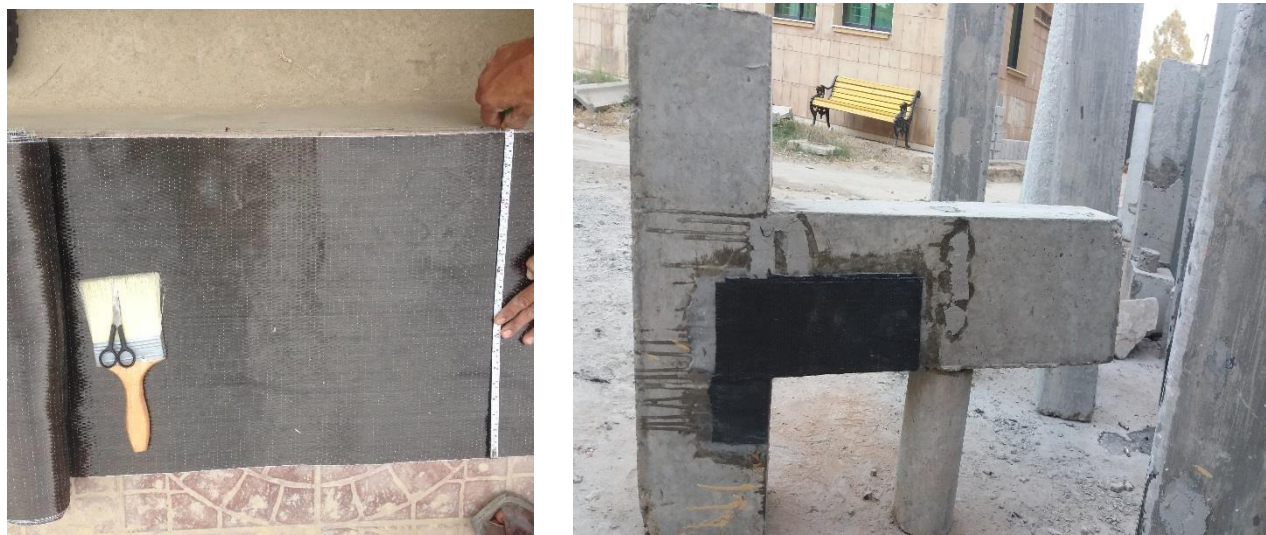
Figure 3.4 CFRP being applied to damaged specimen

To ensure the bond between concrete surface and CFRP wrap, epoxy adhesive was utilized. Properties of CFRP composite and epoxy adhesive used for strengthening and retrofitting are presented earlier in Table 3.1 to 3.4.

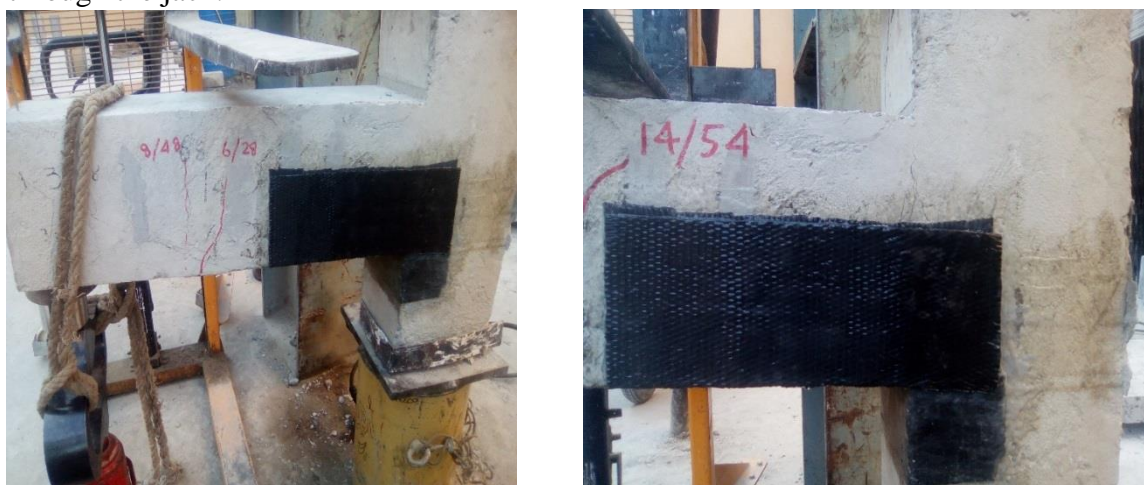
Figure 3.6 Joints repaired using CFRP

During the conduct of test the compressive load was kept constant on the column, thus nullifying any chance of column movement. The nomenclature assigned to beam column joints is discussed above. CRCJ represents Conventionally Reinforced Concrete Joints and SSCJ represents Steel Strip Confined Joints. A load cell was placed over a hydraulic jack and this arrangement was placed under the free end of the beam. Load on beam was then applied through the jack.

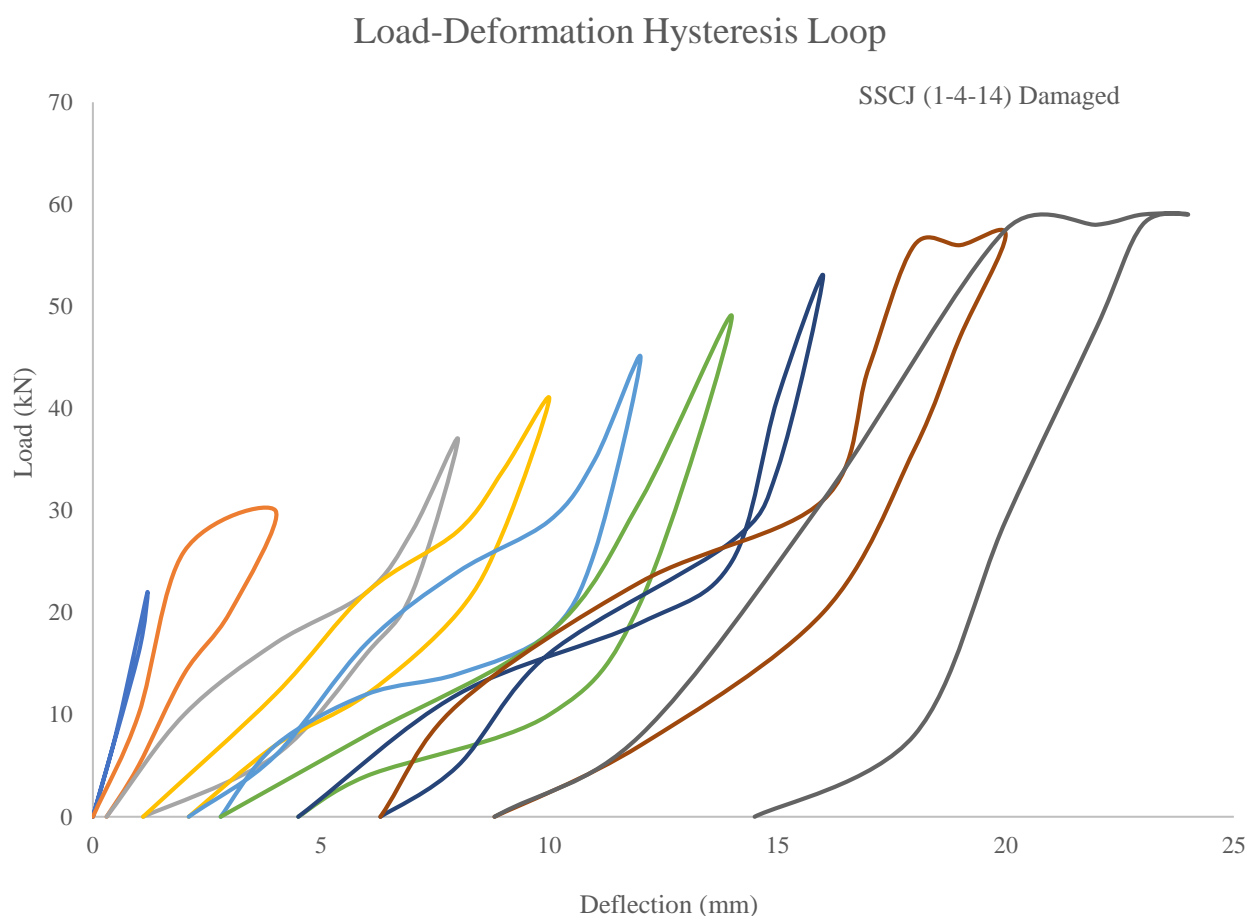
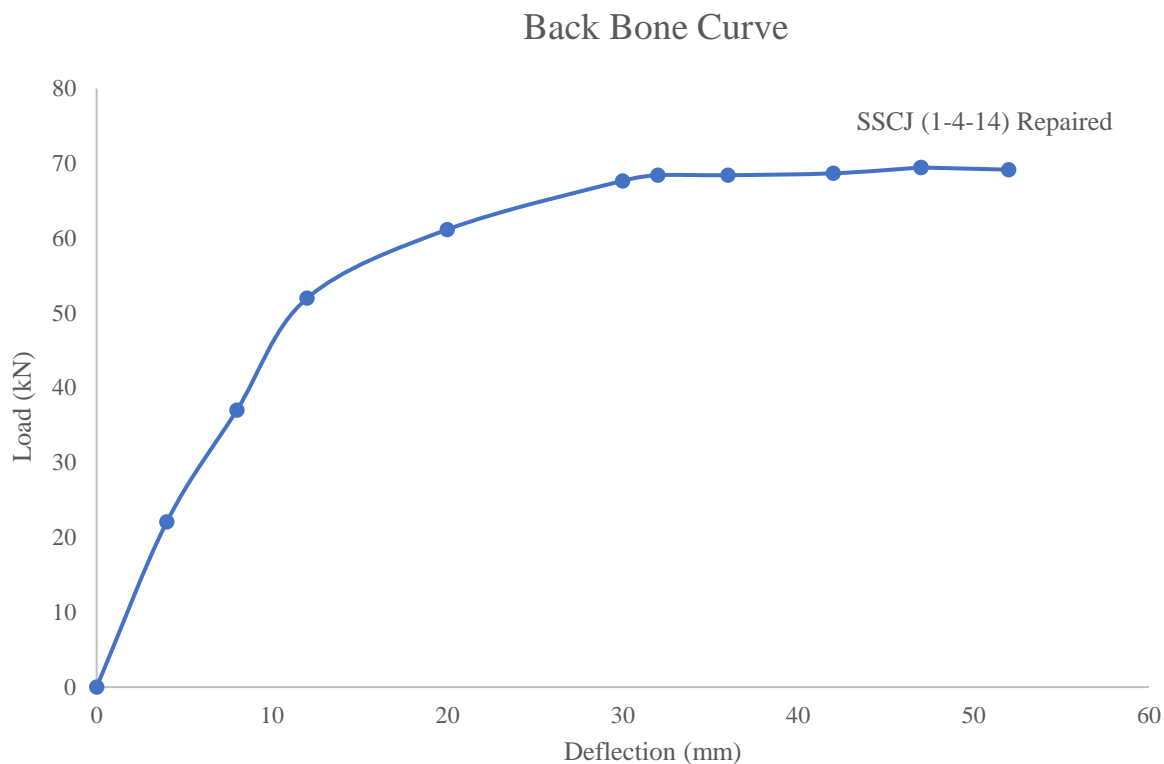
Figure 4.3: SSCJ 02 (1-4-14) Curves

In 9th cycle of loading 20% degradation was achieved. The deformation in the joint started at 18 KN load during the 1st cycle and achieved a displacement of 1 mm, while for repaired specimen at the load of 20 KN displacement was 3mm, with the appearance of a hair line crack at a distance of 9 mm from joint. In the 9th cycle peak load of 59 KN was recorded, while for repaired peak load was 69 KN. The residual displacements became significant after 5th cycle. The residual displacement was 14.5 mm at the completion of test. The hysteresis response and backbone curve are shown below.
