FORENSIC DISTRESS EVALUATION OF CADETS BLOCK

PAF ACADEMY ASGHAR KHAN

FINAL YEAR PROJECT UG 2014

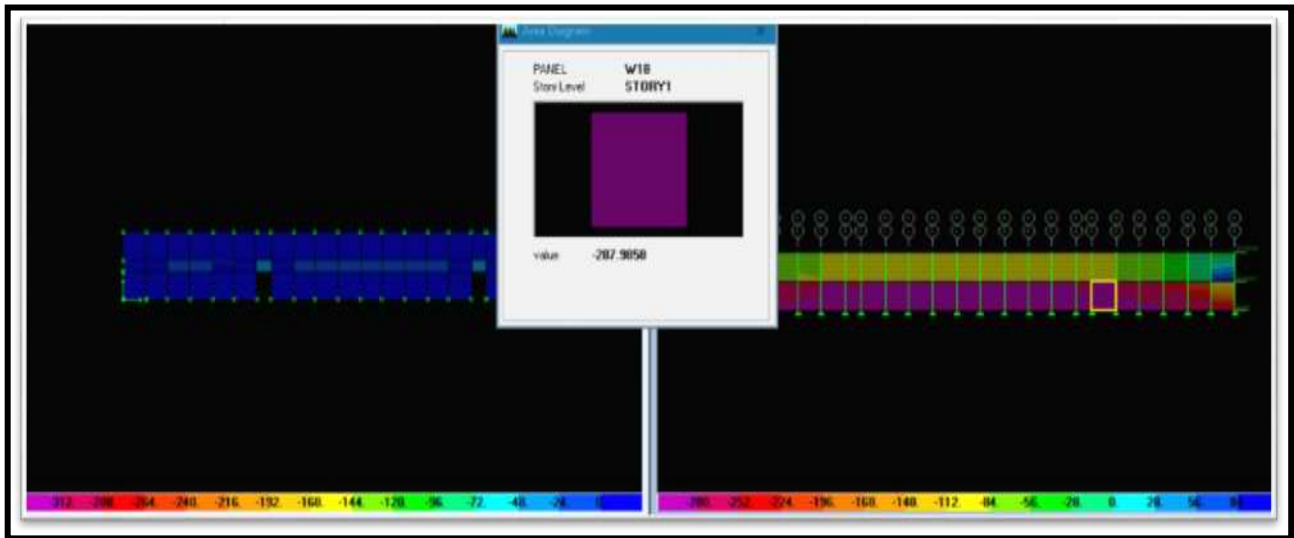
**F MAX ELEV 4 (NEAR STAIRS) Top Floor
= 288 psi**

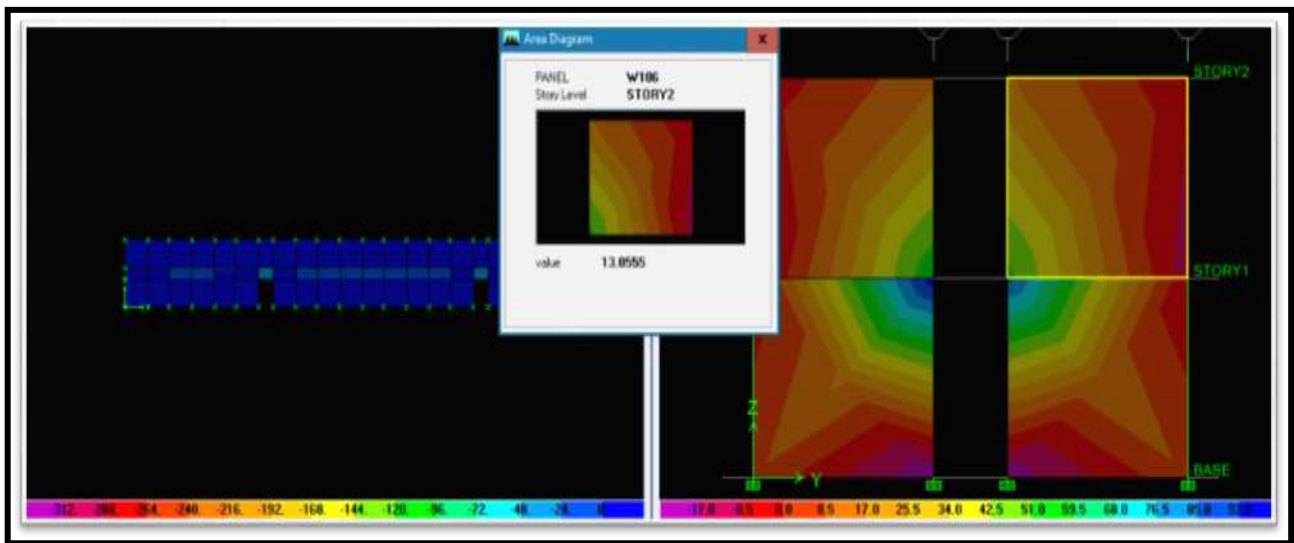
F MAX ELEV H (NEAR STAIRS) Top Floor
= 15 psi

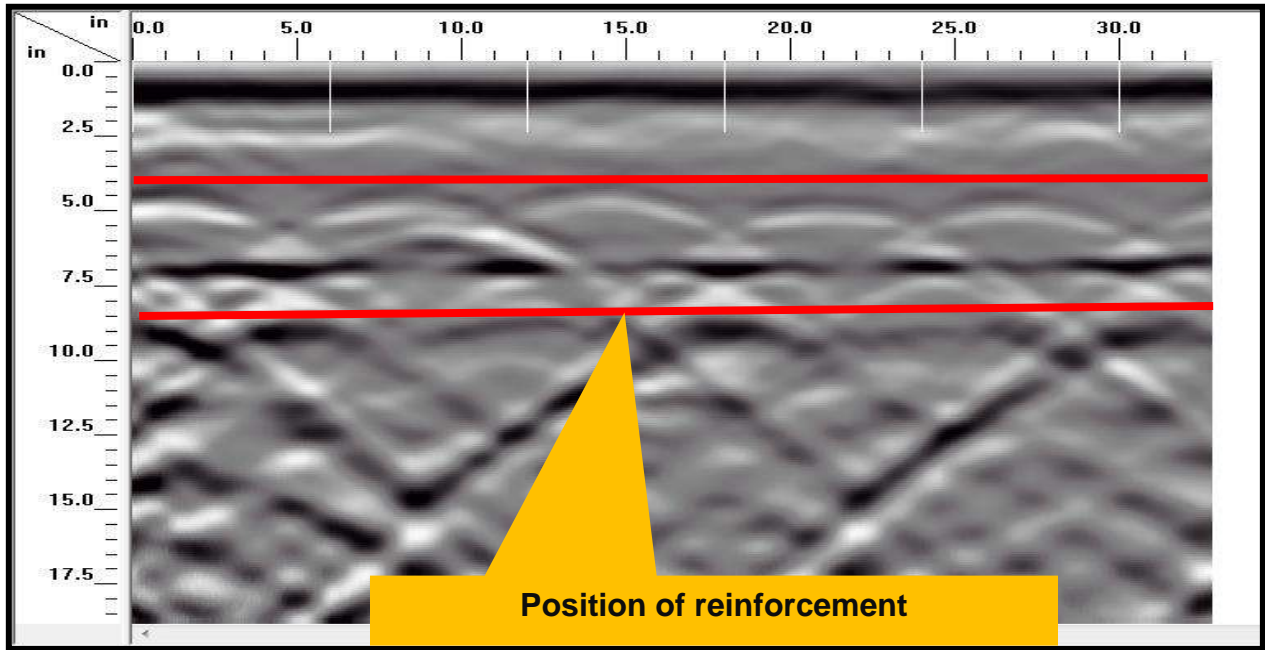
19. Analysis by RADON Scanner

- By calculating slab reinforcement based on geometry, spacing of reinforcement should be 10” as verified by the scanner
- Thickness of slab is 5 “
- So no issue with the slab reinforcement
- Slab has lost his strength due to seepage problems

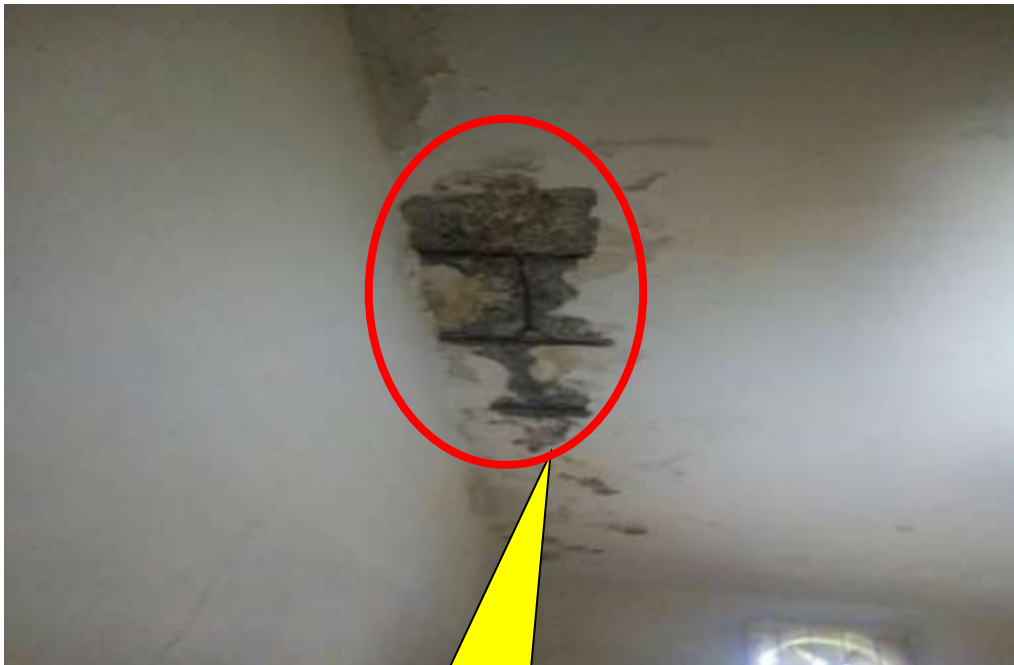
Spalling of Concrete

Firstly, the broken and loose pieces of concrete to be removed keeping in mind the structural stability of the structure, then the solid concrete and corroded steel rods completely uncovered. By scrubbing or grinding rust should be removed from the steel, depending on the extent and level of corrosion. Next, anti-corrosive epoxy primer or cement based anti-corrosive coating to be applied on the exposed steel bars in order to protect them from further corrosion.

Subsequently, the peeled area will be repaired by the application of high performance patching mortar, in order to restore the monolithic nature and strength of the damaged structural element.

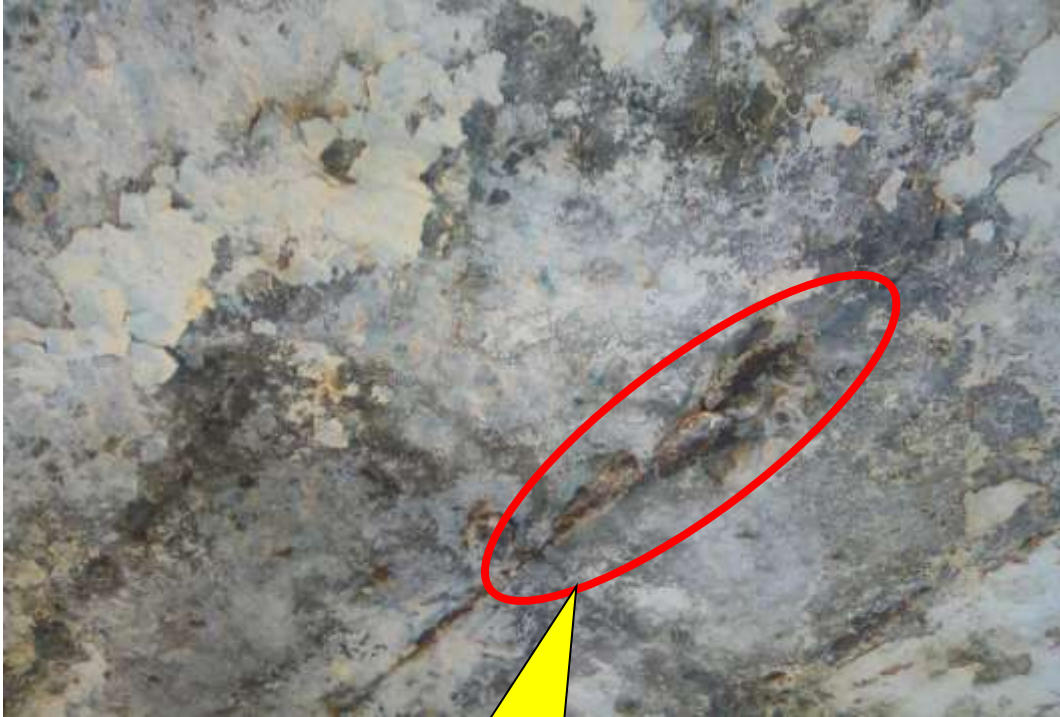
Corrosion of Reinforcement

24.5 Replacement of Corrosive Reinforcement

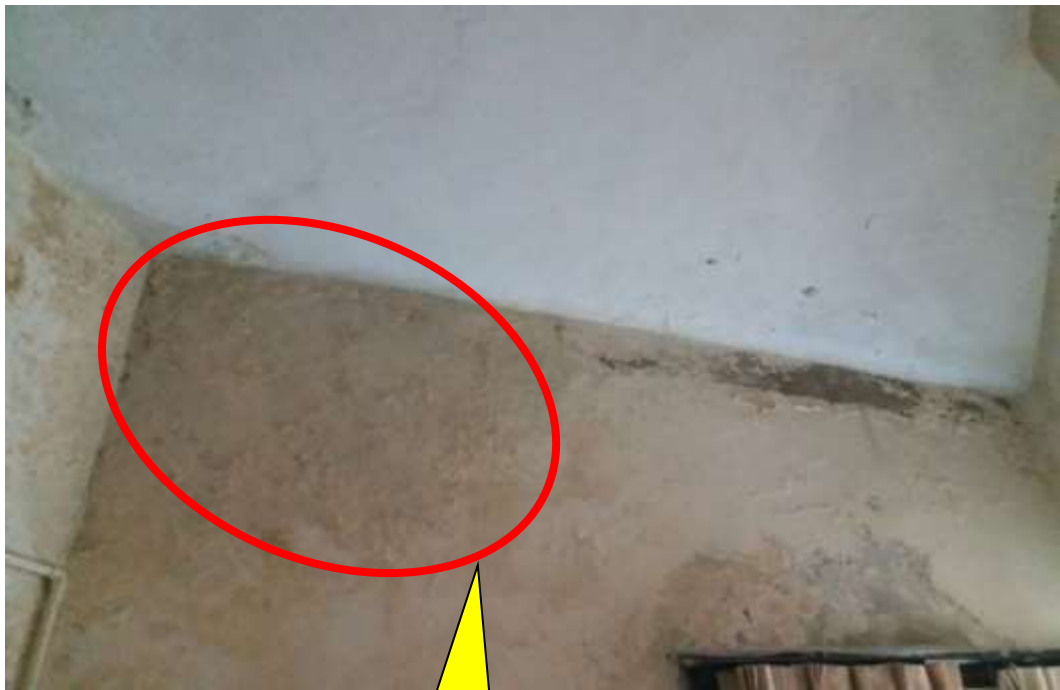
Flaking of Paints

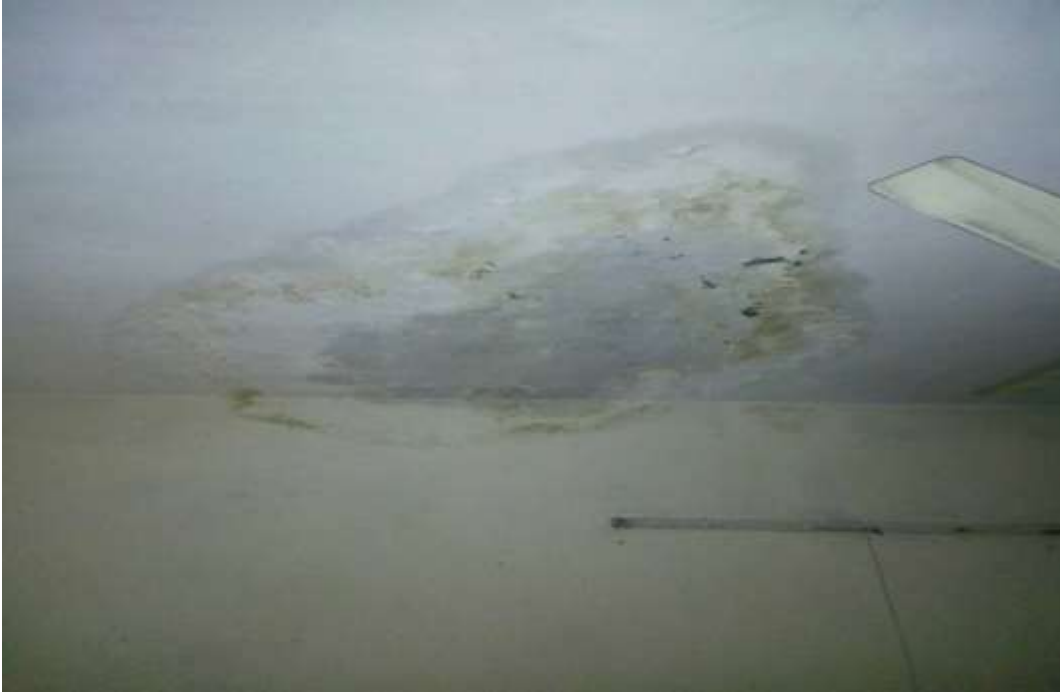
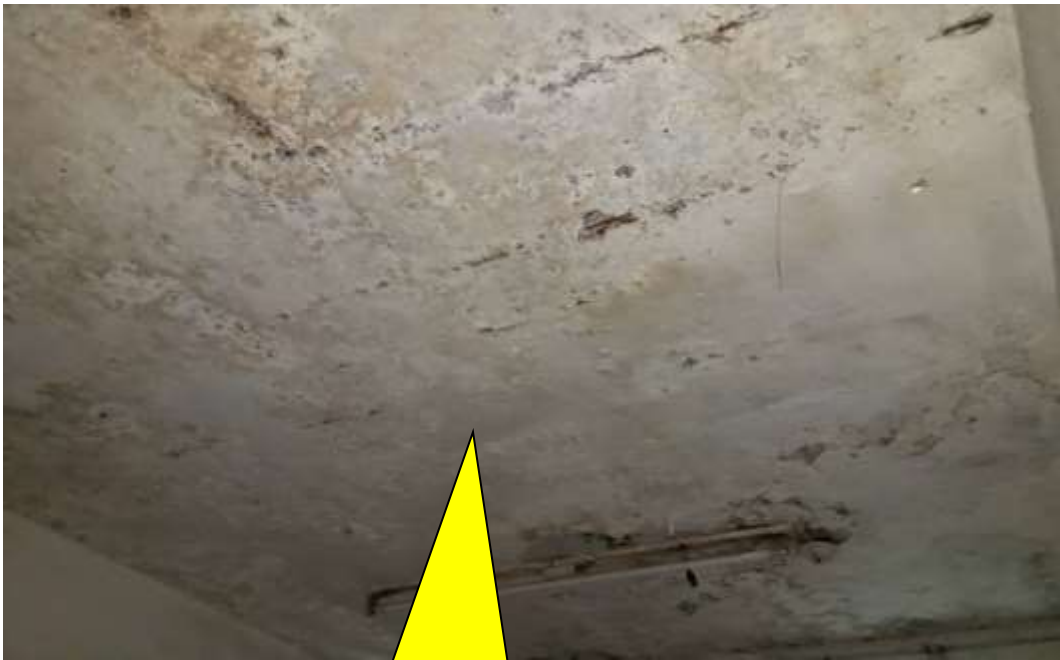
**Blistering & Flaking of Paints
with Staining**

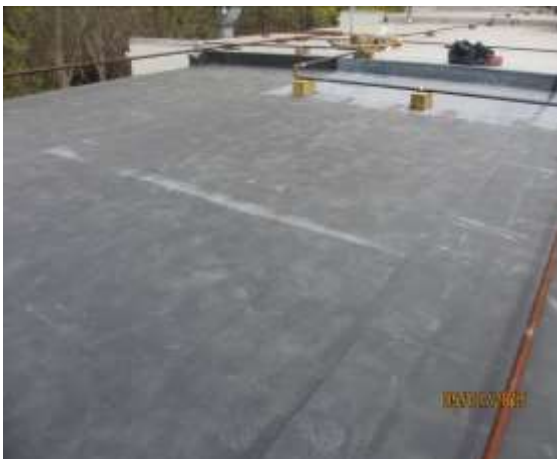
24.2 Laying Bitumen on the Roof.

A coating of bitumen should be laid on the roof to cover all micro pores and cracks that have developed over time due to water seepage and deterioration of building materials.

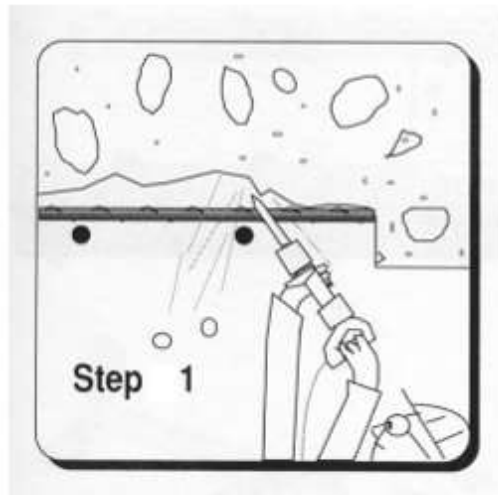
STEP 1

Removal of broken and loose pieces of Concrete and uncovering the corroded Steel bars
