**ANALYSIS OF HIGHWAY SAFETY ISSUES ON  
NATIONAL HIGHWAY N-15 MANSEHRA TO CHILAS (233KM)**

A thesis submitted in partial fulfillment of  
the requirements for the degree of

**Transportation Engineering**

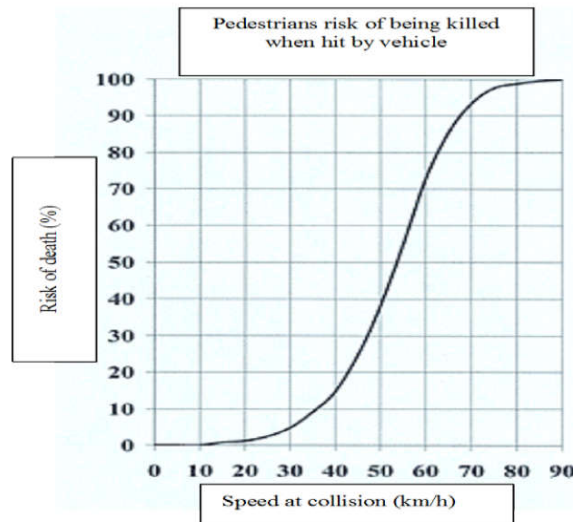
Figure 3.2: Speed Vs Risk of Death Graph

Undoubtedly, major problem is excessive speed on the Mansehra – Chilas road, and thus poor safety conditions on the road is contributed by excessive speed.

United States studies showed that one of the severe problem is motor-vehicle-pedestrian collision. In 1998, almost 69,000 people were injured and about 5,220 people were killed in road incidents. Pedestrian crashes were also a major problem in US. Nationally, pedestrian fatalities were 12.6% of total fatalities. One reason for Such higher rate of these fatalities is due to high vehicular speed is one of the major reason.

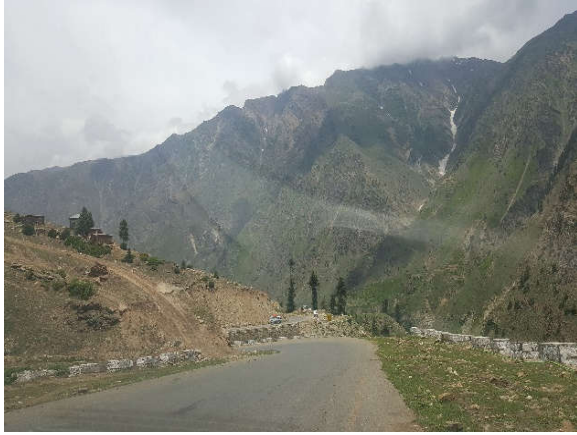
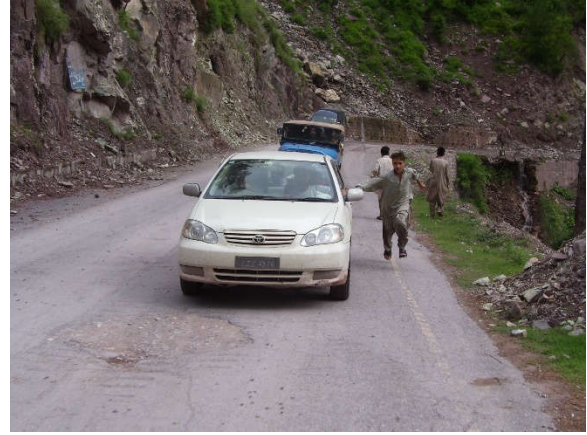
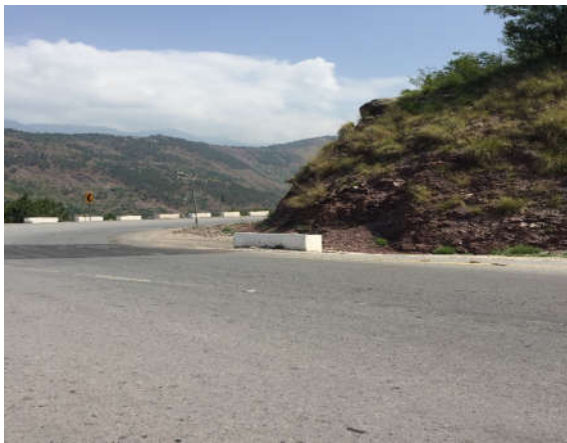
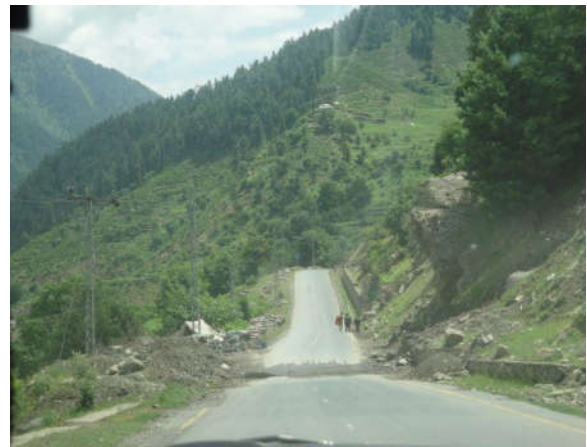
Figure 4.14- existing faded pavement marking on Project Road

##### **Fade Pavement Marking**

Pavement markings used were already faded.

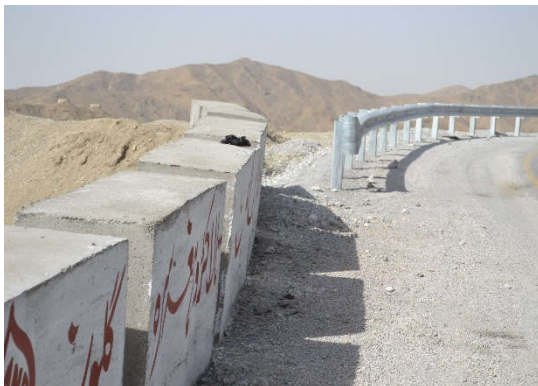
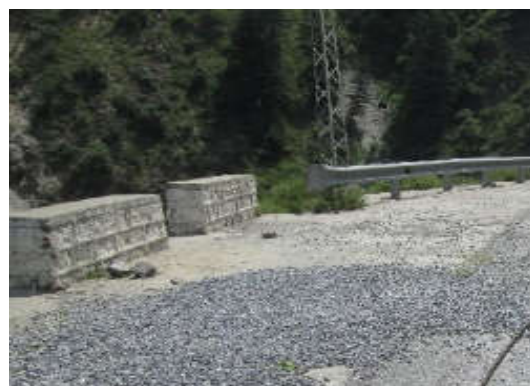
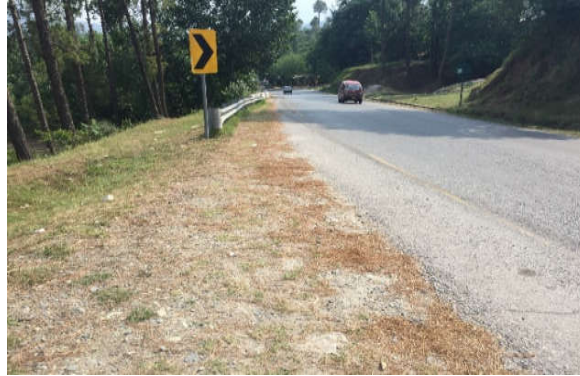
Figure 4.15 - guide rail and concrete barrier disconnect and unconnected guard rail along the route

**Connection of and barrier and guard rail unconnected guard rail**

Barriers were not connected with guide rail which is safety hazard.

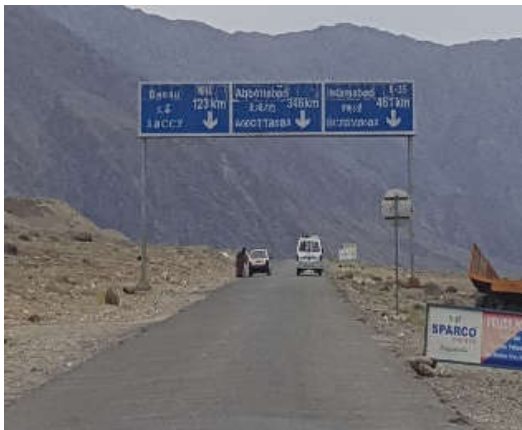
Figure 4.17: Existing gantry sign post in Chilas

Rigid sign posts that are close to travel lane are fixed object and safety hazard if not protected.

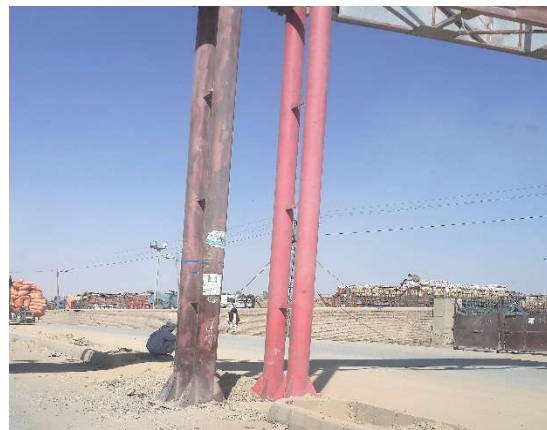
Figure 4.16: Existing gantry sign post on N-15.

### Gantry Sign Post

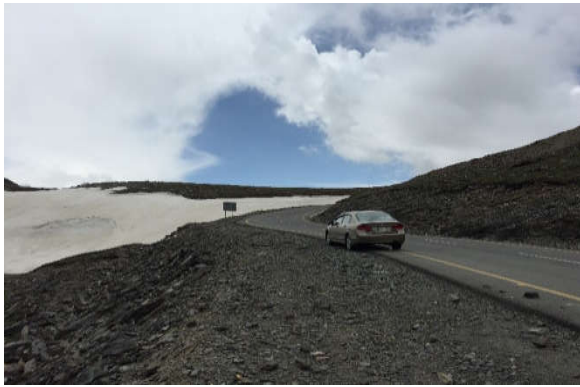
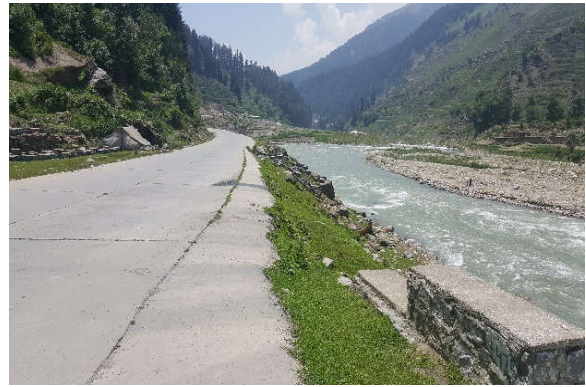
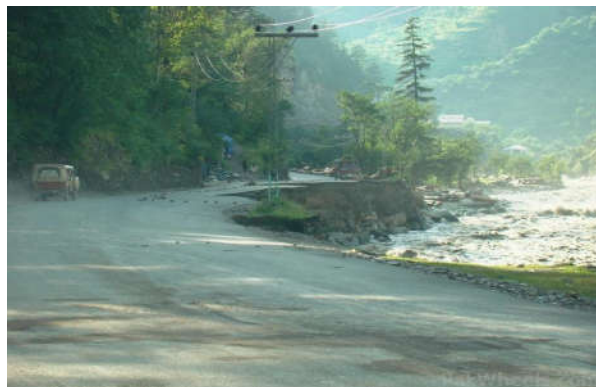
Figure 4.19: Showing Steep Foreslope

### Steep Foreslope

1V:2H foreslope is provided which is not traversable for an errant vehicle leaving the roadway and will cause overturn of the vehicle. These fore slopes are currently unprotected regardless of the depth of fore slope.

Road side steep cut/fore slope is a safety hazard and errant vehicles need to be protected from falling from the road into deep ravine particularly along Balakot to Chilas section. Also, drainage design and road side design needs to be designed considering safety conscious design

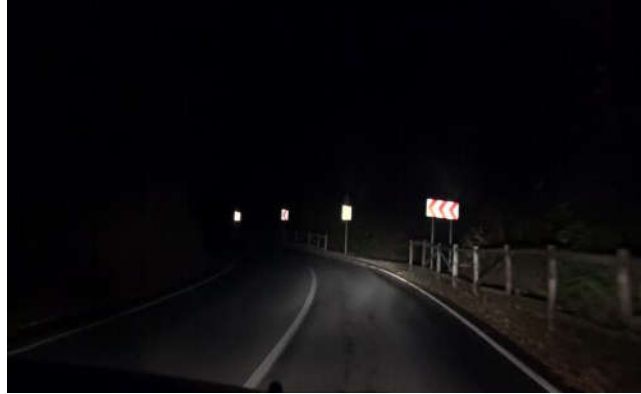
Figure 4.20: illustrates the problem of poor visibility at night on a rural road (not project road)

The entire length of the road will be unlit. Statistics indicate that night time crash rates are higher than day time crash rates. This may be attributed to reduced visibility at night.

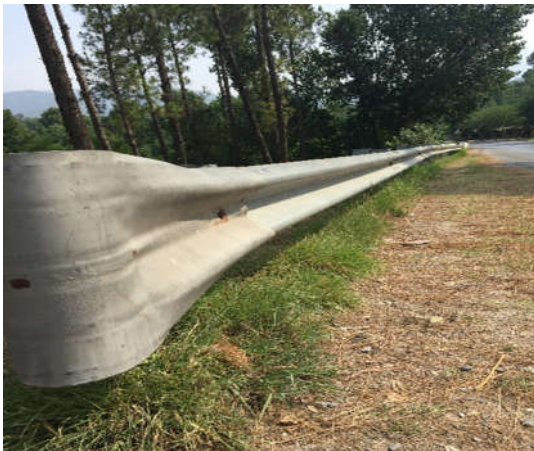
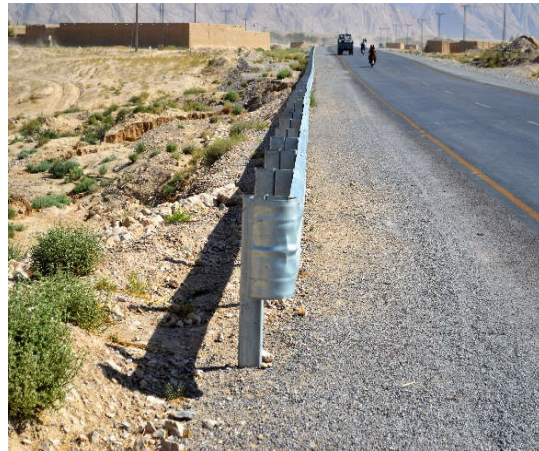
Figure 4.21: Existing guard rail end design on N-15 Mansehra-Naran-Jalkhand-Chilas Road project i.e. Balakot

## Guide Rail End Design

Guide rail ends as currently installed are fixed object and safety hazard for moving traffic.

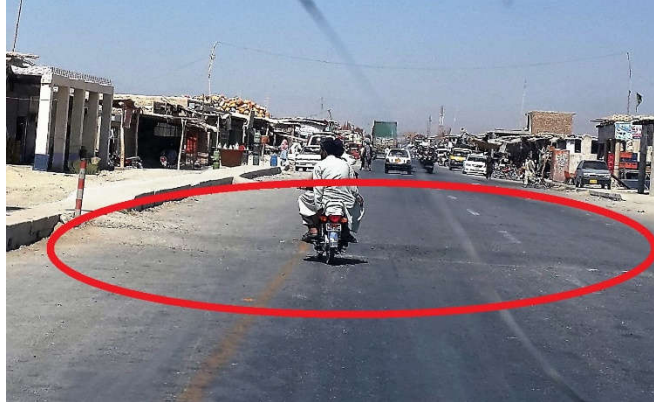
Figure 4.22: Existing speed bumps installed along the Route i.e. Mansehra

## **Speed Bumps**

Speed bumps are installed at populated areas and commercial areas. These were without warning marking and sign. Speed bumps are rarely visible to the traffic and may cause safety issues.

It is the understanding that functional classification of this road is “Rural Principal Arterial”, however, road passes through many recreational (tourist attractive), commercial/sub-urban areas as well. It is recommended to develop Access Management plan for this road to avoid future safety and operation problems and to maintain intended function of the road particularly for Mansehra to Balakot section of this project. No street lighting was provided on this road. While unlit rural arterial is accepted practice, consider providing Street lights at geometrically challenging locations and at commercial/sub-urban areas to alert drivers of potential danger or conflict with pedestrian. Existing Road Bumps if warranted should be converted to road humps with warning sign and retroreflective pavement markings installed on hump to alert drivers of their presence.

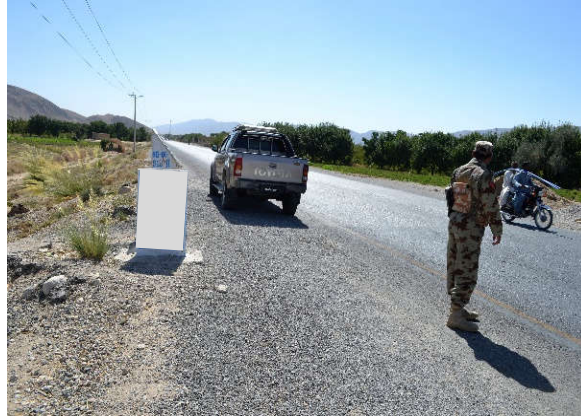
Figure 4.23: Existing rigid kilometer post on route i.e. Balakot

## **Kilometer Post**

Concrete Kilometer Posts are fixed object and can cause a severe crash in case of vehicle leaving the roadway.

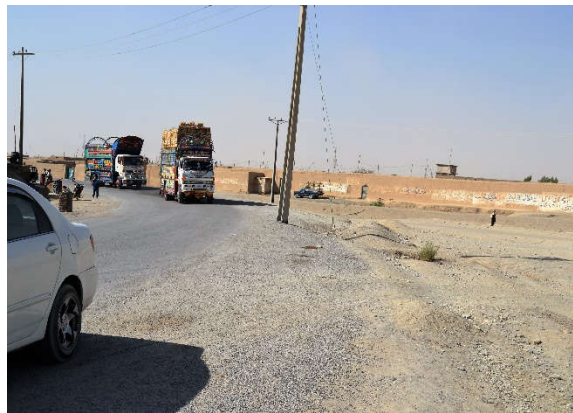
Figure 4.24: illustrates light pole along the road within vehicles trajectory (Mansehra)

### **Electricity Pole**

Electricity pole is located next to travel lane on a horizontal curve which is in path of vehicle natural trajectory and pose safety hazard.

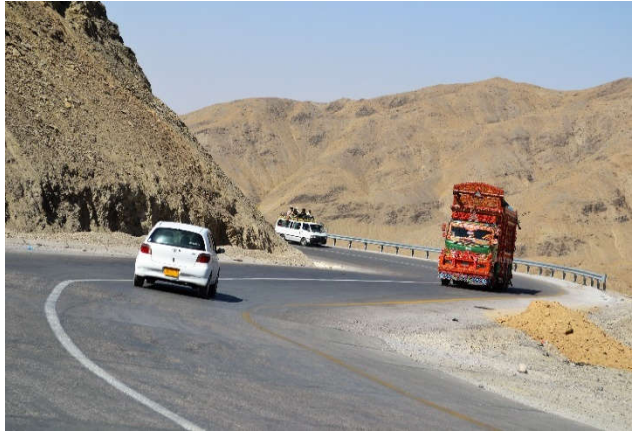
Figure 4.25: illustrates problem with vehicle negotiating the curve (Batakundi)  
*Note: car has encroached into opposite traffic lane*

### **Pavement width at Horizontal Curves**

In horizontal curves, the radius followed by vehicle front wheels is larger than the radius of its rear wheels which increases the width swept. Moreover, the difficulty in negotiating the curve increases the risk of encroachment in opposite lane which may cause head-on collision. Current design does not appear to provide wider lanes at curves.

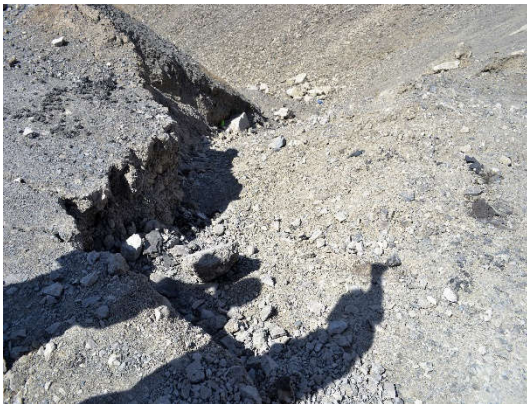
Figure 4.27: illustrates the erosion problem (non-project)

Rainfall may cause hydroplaning due to which vehicle may lose control and fall in ravine. Erosion was observed at causeway edges which may cause failure in the pavement structure.

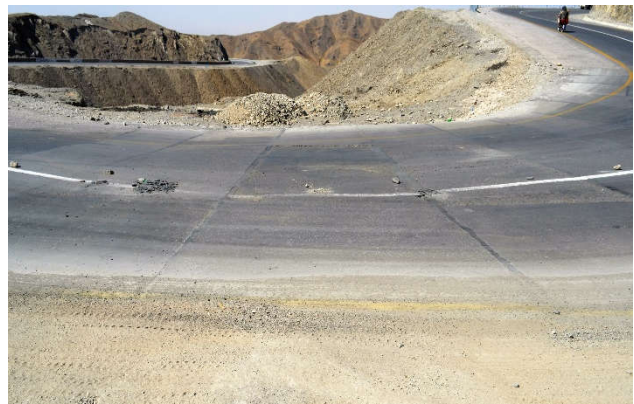
Figure 4.26: Causeway constructed (Enroute Naran)

## Causeway

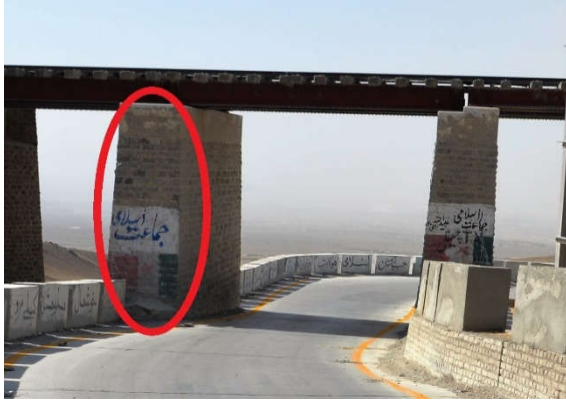
Figure 4.28-Illustrates fixed object at section (Non-project)

Certain structures along road are Fixed objects which is safety hazard.

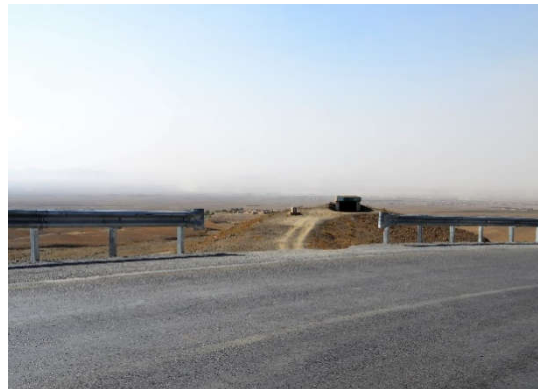
Figure 4.30: illustrates the discontinued guide rail (Naran)

### **Discontinued Guide rail**

Guide rail was discontinued at various locations along the section which is a safety hazard.

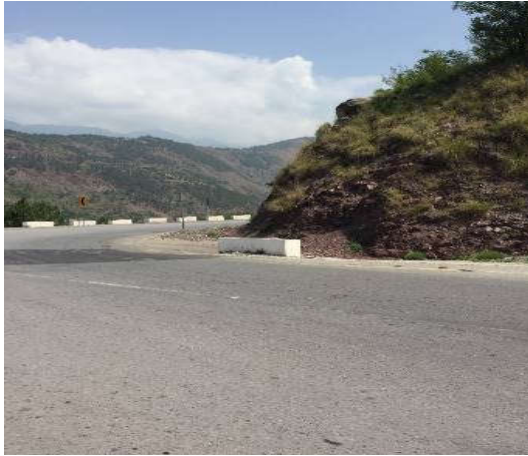
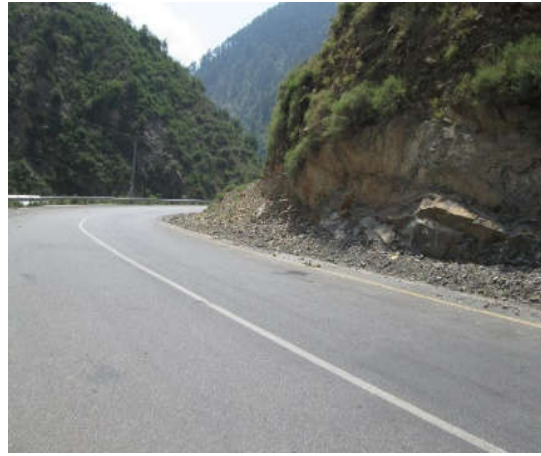
Figure 4.31: illustrates the sight distance problem

Sight distance at sharp horizontal curves is not sufficient and will cause safety problems.

There are very sharp curves which become black spots on the road also at many areas there is very less sight distance to see the upcoming vehicle from the opposite side. There is a critical concern over this safety hazard as sharp curves and less sight distance can have collision with opposite moving vehicular traffic and with the road side features which currently does not have even any warning sign and not any convex vehicular safety mirror at the edges. During the research and field study of the subject route significant deficiencies in geometric design particularly horizontal alignment and roadside design were also found. To overcome these hazards appropriate measures to warn drivers of sharp horizontal curves with restricted sight distance should be taken. Overtaking should be prohibited at those locations. The road also has a lot of steep vertical grades ranging from 4000ft to 14000ft which causes safety and operational problems due to slow movement of heavy vehicle on upgrade and longer braking distance needed by loaded truck on down grade. Consider converting shoulder to climbing lane in these areas.

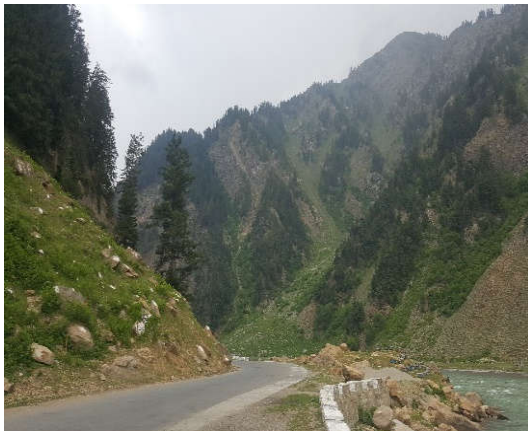
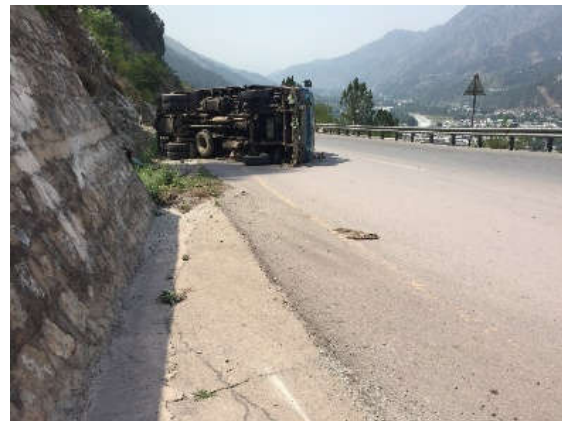
Figure 4.32- illustrates the Sharp Curve which Causes Accident curve on N-15

### **Sharp horizontal curves**

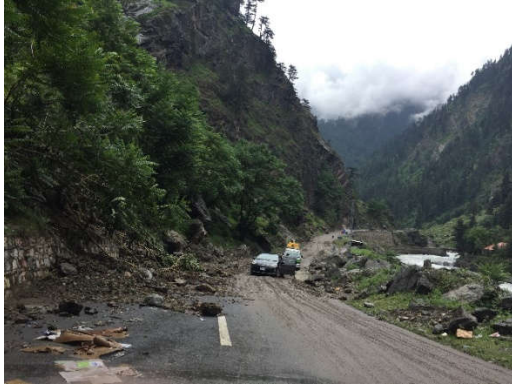
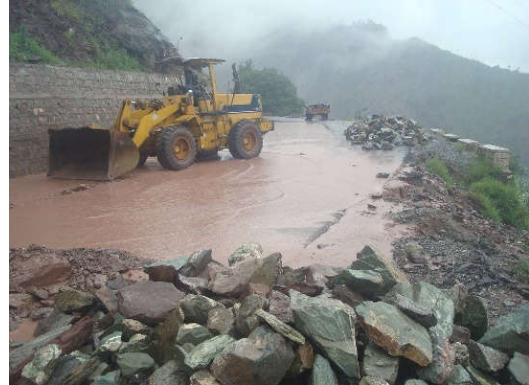
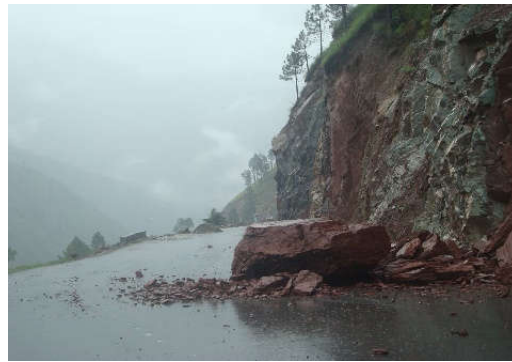
Figure 4.33: Illustrates land sliding blocking row

### Land Sliding

Land sliding at many locations along the route cause safety problems. Especially when it rains large sand dune and boulder often slides down and cause damage to moving vehicles.

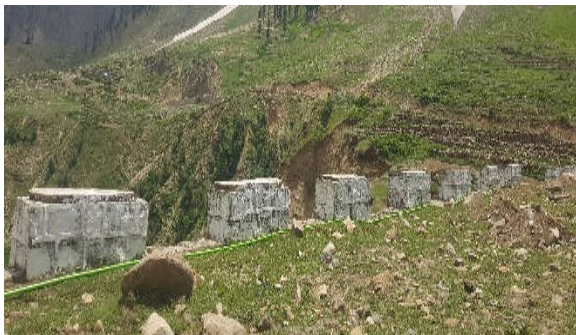
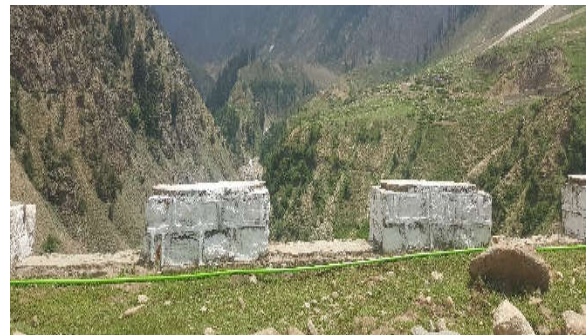
Figure 4.34: Installed Barriers along the edges (Also Broken from corners i.e. Burhwai)

### Concrete/Stone Masonry Barriers

Barriers are installed along the route on the edges to protect the vehicle falling off the edge but the vehicles hit the barriers and fall along with the barrier. Their strength is not measured. Barriers were not installed they are just putted there having no foundation and they can easily break when hit with an HTV.

- Concrete barriers are installed on almost the entire length of the study route. They should be replaced with guard rails. The strength of guard rails is measured but this concrete barriers or stone masonry barriers strength is not measured. The use of these barriers should be discouraged.

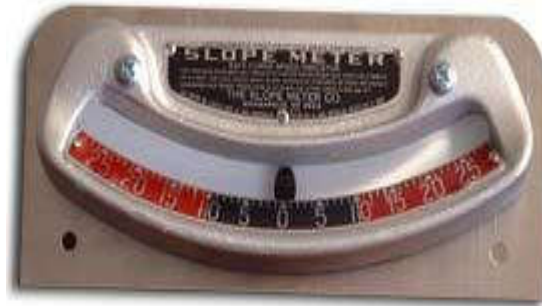
**Safe Curve Speed Indicator:** The safe driving speed for any curve is quickly and accurately determined with the "SCSI" mounted in the engineer's car. The scale reads zero when the car is level, and will show "tilt" up to 25 degrees on each side. The scale is red beyond +/-10 degrees to denote danger zones. The "SCSI" was designed by Slope-Meter in accordance with the specifications of the Minnesota Highway Dept. Traffic Division and is used nation-wide by highway and traffic engineers.
