**ENHANCING LATERAL LOAD PERFORMANCE OF
TRADITIONAL TIMBER WALL (DHAIJI-DEWARI) BY
STRENGTHENING OF JOINTS**

MS STRUCTURES DISSERTATION

September, 2017

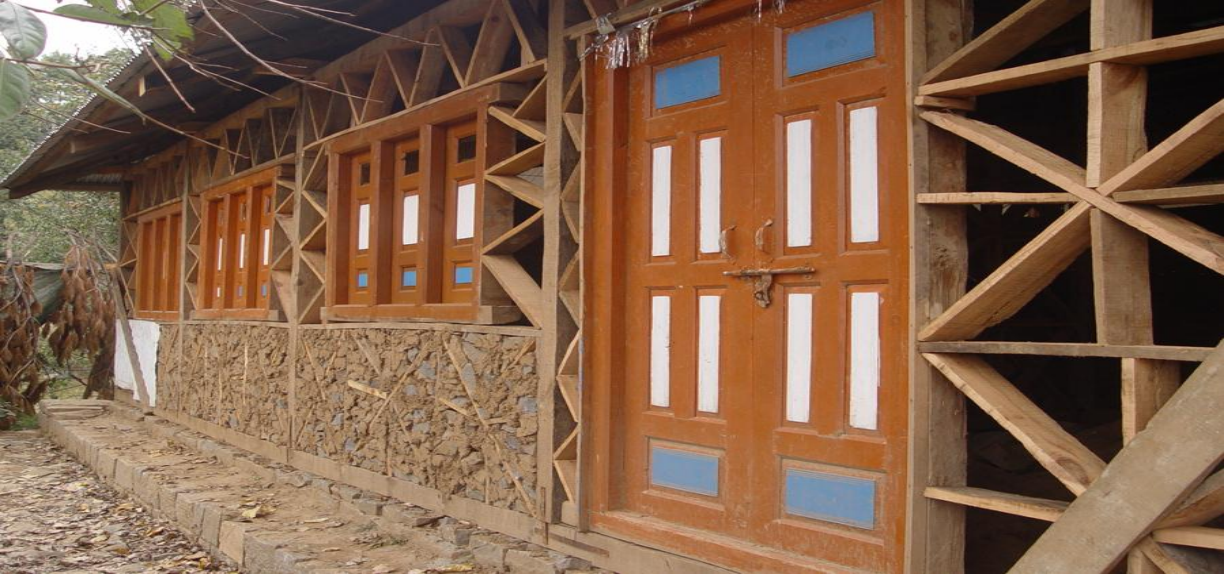
Fig 2.1: A Typical Dhajji Dewari House [9]

Dhajji Dewari is traditional construction found in the Northern areas of Pakistan and Kashmir [2]. The word Dhajji Dewari is a Persian word meaning “patchwork wall”, consisting of timber, stone and mud. Dhajji most commonly consists of a braced timber frame, the spaces left between the bracing or frames is filled with a thin wall (single Layer) of stone traditionally laid and plastered with mud mortar [3]. The timber frame of Dhajji houses consists of vertical and horizontal posts of relatively bigger cross sections and frame further divided into secondary vertical and horizontal posts of smaller cross sections. And finally these secondary posts are provided with different types of bracing arrangements those later filled with stone or masonry. These houses are bolted with concrete or stone foundation to provide fixity with ground. Roofing system is quite simple in these houses; often wooden truss with corrugated sheets or simple corrugated sheets on flat wooden planks are used as roof [8].

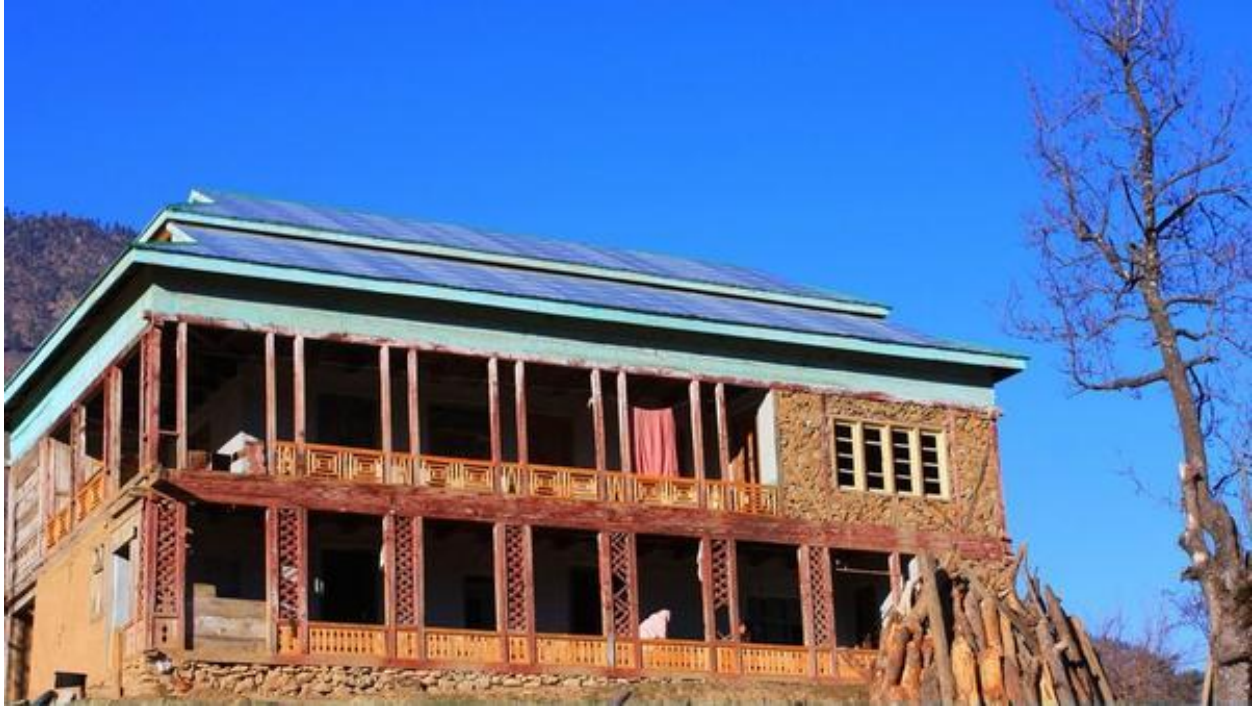
Fig 2.3: A Good Quality Dhajji House [9]

These types of traditional houses consist of framework filled with burnt clay bricks. The composition of this type of structure is very different from that of a typical brick masonry structure and its superior performance has been proved to be earthquake resistant. In Dhajji Dewari houses the connected timber studs sub divides the infill which helps in detention of loss of masonry, and resists the destruction of wall.

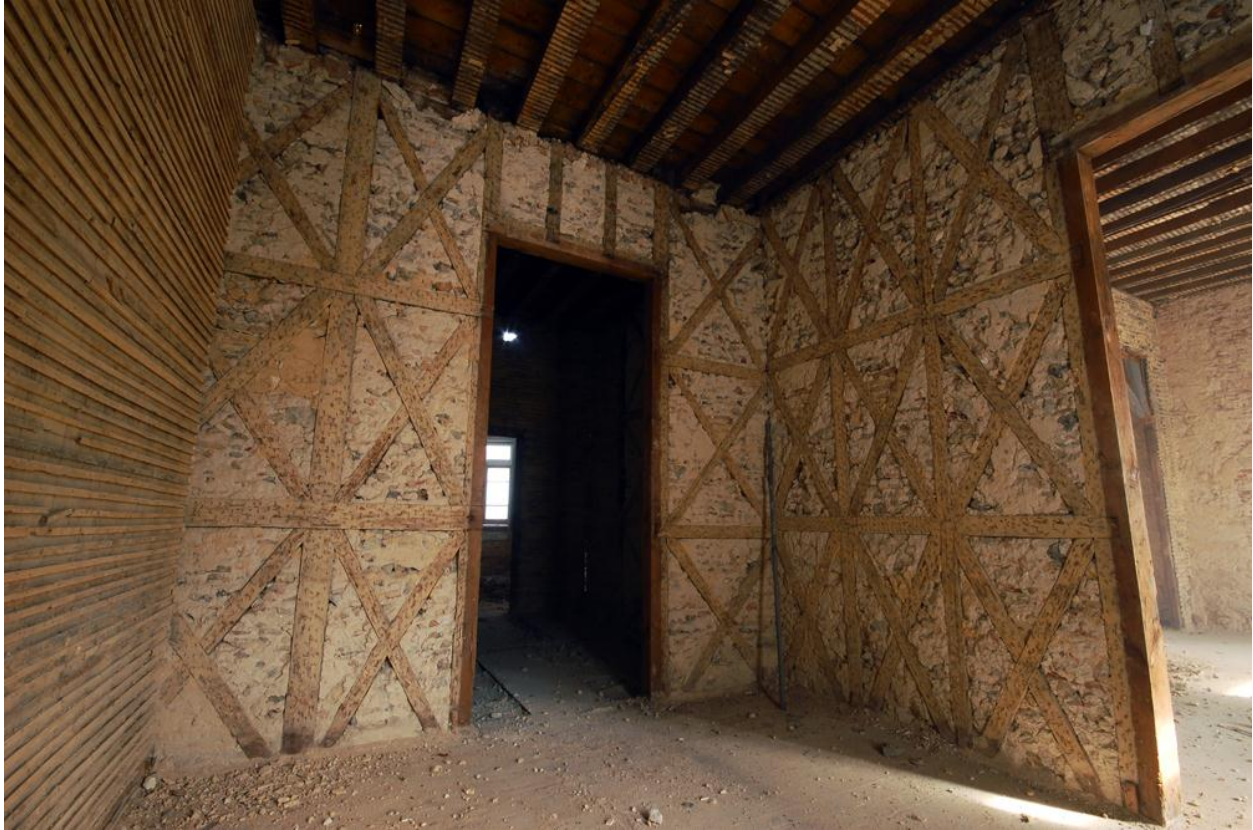
Fig 2.4: Gaiola in Pombalino Buildings [13]

Lisbon earthquake 1755, had destroyed many areas including central region known as Baixa, the people of Baixa gathered the cluster of engineers to determine the best solution which retain their houses during earthquakes. The type of construction nominated by engineers was called as Pombalino wall, which was also called as gaiola or cage construction. [11]. The gaiola construction or Pombalino system consists of timber frame with horizontal and vertical square cross sections about 10-12 cm size and used in interior parts of buildings, with cross slope which act as internal bracing. The empty space between these walls was than filled with bricks and mixture of stones in different arrangements. The walls after filling with rubble stones were covered with plaster. The front side of Baixa buildings was rebuild with masonry wall having thickness about 60 cm and interior of wall had timber frame as well.[12]. The significance of these walls lies in the fact that they can resist the lateral loading of earthquake by enhancing the structural ductility.

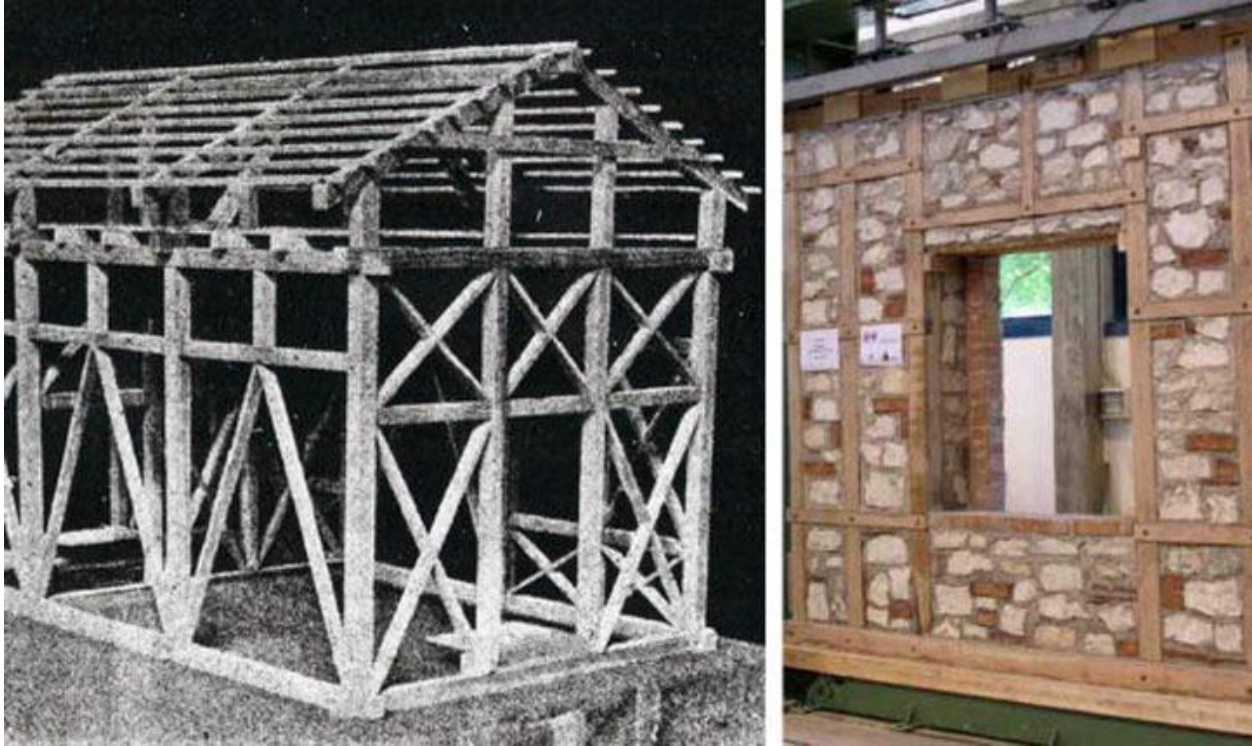
Fig 2.5: Casa Baraccata Buildings [9]

Similar to Pombalino buildings another type of traditional timber frame structure was developed in Italian cities of Calabria and Sicily and was called as Casa Baraccata building systems. This type of structure was developed in response to the occurrence of earthquakes in the region. The origin of this type of structure coincides with the Gaiola in Portugal. During the 19th century and the first two decades of the 20th century Casa Baraccata due to manifested applications for the seismic resistance it became the basis of instructions for construction practices in Italy [14]. This traditional building construction type was the only alternative for inhabitants of Europe and other parts of the world against seismic actions. It was the first time that these traditional buildings were adopted as an earthquake resistant structures on government level.

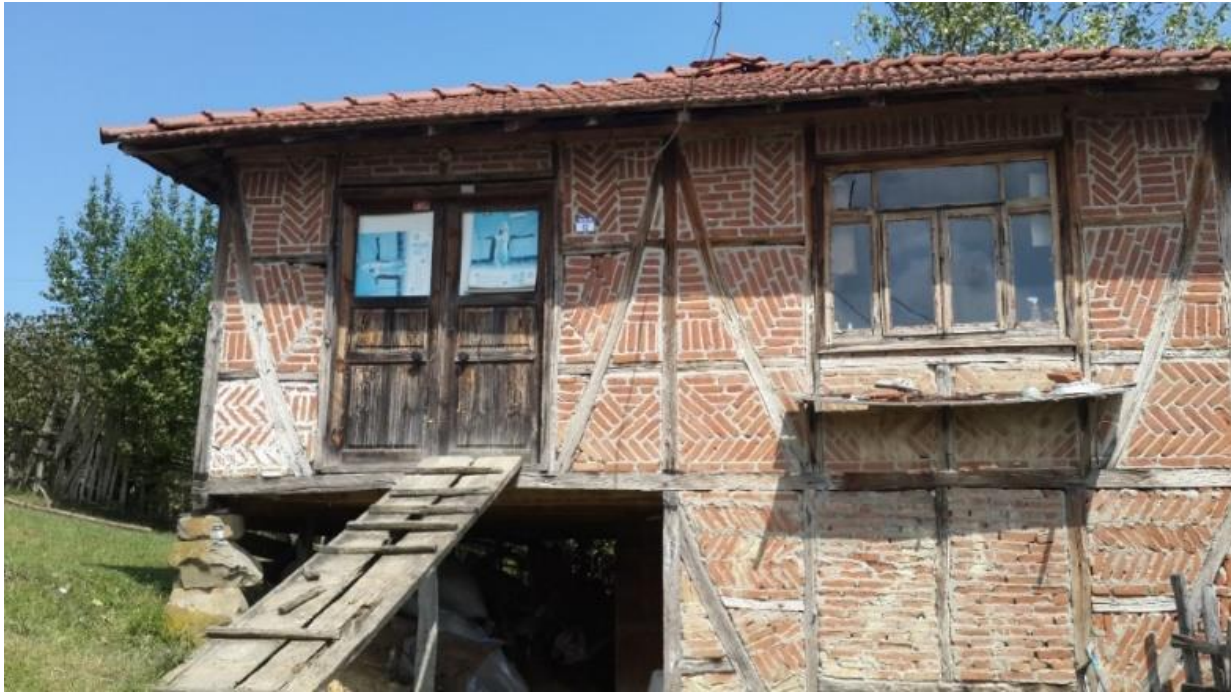
Fig 2.6: Himis House (Turkey) [12]

Himis is another type of commonly used traditional buildings that is found in different parts of the world [4]. The masonry pattern in this type of building is different from the traditional bearing wall masonry. The timber frame is essential for providing the framework for the infill masonry. It consists of one layer of brick masonry, or a thin sheath of rubble stone mixed in mud of lime mortar. For decorative and aesthetic purpose bricks are placed at different angles on the front side. The thickness of the wall consisting of both timber and brick is 10 to 12 cm. Himis is in common use in Turkey but it was overtaken by the reinforced concrete rapidly in the beginning of the 20th century [12].

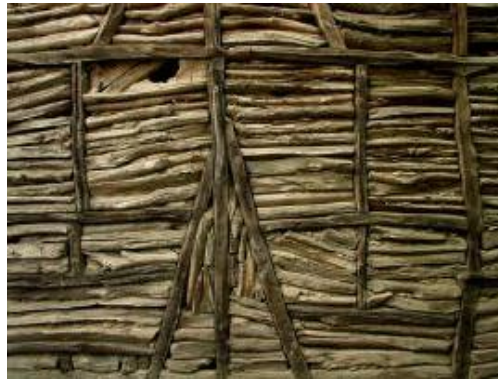
Fig 2.7: Bagdadi Construction [12]

Bagdadi construction is another type of construction and fairly found in areas where Himis is common. This type of construction consists of short and rough pieces of timber for infill purpose which cover with plaster and form a solid wall. The significance of Bagdadi houses lie in the fact that they are light in weight, uses scrap wood, easy and economical to build. The main defect of these walls is the attack of insects which causes bigger rots to deteriorate [12]. A typical Bagdadi house is shown in figure 2.7.

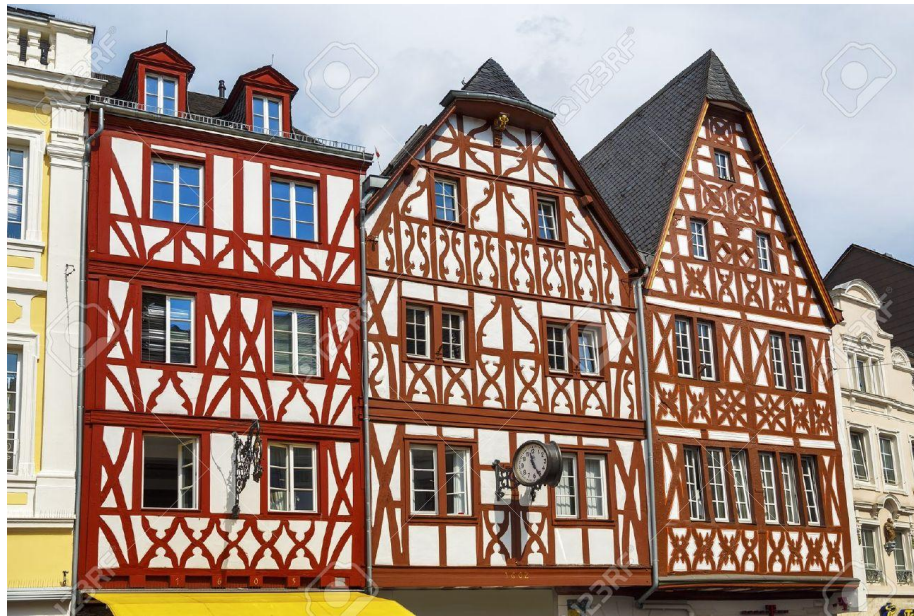
Fig 2.8: Half -Timber House (Britain) [9]

Half-Timbered structure traditionally found in Roman Empire, also referred to as Opus Craticium [17]. Half-timbered structures consists of timber and masonry materials. Mostly timber wall is used in construction with masonry wall. According to Tampone [18] timber elements was used in construction of Knossos and Crete located in Minoan forts were used to support the masonry work.

Different type of timber configuration was used in half-timbered construction but the mean and common method was that the timber members can resist tension, and masonry members resist compression thus making a perfect assembly to resist lateral. However using timber in conjunction with masonry not only provide confinement to structure but also improves mechanical properties against lateral loading. [19, 20].

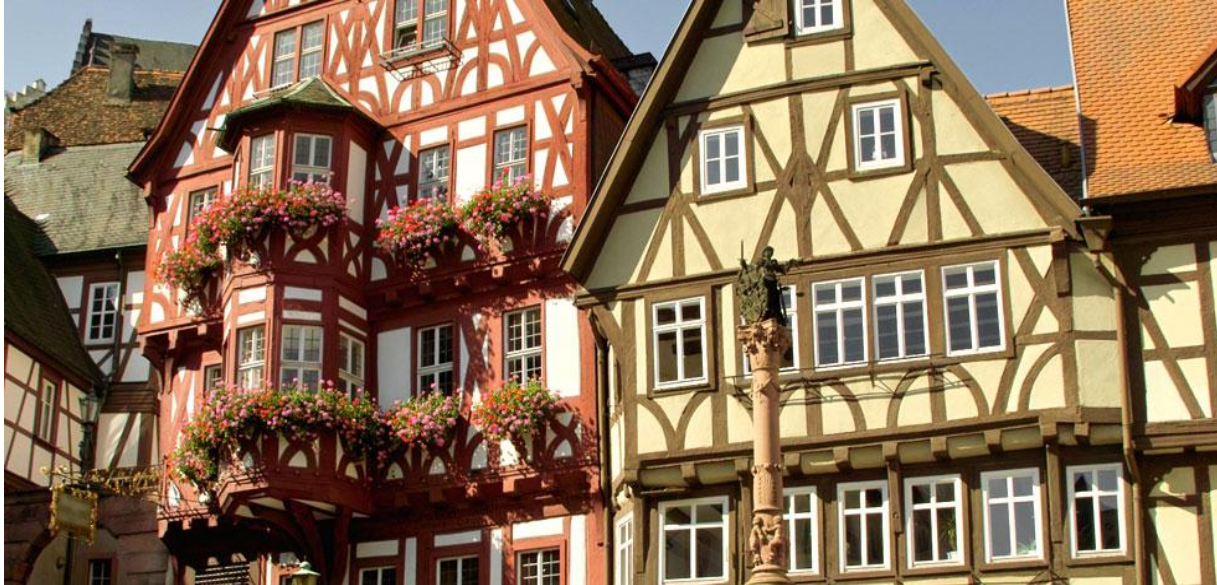
Fig 2.9: Fachwerk House (Germany) [9]

Fachwerk construction is very common in Germany. Different types of timber frames found and are classified by the number of stories and the geometric shapes. This type of construction was

introduced in the 7th century but it took till 16th and 17th century to gain popularity. It has three main types (Alemannic, Lower Saxonian and Franconian), which are differed from each other due to dimensions, spacing of the elements and the nature of the framing [13].

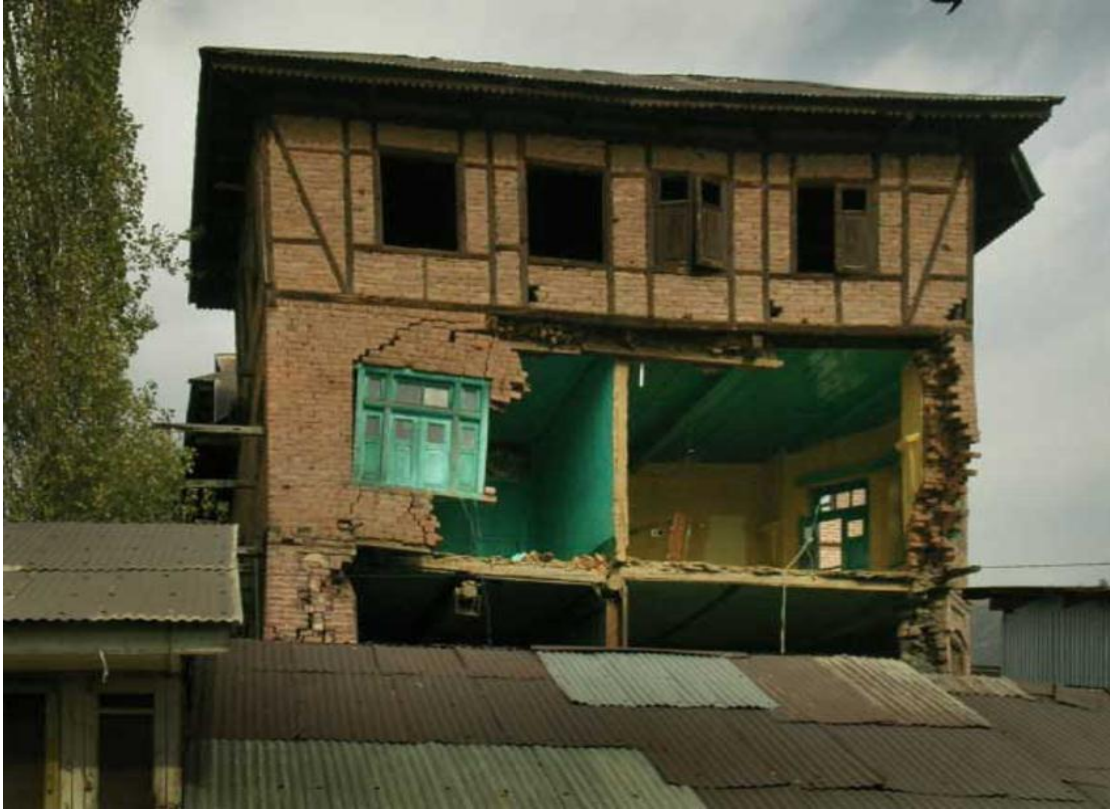
Fig 2.10: A Dhajji House After 2005 Earthquake [9]

The closely spaced vertical and horizontal posts, diagonal bracing, and the inherent property of wood to be flexible without breaking during an earthquake contribute to the due performance of the system. The performance of Dhajji Dewari in the 2005 Kashmir earthquake is another evidence of the steadily earthquake resilient behavior of this system. After Understanding of good

performance of Dhajji Dewari, Earthquake Rehabilitation department of Government of Pakistan (ERRA), encouraged its use for construction of housing units in the far mountainous earthquake affected areas.

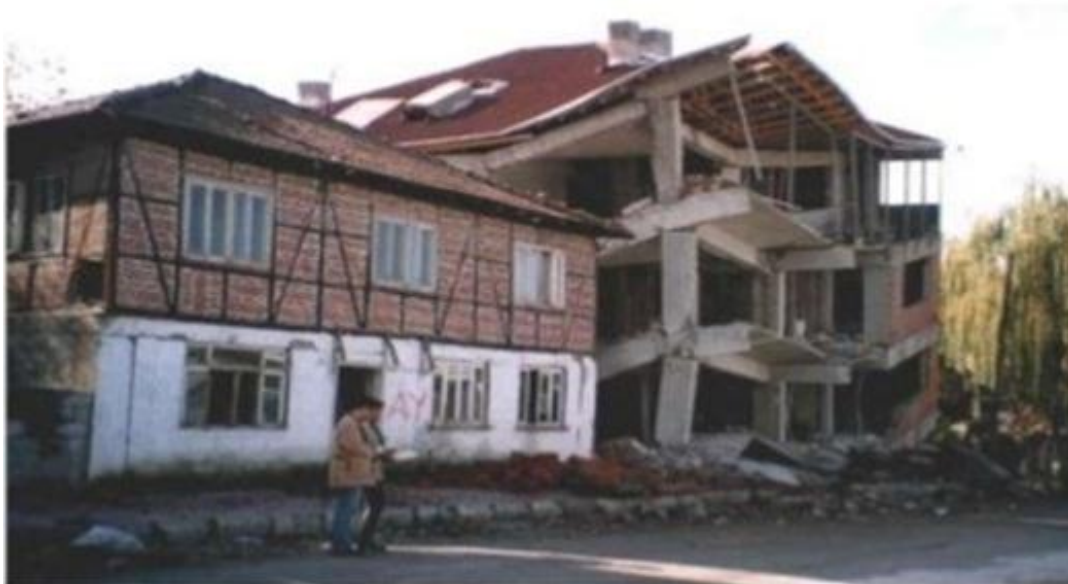
Fig 2.11: An Example of (1999) Turkey Earthquake [12]

Traditional timber buildings have performed better in different earthquakes around the world. Although they are called as non-engineered structures, history shows that these traditional structures have performed well in event of an earthquake. In 1999, Kocaeli earthquake, traditional timber structures remained safe but modern concrete structures were heavily damaged. This finding was set by Turkish researchers Gulhan and Guney after detailed statistical study on damaged areas of district [16].

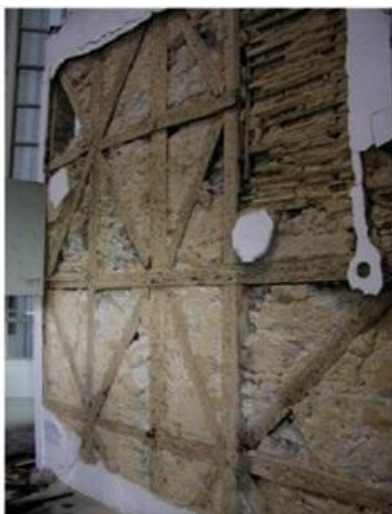
Fig 2.12: Gaiola Wall after Test

Graca Vasconcelos et al. [23] conducted experiments on typical Gaiola wall subjected to in-plane cyclic loading in order to perceive its mechanical behavior and to assess its performance under seismic actions. Cyclic test was performed and for this purpose three types of frames each having different typologies was analyzed. (1) Timber frame unreinforced and having no infill; (2) Glass Fiber Reinforced Polymer sheets (GFRP) used on connections of timber frame having no infill; (3) Brick masonry was used as infill in timber frames. Tests on typical “Gaoila wall” have shown that the walls in all cases were able to dissipate energy over many cycles without losing their structural integrity [23].

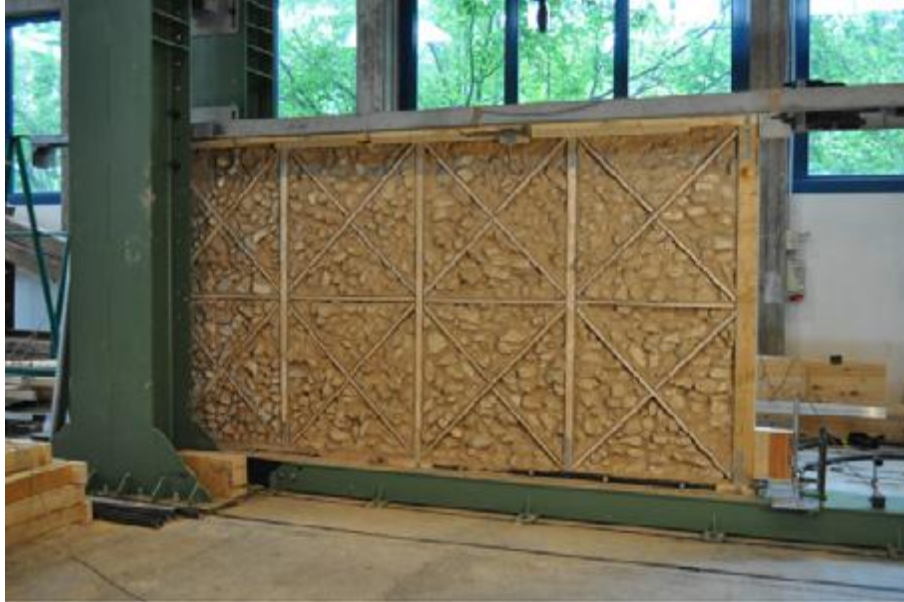
Fig 2.17: Traditional wall tested by Vieux [26]

Vieux et al. [26] conducted various tests to study the seismic performance of timber framed structures filled with natural stones and earth mortar on three scales of experiments during which both cyclic and monotonic loadings were applied. For checking capacity of connection tests were performed in both normal and tangential directions to obtain the hysteretic behavior of nailed connections. Pushover and reversed cycle tests were performed to obtain the hysteretic behavior as a function of infill characteristics. Walls without any openings were considered. Through these tests the influence of the infill on stiffness, maximum load or equivalent viscous damping was analyzed. Based on experimental results they concluded that timbered masonry structures have appropriate seismic resistance [26].

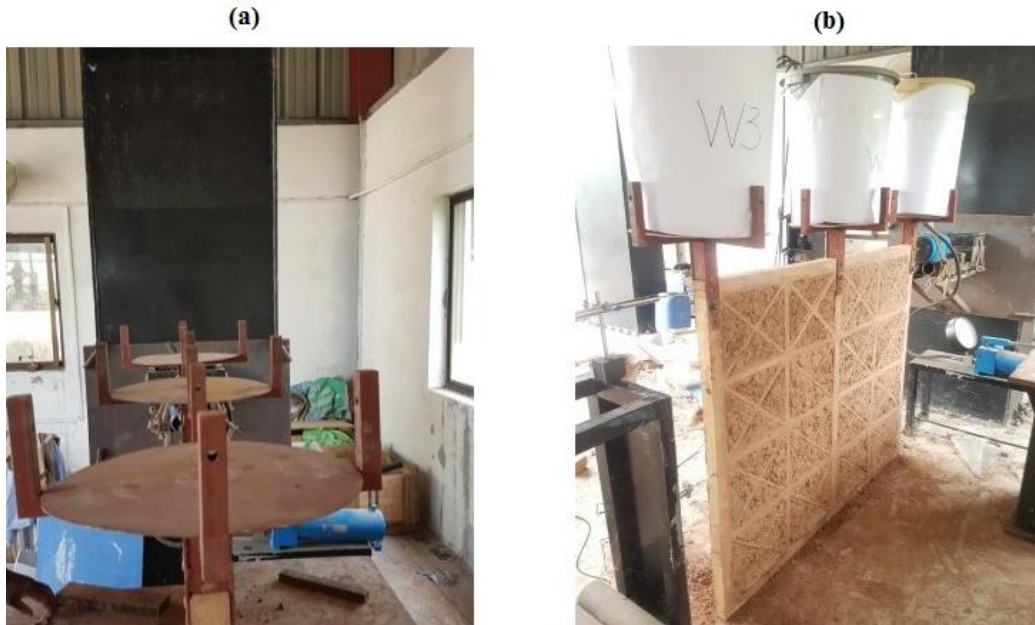
Fig 3.6: (a) Iron Moulds (b) Application of Load

Vertical load having magnitude 1 KN was applied to mimic roof dead load. Iron molds were designed for application of pre-compression point load on main vertical posts of wall, and using the magnitude of pre-compression load resulting in final sizes of 18" dia. circular moulds which were later bolted on top of main posts. Then load was applied with the help of aggregate filled with in containers. Application of load is shown in figure 3.6.

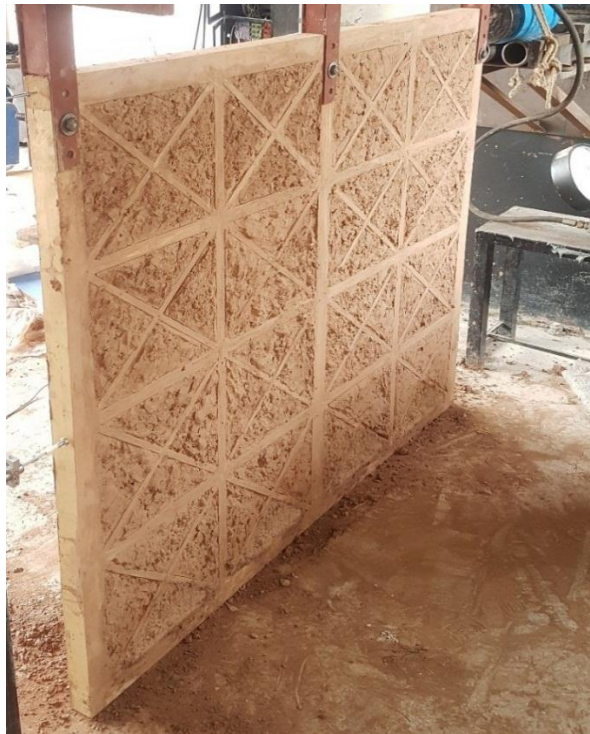
Fig 3.8: DDW1 (Reference Wall)

This wall was used without any strengthening as shown in figure 3.8 and consider as reference wall to check the behavior of conventional wall and for comparison purposes with strengthened walls.

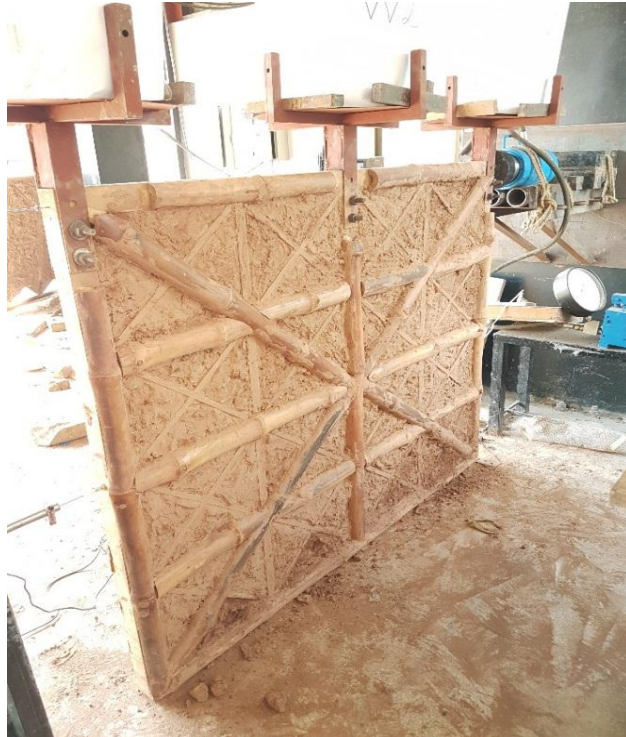
Fig 3.9: DDW2 (Wall Strengthened With Bamboos)

DDW2 was strengthened with Bamboos on periphery of wall and along tension and compression struts for purpose of enhancing lateral load performance by strengthening the joints. Detail is shown in figure 3.9.

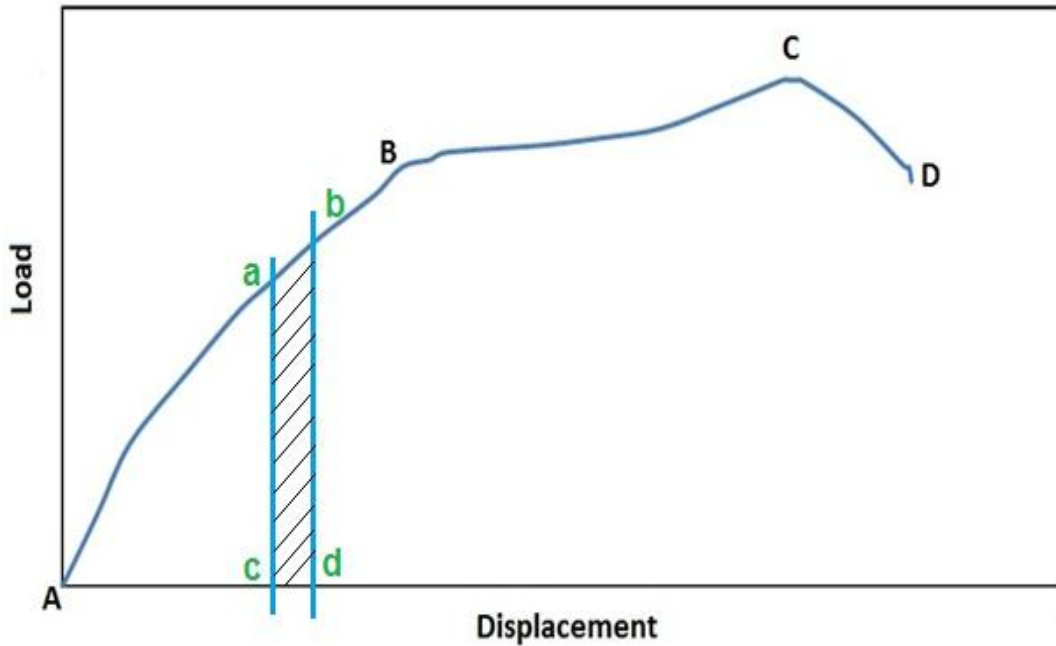
Fig 4.3: Area Enclosed by Segment abcd

$$\text{Area Under Curve} = \left(\frac{a+b}{2}\right) * (d - c) \quad 4.1$$

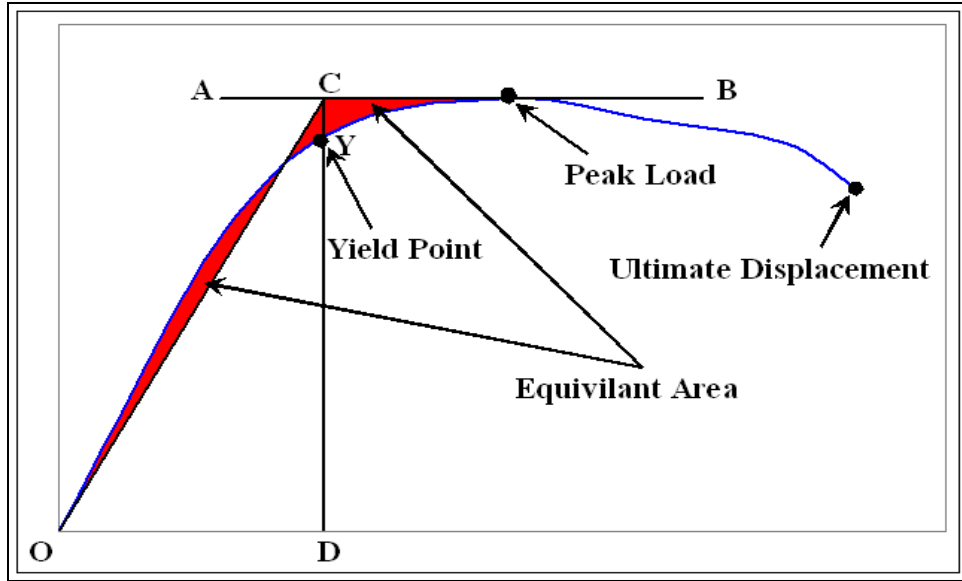
Fig 4.4: Muguruma Model of Yield and Ultimate Points

Where, μd is ductility factor, Δu and Δy are ultimate and yield displacements respectively. Muguruma et al. [27] concept of equivalent elastic-perfectly plastic system was used to determine the yield and ultimate displacement on load displacement curve.

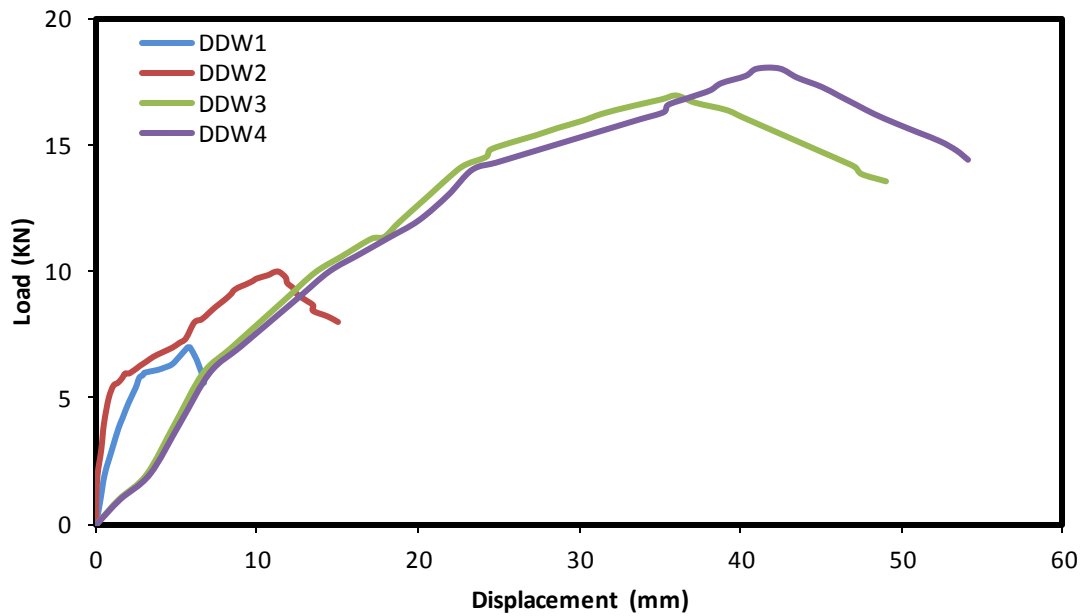
Fig 4.6: Load Displacement Curves of all panels

The load displacement curves presented in figure 4.6 refers to the horizontal displacement at top of wall vs. lateral load applied to the wall. The main results obtained from Monotonic test were in the form of load displacement curves which give further information in terms of ultimate displacement, energy dissipation, ductility and stiffness degradation. Load displacement curves are important to study the behavior of connections of timber frame walls. Curves represent that all the strengthened wall show good lateral load behavior and stiffness of walls gradually decreasing with the increase in load.

Figure 4.6 shows the comparison of load displacement curves. From load displacement curves it is clear that DDW2 show good elastic behavior and peak has also occurred at larger lateral displacement than the DDW1. After reaching the peak stage, DDW2 could not maintain peak load and degraded gradually. Quick stiffness degradation after yielding was due to rocking of the wall and propagation of separation crack. DDW1 show lower ultimate response due to brittle mode of failure. The cracking started at a lateral displacement of 2.75 mm. Peak stage occurred at a lateral displacement of 5.74 mm. The gain in lateral strength at peak was not very high and it degraded abruptly due to joints pullout.

It can be seen clearly in figure 4.6 that the specimen DDW4 showed higher lateral resistance before yielding and peak has also occurred at larger lateral displacement than the specimen DDW1 and DDW3. After peak stage, the lateral load of specimen DDW4 degraded gradually. Gradual stiffness degradation was due to ductile shear failure of the specimen and propagation of shear cracks at intermediate joints. The specimen DDW3 show lesser lateral load till yielding with lesser yielding displacement due to combination of rocking and shear mode of failure. The cracking started at a lateral displacement of 17.875 mm. And peak stage occurred at lateral displacement of 35.99 mm. The gain in lateral strength at peak was comparatively less compared with DDW4 and specimen failed due to joint pullout and shear crack formation at intermediate joints as shown in figure 4.19. The overall load displacement behavior of wall DDW3 and DDW4 was very effective compared with DDW1 because wall DDW1 was failing in rocking and showing brittle behavior

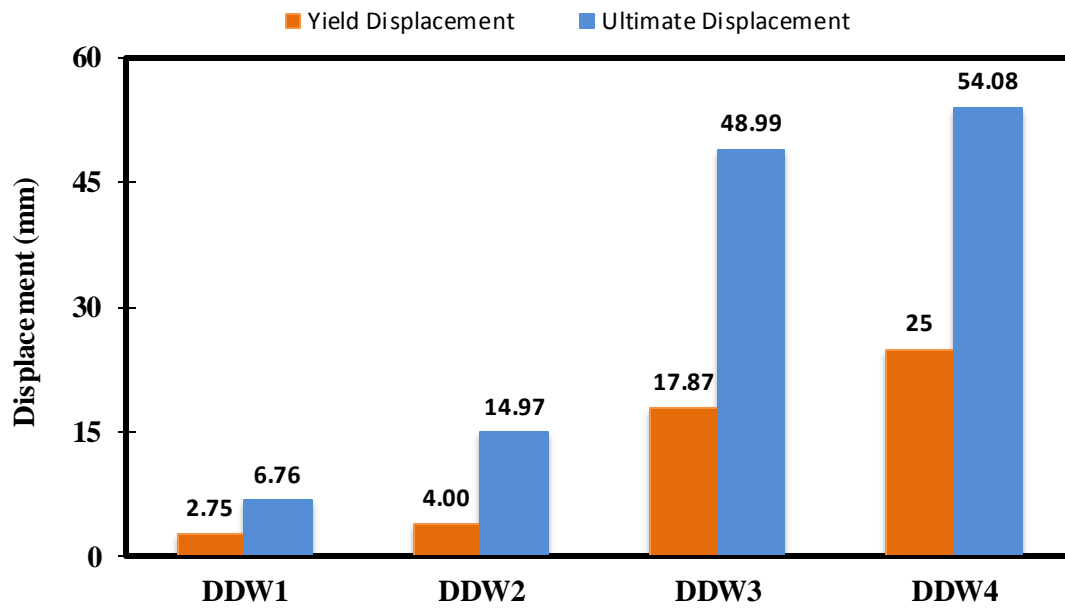
Fig 4.7: Comparison of Lateral Displacement at Different Stages

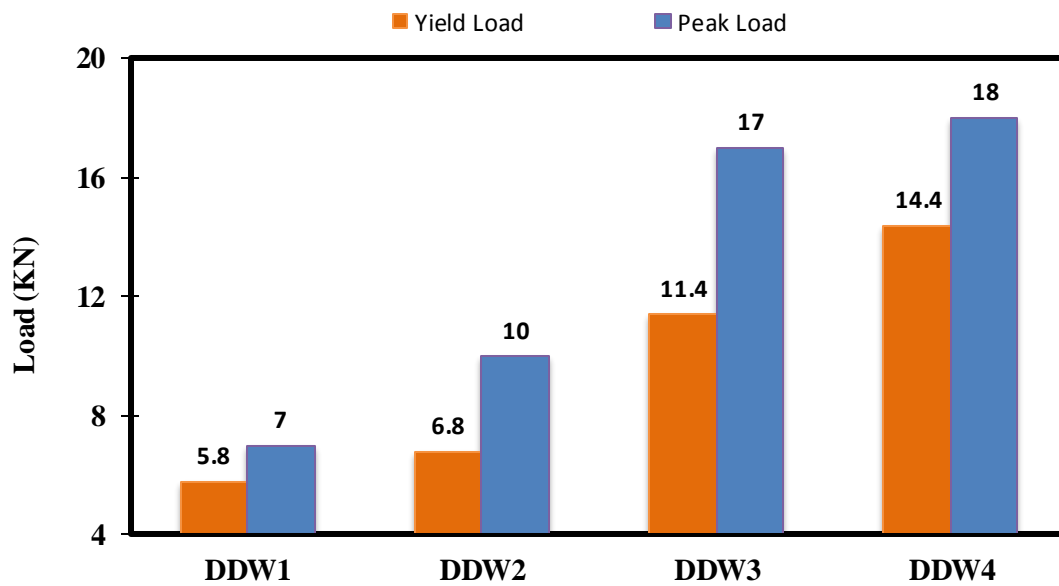
Fig 4.8: Comparison of Lateral Load at different Stages

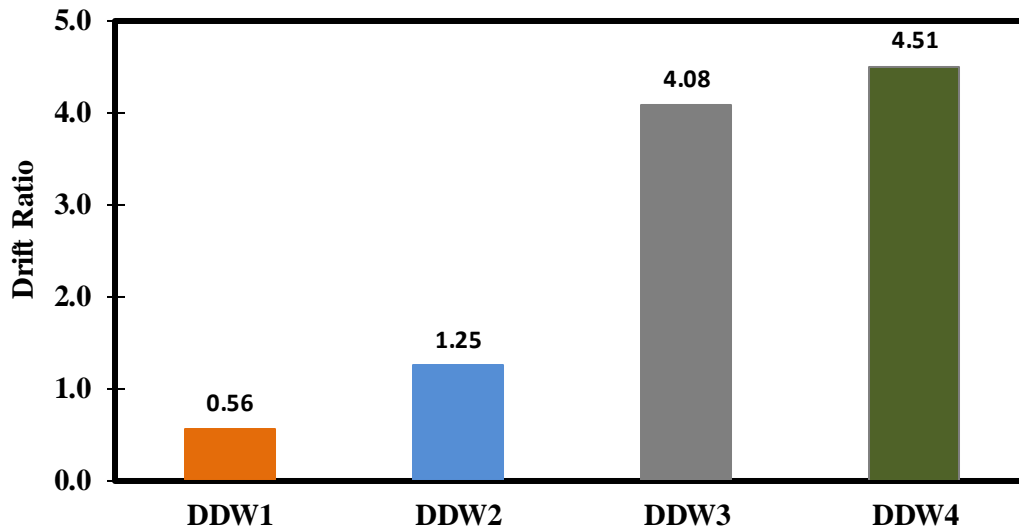
Fig 4.9: Comparison of Drift Ratio

Higher lateral resistance of wall DDW2 was due to its ductile mode of failure because panel was strengthened with Bamboos along tension and compression struts. The ultimate displacement was not very high despite of delayed occurrence between yield and peak stages. The drift ratio of 1.25% was recorded for specimen DDW2 at ultimate stage as shown in figure 4.9, which was 2.23 times higher than reference specimen.

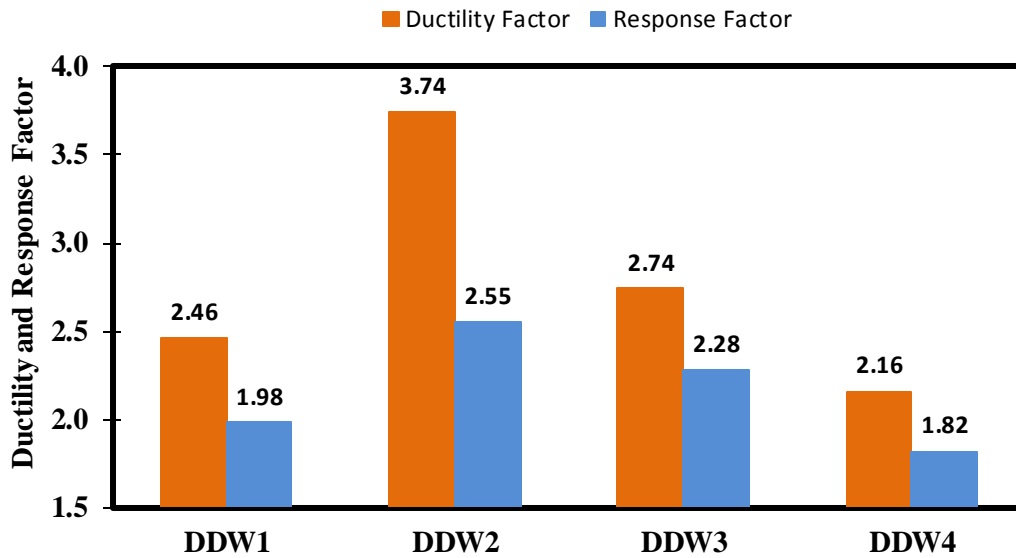
Fig 4.11: Ductility and Response Factor of all specimens

It can be seen in figure 4.11 that wall DDW2 show higher values of response factor which indicates the good ductile behavior of wall. And values of all strengthened walls are 1.28, 1.07 and 0.92 for DDW2, DDW3 and DDW4 with reference to unstrengthen wall respectively. Value of response factor for wall DDW4 is less than other panels which indicates that difference in yield and ultimate displacement is less which might be due to lower rate of stiffness degradation and delay in occurrence of yield point because of stresses redistribution.

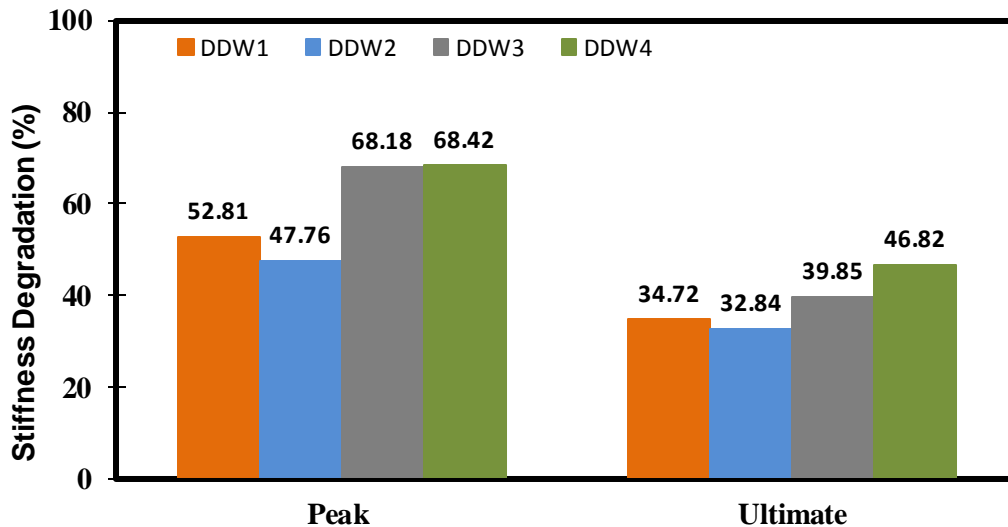
Fig 4.12: Stiffness Degradation Ratio of all specimens
