**Increasing the Lateral Capacity of Timber Wall Panels using
Inexpensive FRP Retrofitting Techniques**

MS STRUCTURES DISSERTATION

NUST Institute of Civil Engineering (NICE)
School of Civil & Environmental Engineering (SCEE)
National University of Sciences and Technology (NUST), Islamabad, Pakistan

July, 2019

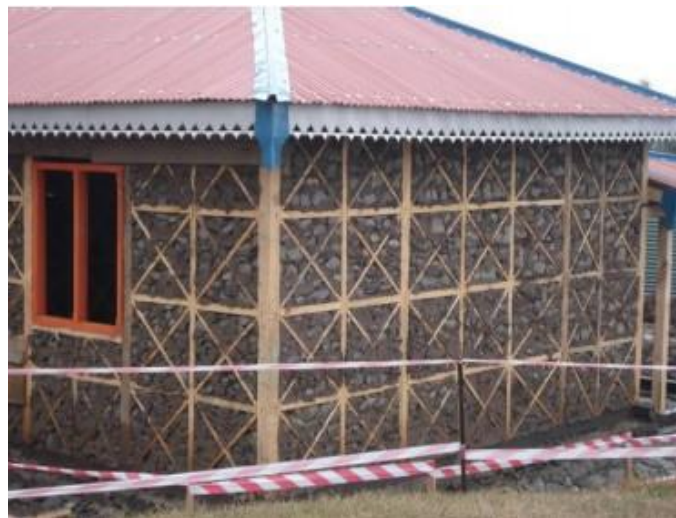
Figure 1.1 Typical Dhajji Dewari House

in those areas conventional building construction materials aren't readily available, so people have to make do with what's available in abundance in that region. It can be easily constructed using locally available materials such as timber, stone and mud and with the help of locally available labour [31]. The word Dhajji Dewari originates from the Persian language meaning "patch quilt wall". Dhajji Dewari consists of a timber braced frame, the bracing types vary from their usefulness to their aesthetic qualities but the mostly used bracing technique used throughout the region is the cross-bracing system. The spaces left in the timber bracings are usually filled with stone and mud mix, crushed brick masonry in combination with mud mortar are also used in some areas. Dhajji dewari is generally used for single story buildings, but several examples of multi-storeyed Dhajji Dewari buildings are found in Northern Pakistan and Indian Occupied Kashmir [2]. This has been done by using Dhajji Dewari in conjunction with timber laced masonry bearing walls, these walls are called taq. The floors of the Dhajji building are made out of a combination of timber beams and floor boards, the floor boards go on top of the beams and are usually overlain by a layer of clay or mud. The walls of the timber framing structure are anchored to the floor with the help of bolts, they are filled after they are erect. A typical Dhajji Dewari house has been shown in the Figure 1.1 below.

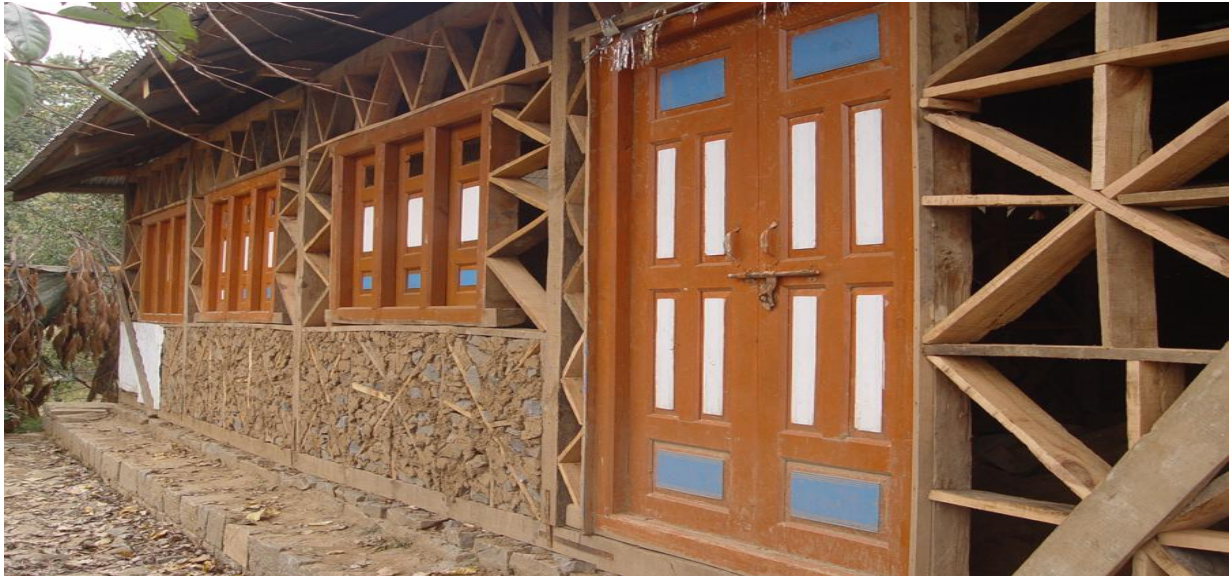
Fig 2.1: A Typical Dhajji Dewari House [40]

These types of traditional houses consist of framework filled with burnt clay bricks. The composition of this type of structure is very different from that of a typical brick masonry structure and its superior performance has been proved to be earthquake resistant. In Dhajji Dewari houses the connected timber studs sub divides the infill which helps in detention of loss of masonry, and resists the destruction of wall.

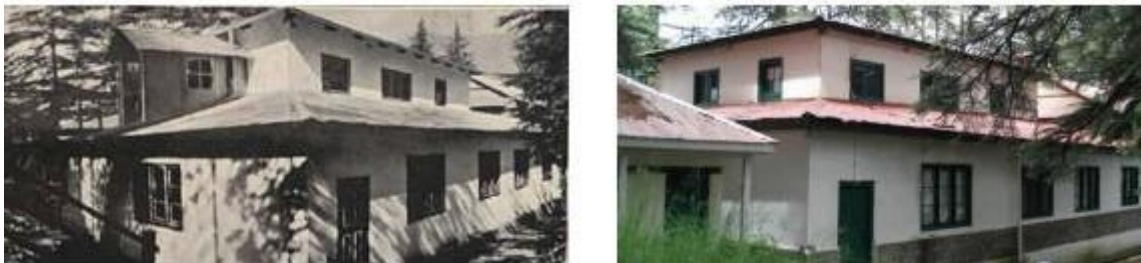
Fig 2.2: Kashmir Museum [18]

The creation and further propagation of diagonal shear cracks and the possibility of out of plane failure of the masonry is halted by the closed spacing of the studs, even in higher stories and gable portions of the walls. In some structures usually the walls in lower portion are made of traditional brick or stone masonry and the upper stories are made as a Dhajji Dewari system. [2]

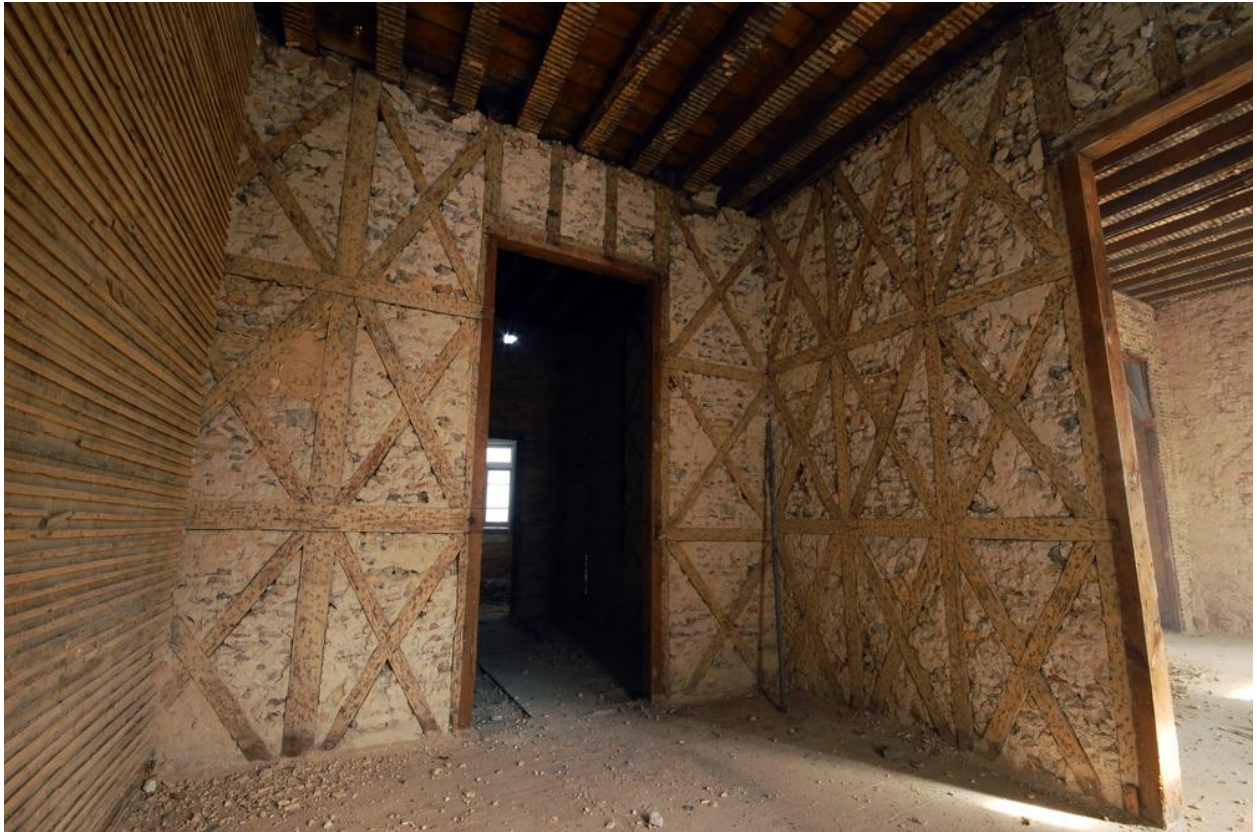
Fig 2.4: Gaiola in Pombalino Buildings [36]

Lisbon earthquake 1755, had destroyed many areas including central region known as Baixa, the people of Baixa gathered the cluster of engineers to determine the best solution which retain their houses during earthquakes. The type of construction nominated by engineers was called as Pombalino wall, which was also called as gaiola or cage construction. [22]. The gaiola construction or Pombalino system consists of timber frame with horizontal and vertical square cross sections about 10-12 cm size and used in interior parts of buildings, with cross slope which act as internal bracing. The empty space between these walls was than filled with bricks and mixture of stones in different arrangements. The walls after filling with rubble stones were covered with plaster. The front side of Baixa buildings was rebuild with masonry wall having thickness about 60 cm and interior of wall had timber frame as well.[16]. The significance of these walls lies in the fact that they can resist the lateral loading of earthquake by enhancing the structural ductility.

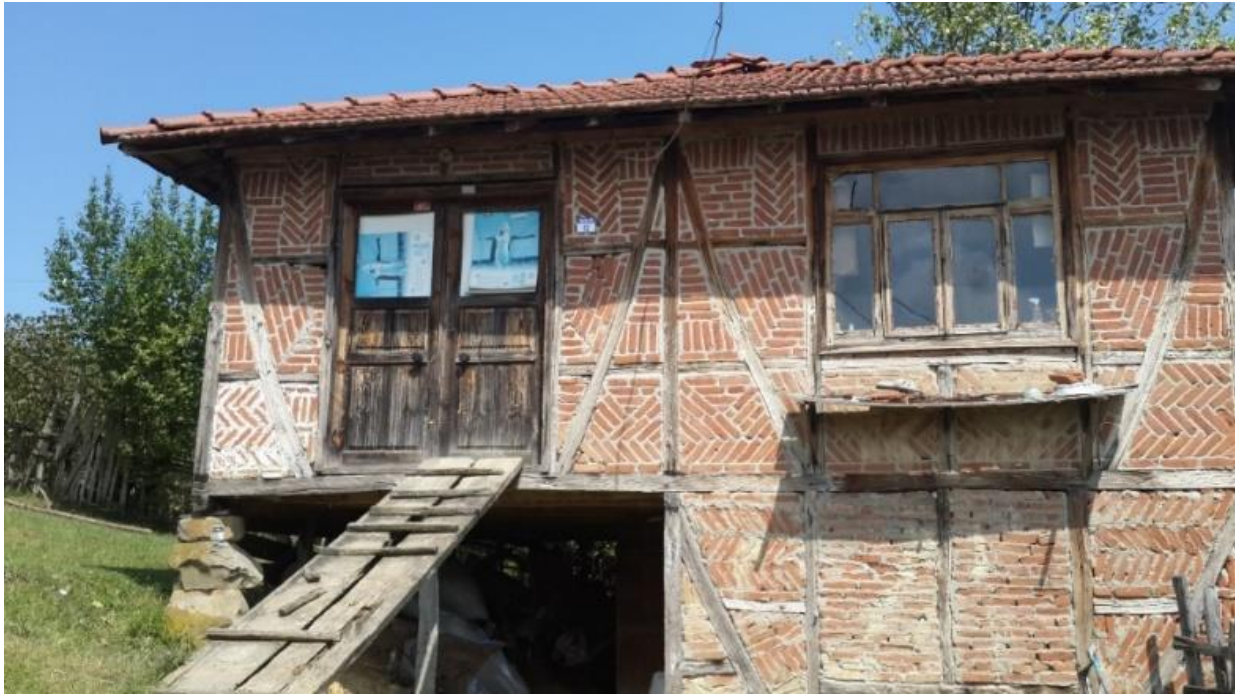
Fig 2.6: Himis House (Turkey) [16]

Himis is another type of commonly used traditional buildings that is found in different parts of the world [21]. The masonry pattern in this type of building is different from the traditional bearing wall masonry. The timber frame is essential for providing the framework for the infill masonry. It consists of one layer of brick masonry, or a thin sheath of rubble stone mixed in mud or lime mortar. For decorative and aesthetic purpose bricks are placed at different angles on the front side. The thickness of the wall consisting of both timber and brick is 10 to 12 cm. Himis is in common use in Turkey but it was overtaken by the reinforced concrete rapidly in the beginning of the 20th century [12].

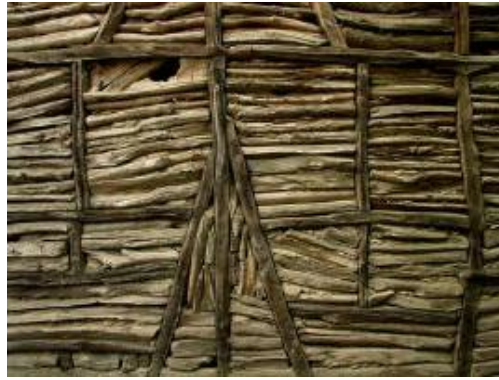
Fig 2.7: Bagdadi Construction [16]

Bagdadi construction is another type of construction and fairly found in areas where Himis is common. This type of construction consists of short and rough pieces of timber for infill purpose which cover with plaster and form a solid wall. The significance of Bagdadi houses lie in the fact that they are light in weight, uses scrap wood, easy and economical to build. The main defect of these walls is the attack of insects which causes bigger rots to deteriorate [16]. A typical Bagdadi house is shown in figure 2.7.

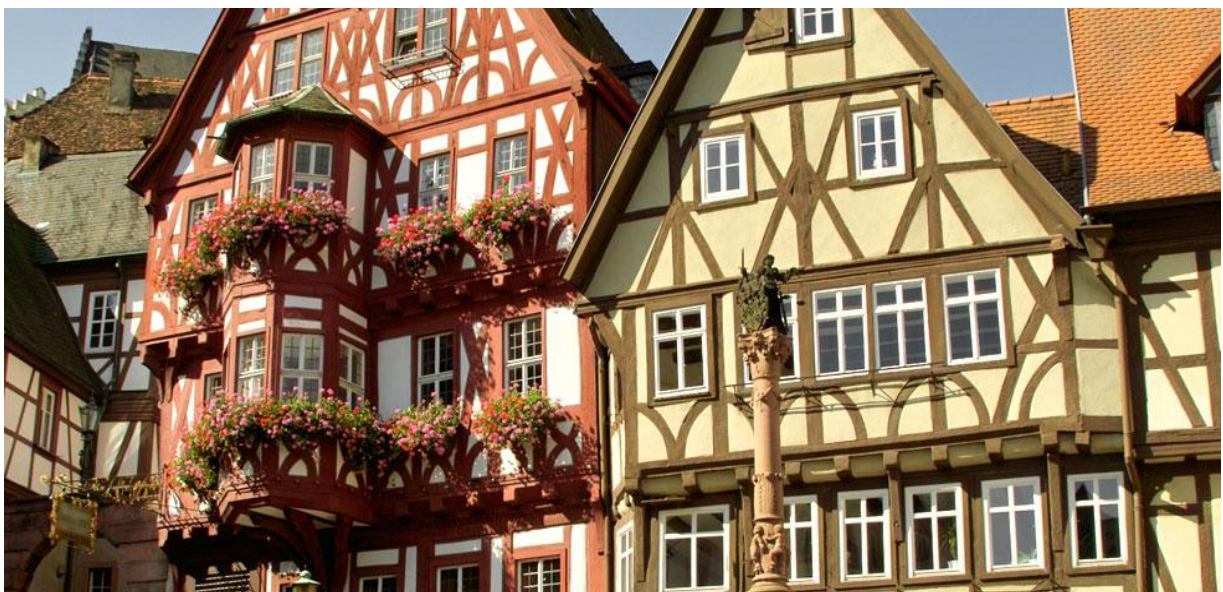
Fig 2.8: Fachwerk House (Germany) [40]

Fackwerk construction is very common in Germany. Different types of timber frames found and are classified by the number of stories and the geometric shapes. This type of construction was introduced in the 7th century but it took till 16th and 17th century to gain popularity. It has three main types (Alemannic, Lower Saxonian and Franconian), which are differed from each other due to dimensions, spacing of the elements and the nature of the framing [13].

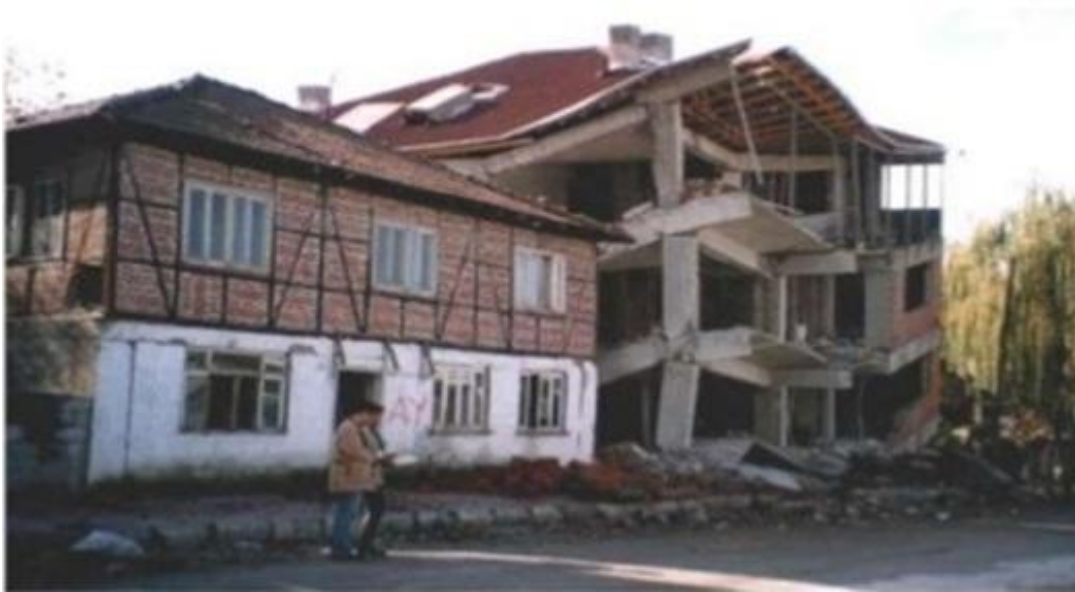
Fig 2.10: An Example of (1999) Turkey Earthquake [16]

structures have performed well in event of an earthquake. In 1999, Kocaeli earthquake, traditional timber structures remained safe but modern concrete structures were heavily damaged. This finding was set by Turkish researchers Gulhan and Guney after detailed statistical study on damaged areas of district [15].

The failure of reinforced concrete structures in an event of earthquake are mostly related to deprived design and poor construction practice. Contrary to this, the traditional buildings those lasted the earthquake were non-engineered, there were no design for them and they were made by local masons, with locally available materials.

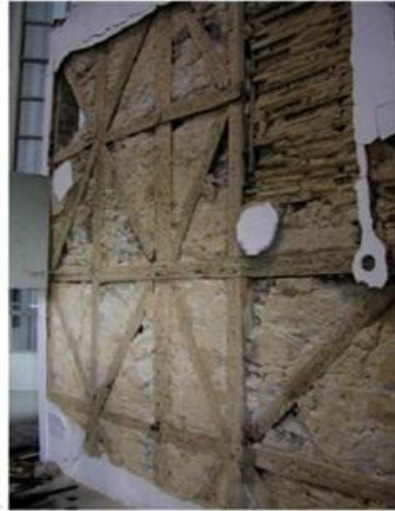
Fig 2.81: Gaiola Wall after Test

performance under seismic actions. Cyclic test was performed and for this purpose three types of frames each having different typologies was analyzed. (1) Timber frame unreinforced and having no infill; (2) Glass Fiber Reinforced Polymer sheets (GFRP) used on connections of timber frame having no infill; (3) Brick masonry was used as infill in timber frames. Tests on typical “Gaiola wall” have shown that the walls in all cases were able to dissipate energy over many cycles without losing their structural integrity [8].

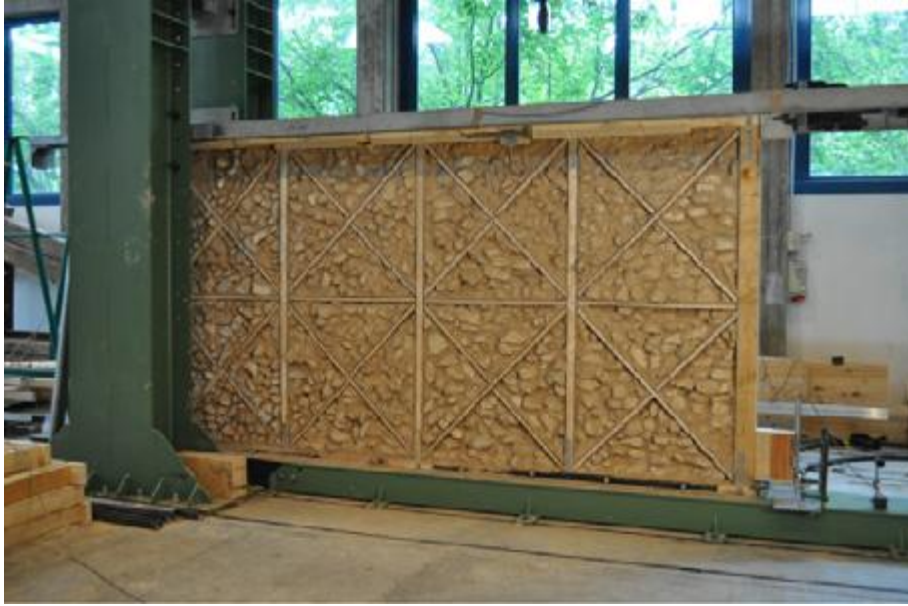
Fig 2.126: Traditional wall tested by Vieux [38]

Vieux et al. [26] conducted various tests to study the seismic performance of timber framed structures filled with natural stones and earth mortar on three scales of experiments during which both cyclic and monotonic loadings were applied. For checking capacity of connection tests were performed in both normal and tangential directions to obtain the hysteretic behavior of nailed connections. Pushover and reversed cycle tests were performed to obtain the hysteretic behavior as a function of infill characteristics. Walls without any openings were considered. Through these tests the influence of the infill on stiffness, maximum load or equivalent viscous damping was analyzed. Based on experimental results they concluded that timbered masonry structures have appropriate seismic resistance [38].

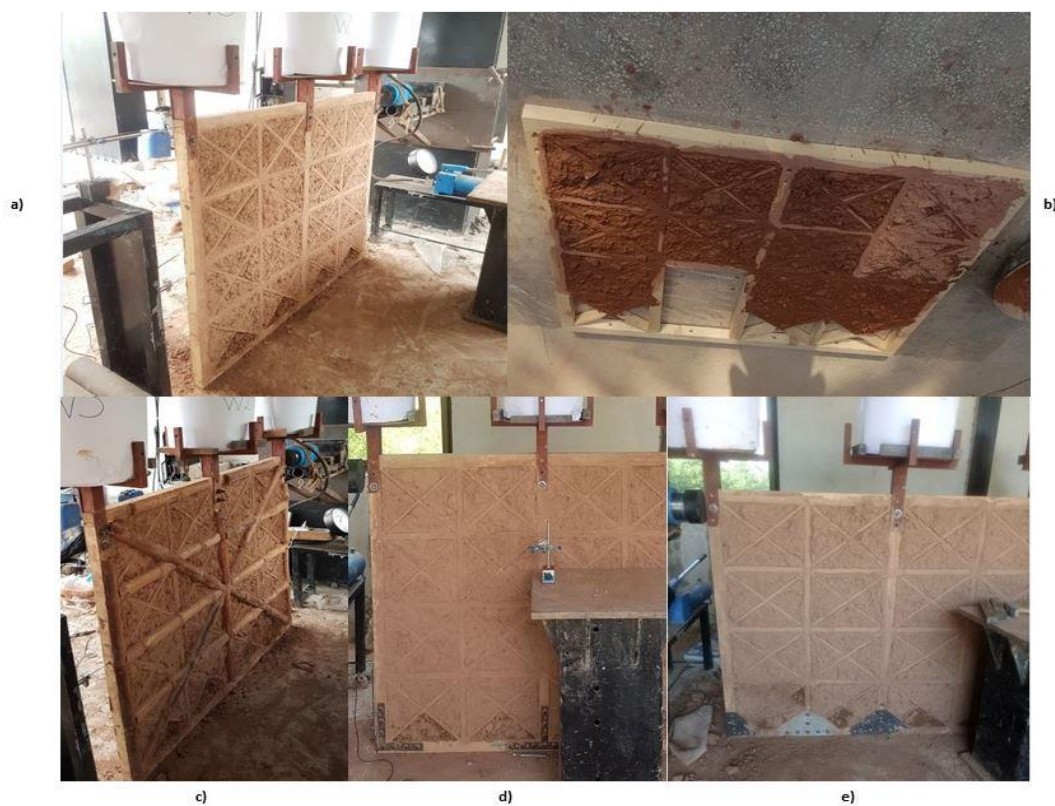
Figure 3.4. (a) DDW1 (b) DDW2 (c) DDW3 (d) DDW4 (e) DDW5.

observe if it enhances the lateral load carrying capacity of the wall sample. The bamboo culms were nailed on the on the cross periphery of the walls as shown in Figure 3.4(c). DDW4 was strengthened at the critical joints, that is joints of the main horizontal and vertical posts of the wall with metal strips. The strips were bolted on. The critical joints were identified by the tests performed on the previous three wall samples. The shape of the strips was L and T-shaped depending on the location and shape of the joints, as shown in Figure 3.4(d). The thickness of the strip was kept at 2mm. The length and width of the strip was selected according to the timber characteristics, that the length was kept according to the spacing of bolts and the strength of timber while the width was 50mm i.e. as the width of the panel's post dimensions. DDW5 was strengthened at the critical joints with metal gusset plates. The joints strengthened in this case were all of the first 3 vertical and horizontal post connections. The strips were bolted on. Like the previous sample tested the shape of the strip was selected according to the location of the joint, i.e. L and triangular shaped plates. The thickness of the strip was kept at 2mm. The length and width of the strips was kept according to the properties of the sample timber properties as shown in Figure 3.4(e).

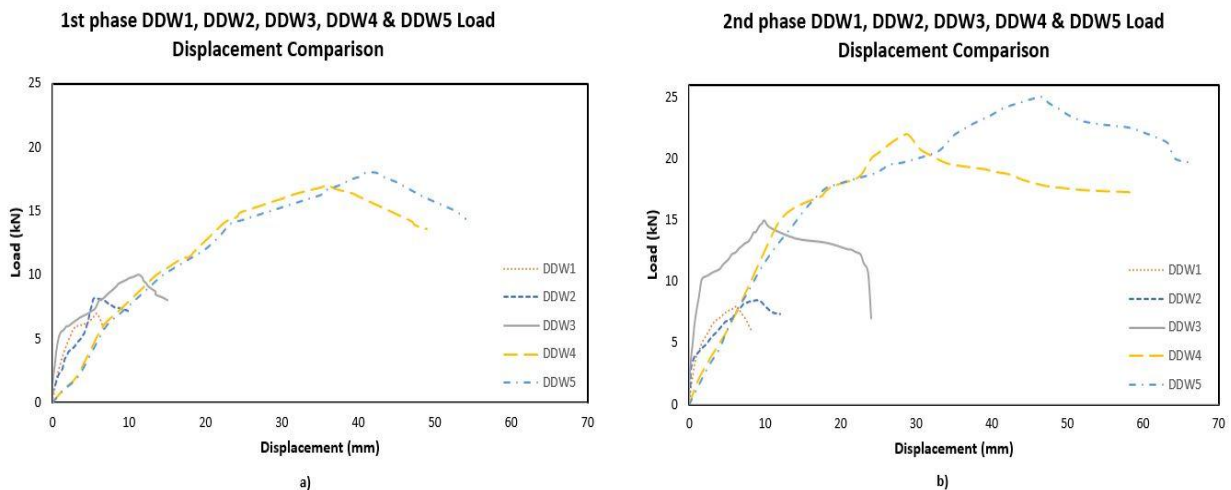
Figure 4.1. Load Displacement curves of all panels a) 1st phase b) 2nd phase.

A load–displacement curve measures the extrinsic properties of the test sample, e.g. the sample wall. The main parameters assessed through a load-displacement curve are stiffness, fatigue, and ultimate load and displacement. The stress–strain curve is similar but it measures the intrinsic properties of the test sample that it because it is normalized for the sample dimensions. These are the elastic or Young's modulus (E), the yield stress and strain, the ultimate stress and strain, and the energies to yield and failure. The load displacement curves for pre and post retrofit are presented in Figure 4.1. They represent the lateral force/load applied at the top of the sample wall vs the horizontal displacement of the walls measured by LVDTs, the absolute values are shown in Figure 4.2.

For the 1st phase test wall samples from the load displacement curve it can be clearly seen that by strengthening the critical joints by Bamboo, Iron strips and Gusset plates improve the wall's load and displacement sustaining capabilities as they should. In DDW1, 2, and 3 the failure was due to wood rupture and tearing of main horizontal and vertical joints also known as the critical joints. While in the case of DDW4, 5 the failure is due to rocking and intermediate joint failure.

For the 2nd phase test wall samples from the load displacement curve it can be observed that even if the wall samples were damaged before (not completely destroyed), if they were re-nailed and properly glued back together with a heavy dose of epoxy and brought back to their almost new condition and were also strengthened at the critical joints and other damaged joints, which were found by analyzing the previous wall test results, with FRP wraps and strips they perform significantly better than wall samples which were strengthened with conventional strengthening techniques, showing better load carrying and displacement enduring capacities.

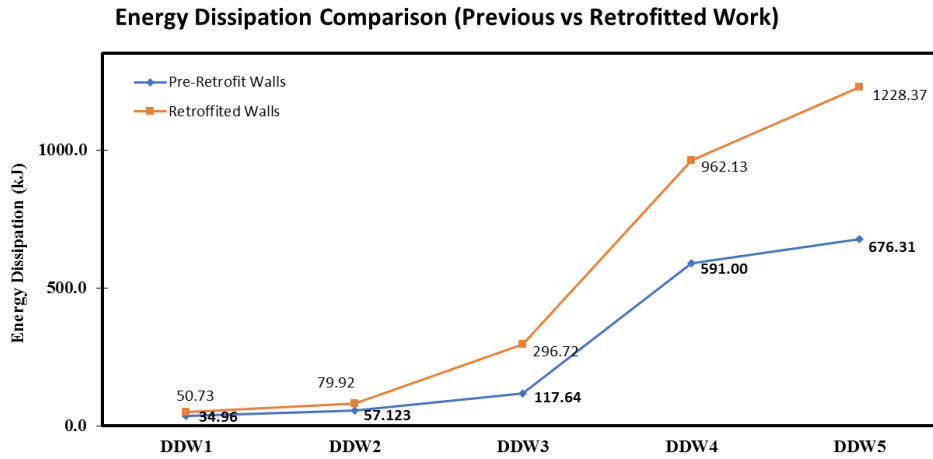
Figure 4.3. Energy Dissipation of all 1st and 2nd phase test samples

The energy dissipated by the sample walls is an intrinsic property of the walls so it is also calculated from the load-displacement or stress-strain curves. Energy dissipation of a structure depends upon several factors, some of the factors involved are (1) the friction along joints, (2) crack propagation, (3) formation of new cracks, (4) crushing of wood, (5) base-lift and rocking. The failure mode of the sample walls also affects the energy dissipated. Higher the value of energy dissipated represent ductile failure, on the other hand higher values of energy dissipated by the specimens can also be due to the strengthening techniques used and

$$\text{Area Under Curve} = \left(\frac{a+b}{2}\right) * (d - c) \quad (1)$$

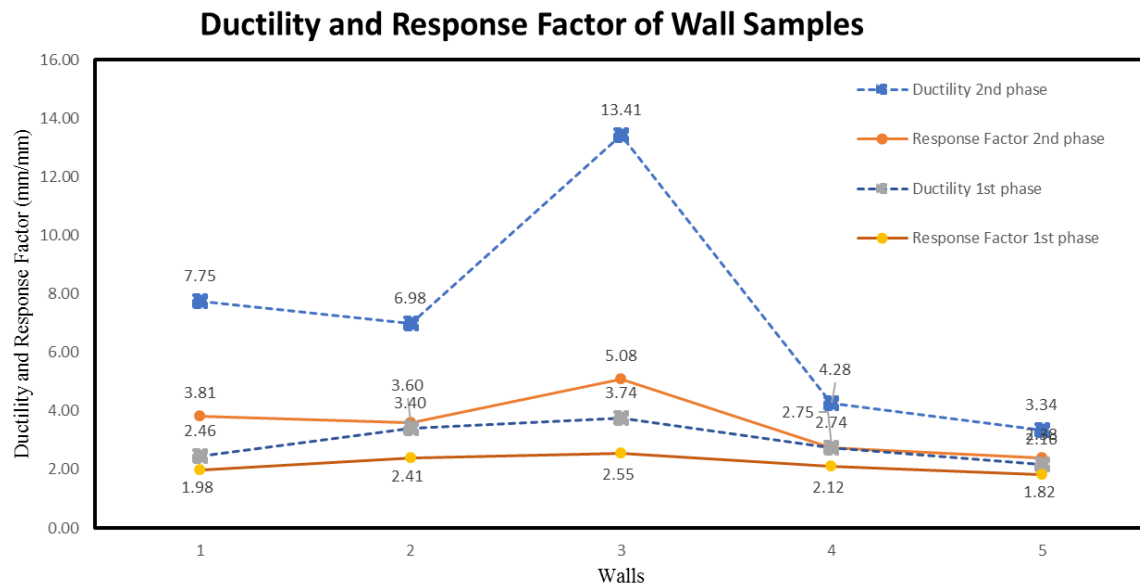
Figure 4.4. Ductility and Response Factor of all 1st and 2nd phase test samples

$$R_f = \sqrt{(2\mu_d - 1)} \quad (3)$$

Where, μ_d displacement ductility, Δ_u is the ultimate displacement and Δ_y is the yield displacement. And R_f is the response factor of the structure.

In 1st phase test wall samples, the wall with the opening the 1st 3 walls i.e. DDW2 and DDW3 represent similar and the best ductile behavior. Since both DDW2 was a standard wall with an opening, the better ductile behavior can be due to fact that in DDW1 the load distribution stopped at joint 2 due to rupture and failure of joint 1 and 2 respectively, while in DDW2 further load distribution and crack propagation occurred, i.e. till main joint 3 and intermediate joints. In the case of DDW3 bamboos were on the cross periphery of walls thus adding further elasticity to the structure. From further wall tests it can be deduced that if crack propagate further along wall sample instead of concentrating on 1 or 2 joints, the better was the ductile behavior of the wall.

In 2nd phase test wall samples, the wall with Double layer FRP wrapping on the 3 main horizontal and vertical critical joints represent the best ductile behavior i.e. DDW3. In the case of DDW3 double layer FRP was used and the second half of walls intermediate joints were left without any FRP wrapping thus allowing better crack propagation. And the results also show that if FRP wrapping and FRP strip (in the case of DDW5) show significant reduction in the ductility of the sample walls. That reduction in the ductility of DDW4 and DDW5 as compared can also be due to the fact that all the joints were over-strengthened and over-strengthening can lead to brittle type failure in case of Dhajji Dewari structures.

Response Factor showed similar trends that is DDW1 to DDW3 showed better behavior while DDW4 and DDW5 showed brittle behavior due to the use of both strengthening technique hence resisting the propagation of cracks and making the joints rigid.

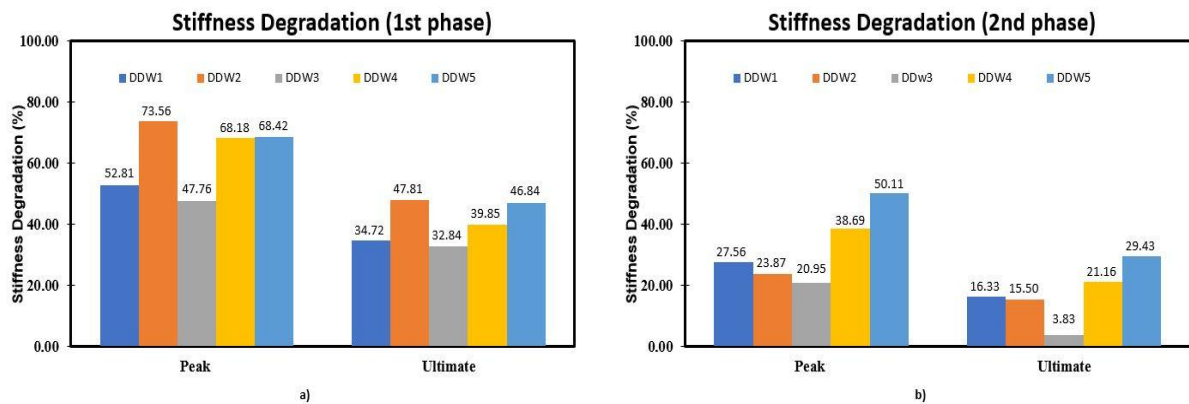
Figure 4.5. Stiffness Degradation Ratio of all panels after testing.

In Dhajji Dewari structures the damage accumulated at the joints is the stiffness degradation. This damage to the joints is measured using empirical formulas and it is related to the bending and pull out of the nails which hold the joints together and with the deformation of the joints. Stiffness degradation represents the rate of stiffness reduction after yielding. Stiffness degradation ratio (C_k) is the rate of stiffness reduction beyond yield. C_k is the ratio of secant modulus at specified displacement (K) to the secant modulus at yield (K_o) as shown in Equation 4 [14]. Lower value of stiffness degradation indicates better seismic capability of the wall sample. Stiffness degradation percentages for all the specimen is shown in Figure 4.5. The overall stiffness values are shown in Table 5.

$$C_k = \frac{K_p}{K_o} \quad (4)$$

As was mentioned before, lower the value of the Stiffness degradation, better the seismic capability of the wall. Even though the stiffness degradation value for the 2nd phase test DDW4, DDW5 have lower stiffness degradation value than their 1st phase test counterparts, their ultimate values are still higher than that of DDW1 and DDW2 and significantly higher than that of DDW3 further showing that FRP reinforcing with conventional reinforcing techniques should be avoided.

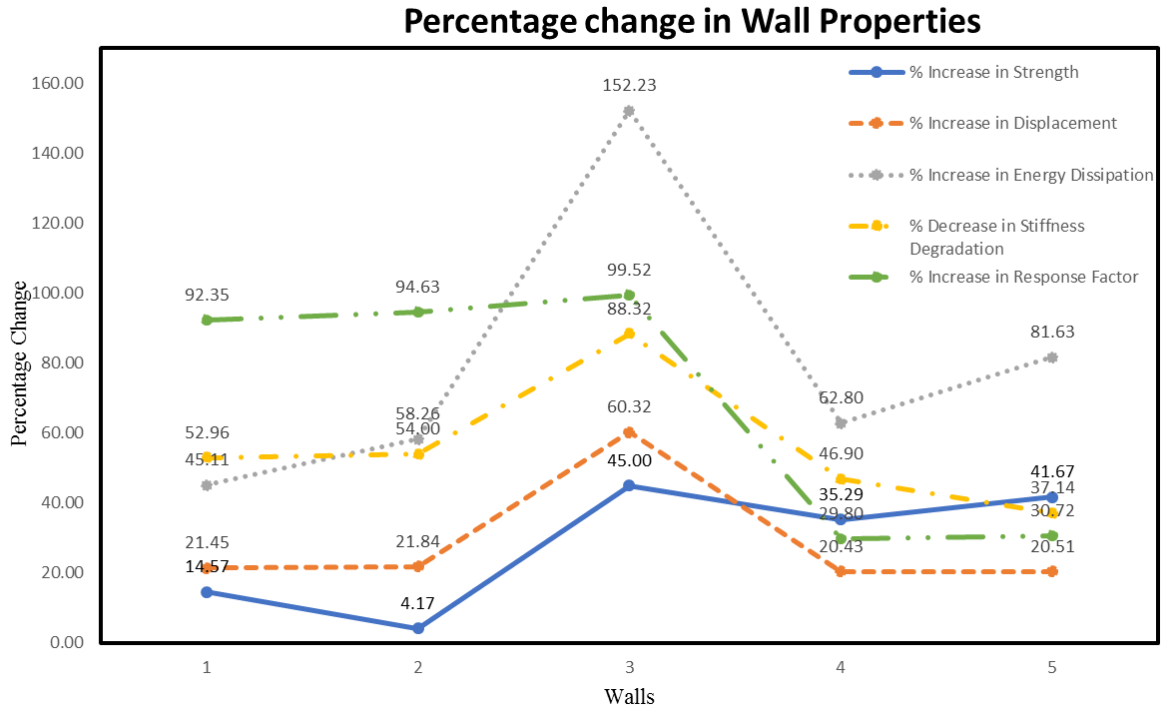
Figure 4.6. Percentage change in Wall Properties after both 1st and 2nd phase testing.

Percentage increase or decrease in all the above calculated parameters have been compiled in Figure 4.6 to get a better picture about which test wall sample improved as compared to other.

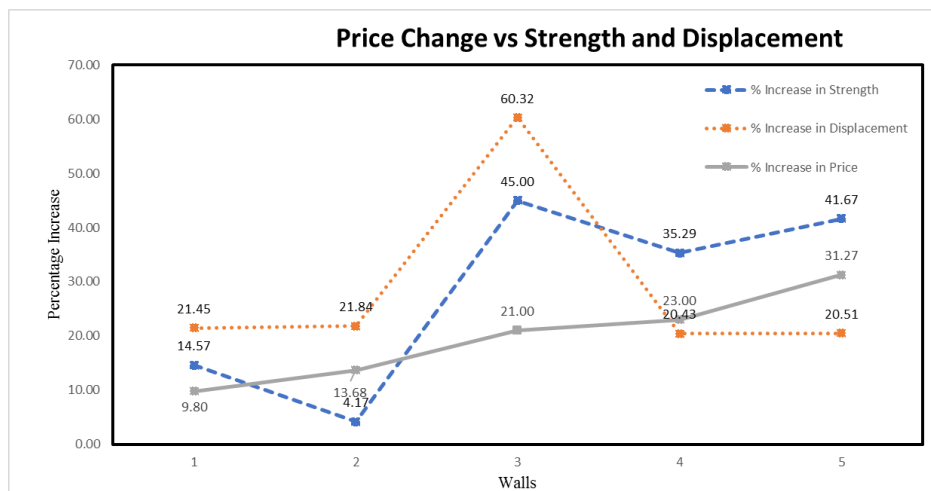
Figure 4.7. Price vs Strength and Displacement

Since strength and displacement are our two most important and relevant properties in terms of a structure’s capability, it was important to do their comparison with the percentage increase in price for the construction and repair work of the test wall samples.

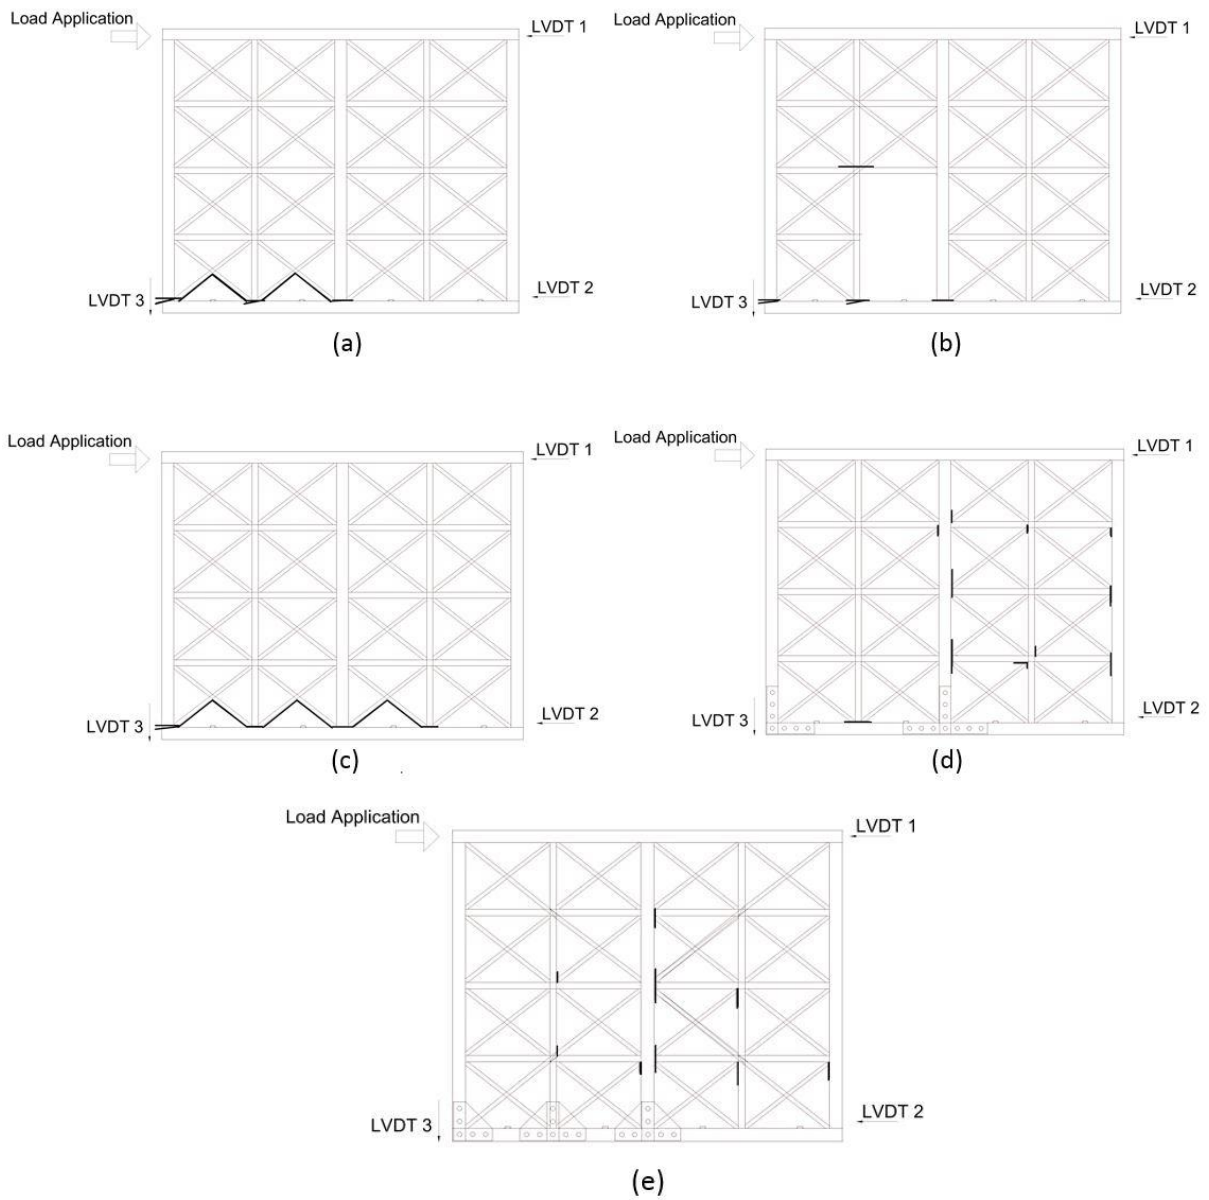
Figure 4.8. Line Schematic of all samples' failure pattern (1st phase)

The failure pattern of 1st phase DDW1 shows that the failure of the wall occurred due to pull-out failure in the main joints 1 and 2 without any intermediate joint damage, while in the case of DDW2 with opening as discussed before the opening helped propagate the cracks and that crack propagation advanced from the joint 1 and 2 pull-out to joint 3 as well with little damage to the joint 3 intermediate joint as well. In the case of DDW3 the inclusion of bamboos not only provided better crack propagation but the failure still occurred due to the main joint rupture instead of pull-out. In the case of DDW4 and DDW5 by providing rigid strengthening on the main joints the cracks propagated from the lower portion to intermediate joints.

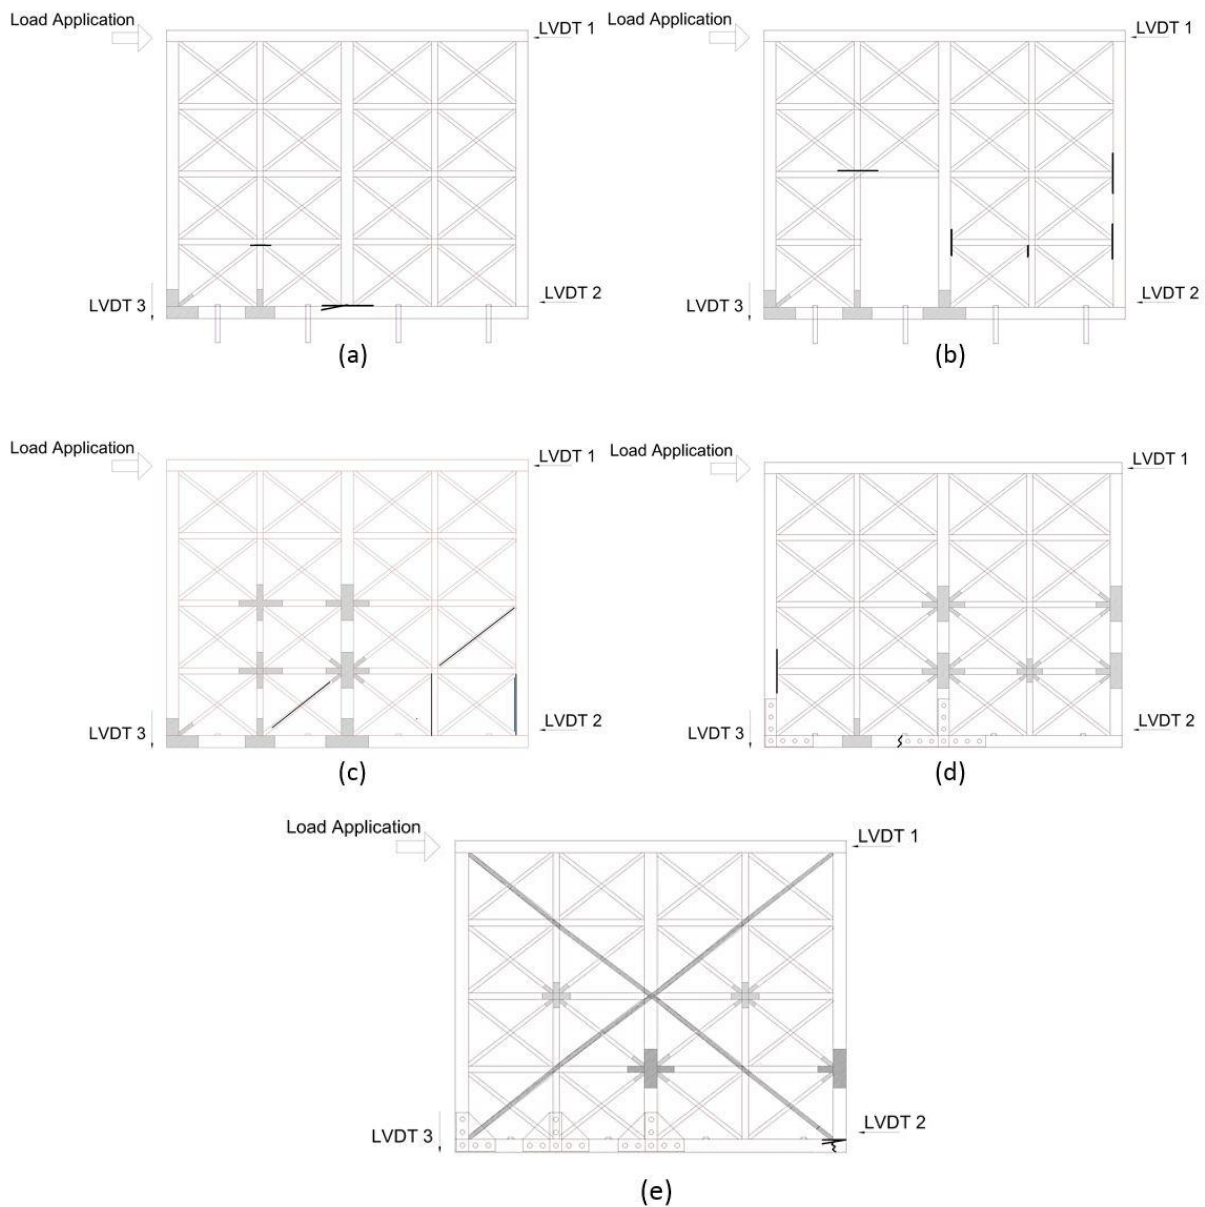
Figure 4.9. Line Schematic of all samples' failure pattern (2nd phase)

Like discussed before by applying a wrapping of FRP on the damaged joints it not improved the key seismic parameters of wall samples but it also removed the scenarios where the critical joints of the wall samples pulled out or ruptured. In 2nd phase DDW1 the cracks propagated till the 3rd main joint before failure. In DDW2 the cracks propagated intermediate joints, same was the case in DDW3. DDW4 and DDW5 started showing signs of over-strengthening by exhibiting bending in the Z-direction hence showing signs of torsional failure by, torsional forces were somewhat mitigated in DDW5 by the inclusion of CFRP strips on the cross periphery of the wall sample. All the actual damaged wall panels are shown in the following figures.
