**REPAIR OF CONCRETE STRUCTURES USING  
FIBER REINFORCED CONCRETE**

A thesis submitted in partial fulfillment of  
the requirements for the degree of

**Bachelors of Civil Engineering**

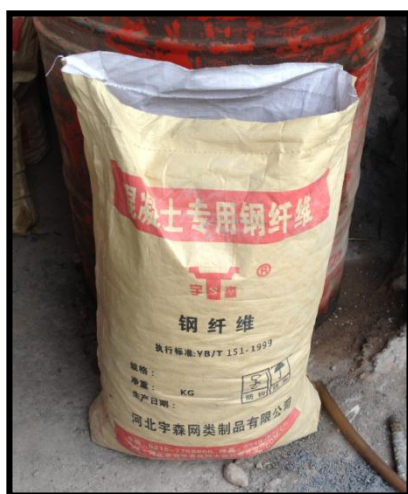
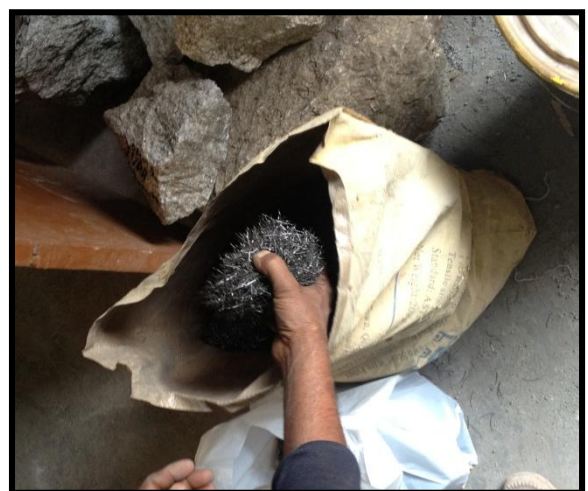
**Fig.2.1 Steel Fiber used in Project**

As the water cement ratio was low so plasticizer was used to give concrete the required workability. "Glenium 51" was used and its dosage was 2% of the cement used in the mix. According to mix design the 28 days strength of the concrete was 32 MPa. Additionally steel fibers were added in the mix to make FRC. The fibers were added 42 kg/m<sup>3</sup> of concrete prepared.

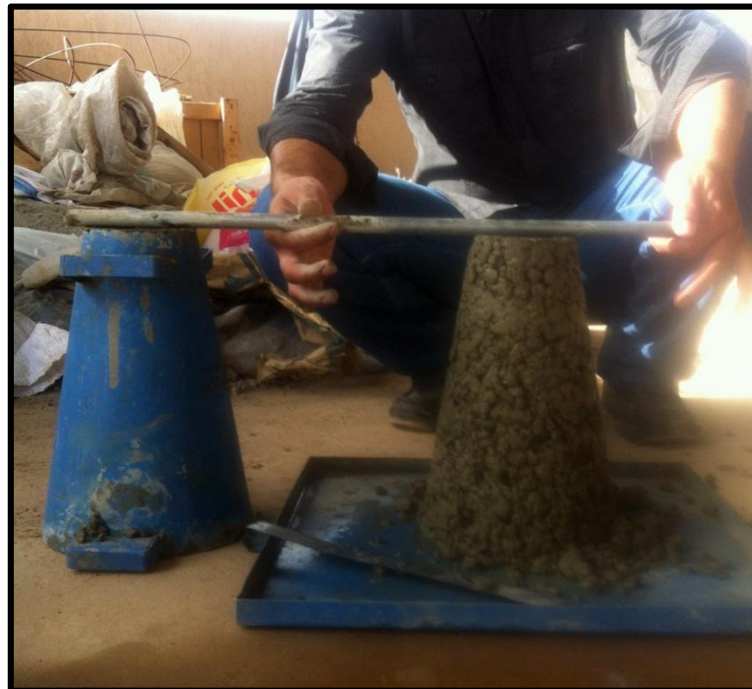
**Fig. 2.2 Slump Test showing True Slump**

Slump test is an empirical method to determine the workability of the freshly mixed concrete. ASTM C143 standard was followed for the determination of slump of the concrete. The cone was dampened and was placed on the base tray of the apparatus. Concrete was poured in the cone in three layers and each layer was rodded 25 times with a tamping rod. Top surface was made smooth by removing extra concrete with a screeding. The mold was removed with a steady upward lift with no lateral disturbance. There was no significant change in the height of the concrete. So the concrete used in all the experimentation was “**True Slump**”.

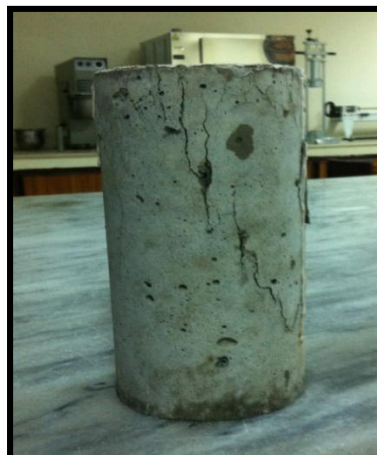
Fig. 2.3 A failed specimen after compressive strength test

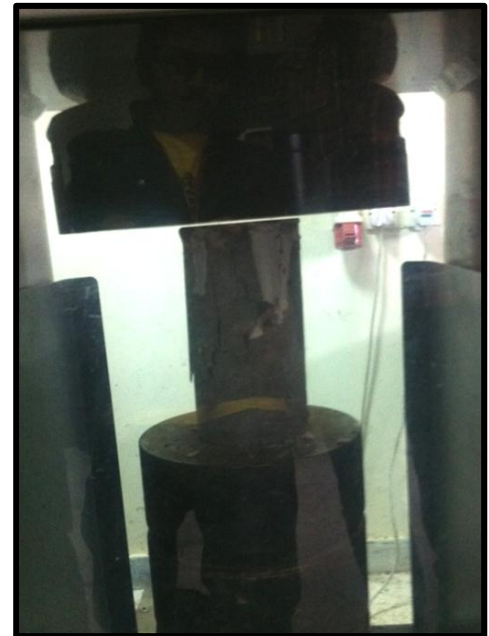
ASTM C 39 standard was followed to perform the test. “Controls” testing machine was used for the determination of compressive strength. The maximum loading capacity of the machine is 5000 KN. The rate of loading stress was 0.25 MPa/s. The Stress was applied till the failure of the specimen. Failure type 2 was observed in the samples.

**Fig. 2.4 A failed specimen after compressive strength test**

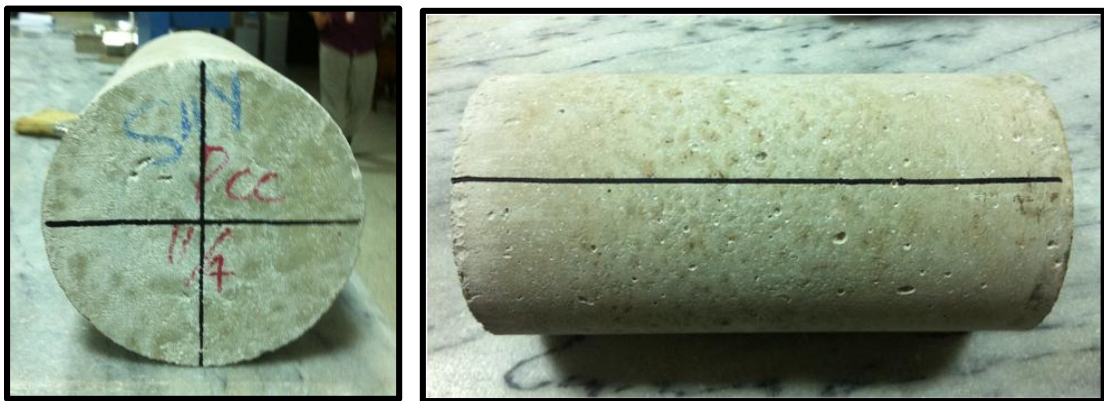
Diametrical lines were marked on the cylinder along the length of the cylinder on both sides. Metallic bearing strips attached with the apparatus were then placed on these marked lines. "Controls" testing machine was used to conduct this experiment. Constant stress was applied at a rate of 1 MPa/min until the failure of the specimen.

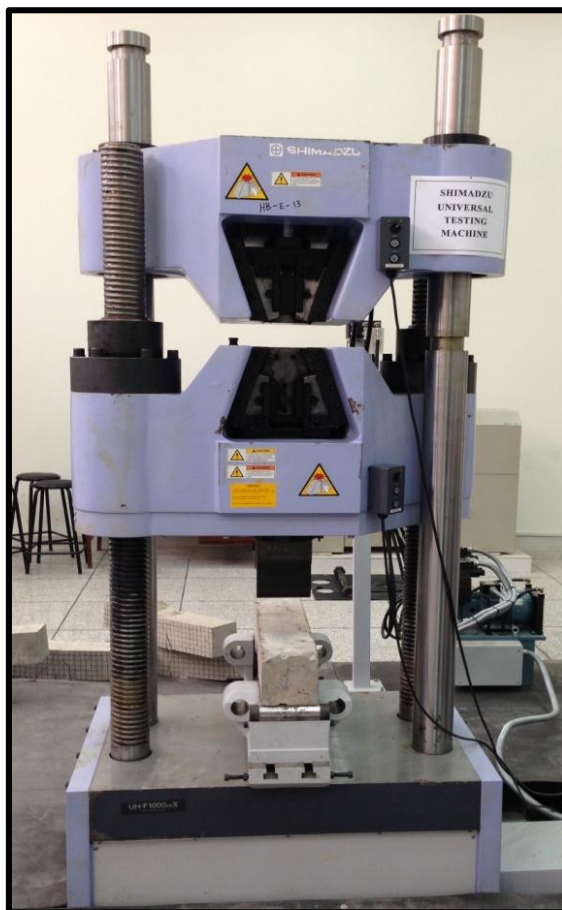
**Fig.2.6 SHIMADZU Universal Testing Machine**

“SHIMADZU” Universal Testing Machine (UTM) was used to perform the experiment. The loading capacity of the machine was 1000KN. It was deflection controlled machine. Rate of deflection was 0.01 mm/min for PCC beams while 0.03 mm/min for FRC beams. The loading was applied up to a considerable value after the failure to sufficiently compare the properties of specimen and determine the differences in behavior.

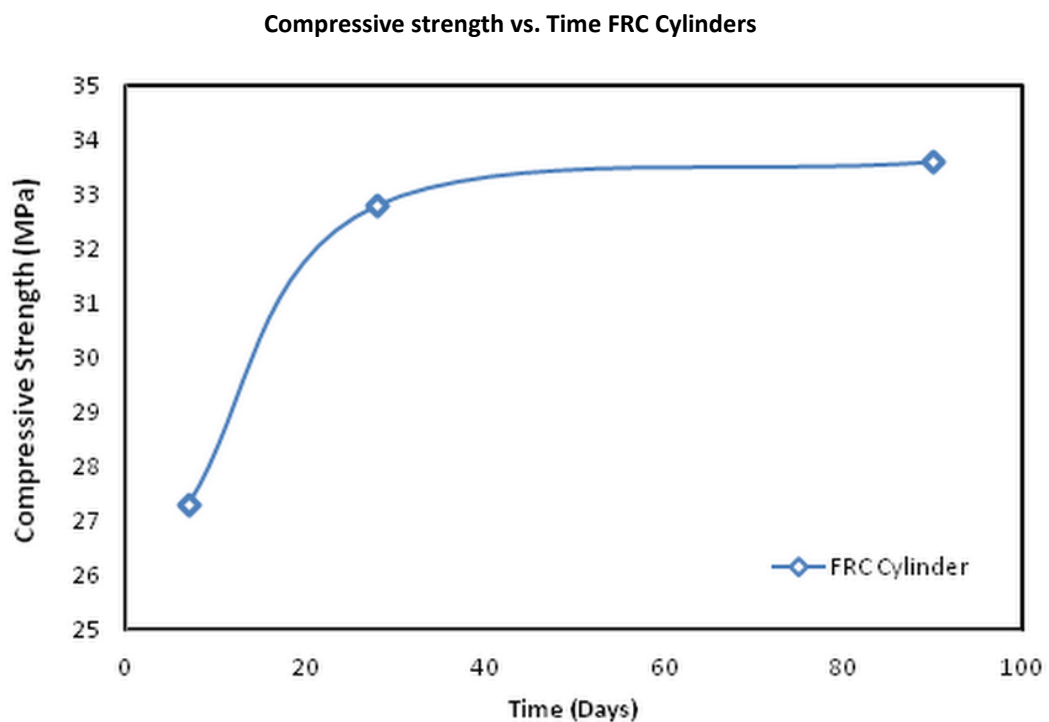
The following graph shows the increase of strength of FRC cylinders with the increase in the number of curing days. With the use of FRC we were able to achieve a maximum compressive strength of 33.6 MPa. The graph shows the regular increase in strength up to 40 days of curing and then achieves at constant value of 33.6 MPa. The different strength values are enlisted in the following table:

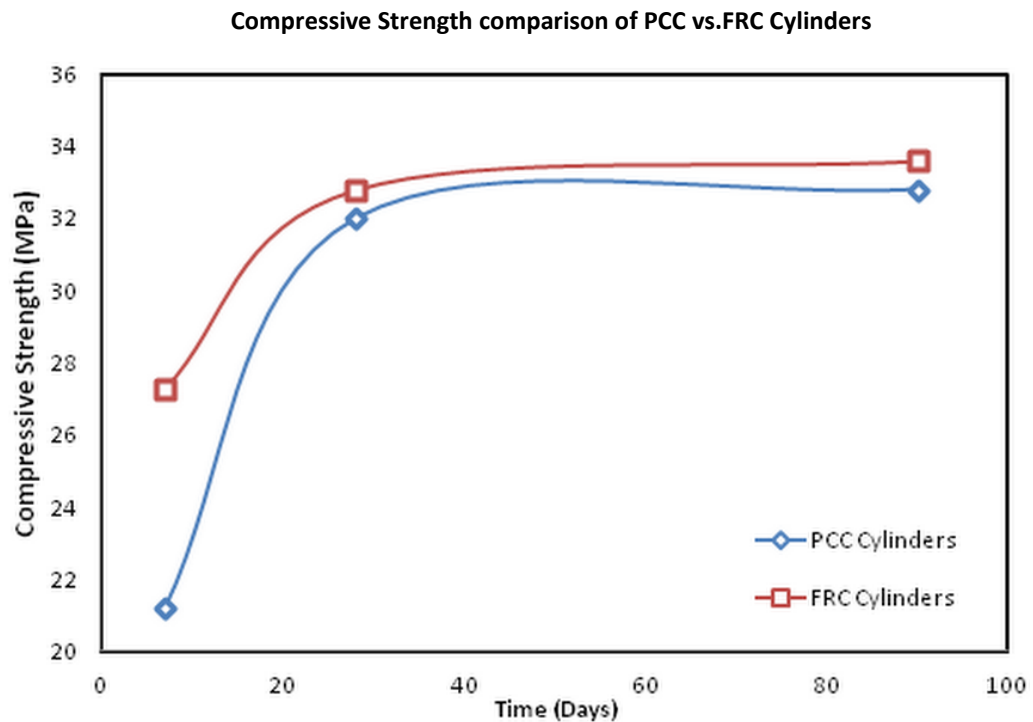
The above graph compares the compressive strengths, achieved corresponding to the number of curing days, for samples with same mix ratios (PCC and FRC). Careful examination of the graph shows that the addition of fiber enhances the early strength gain of concrete matrix. As the curing progressed, the strength gained by FRC cylinders was slightly higher than PCC cylinders. The following table expresses the graph in numerical terms:

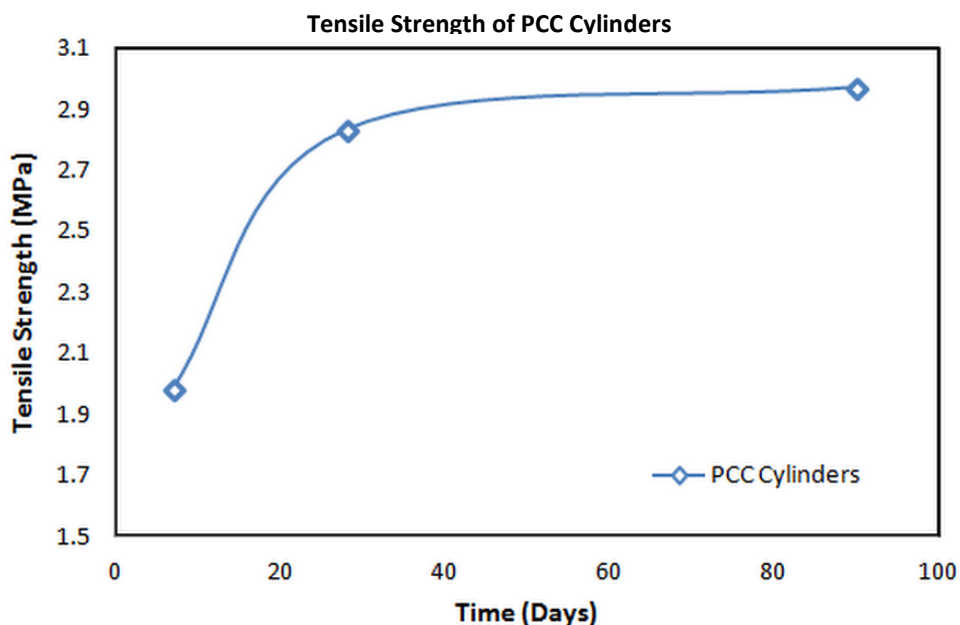
The samples casted with PCC were tested for splitting tensile strength at different intervals of curing. The trend in the below graph shows the increase in the splitting tensile strength of concrete matrix with the increase in the number of curing days. This behavior is attributed to the increase in the compressive strength of concrete and thus increasing the tensile strength of concrete. Also, the graph shows a nearly straight line after 40 days of curing. This is also attributed to the behavior of compressive strength which stays constant after 40 days of curing.

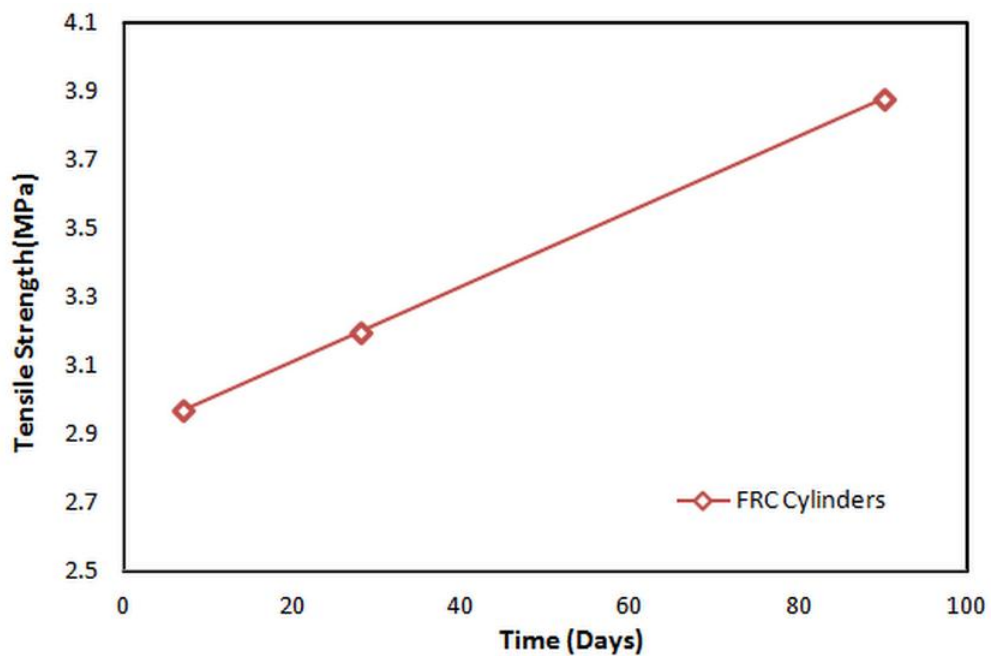
Tensile Strength of FRC Cylinders

The splitting tensile strength achieved with the FRC samples showed a similar trend of increase in splitting tensile strength with the increase in compressive strength with increase in duration of curing. The graph does not achieve a constant value after 40 days even though when the compressive strength has achieved a constant value. This is due to the enhancement of tensile strength of concrete with the introduction of steel fibers. Addition of fibers significantly improves the performance of concrete under tensile loads.

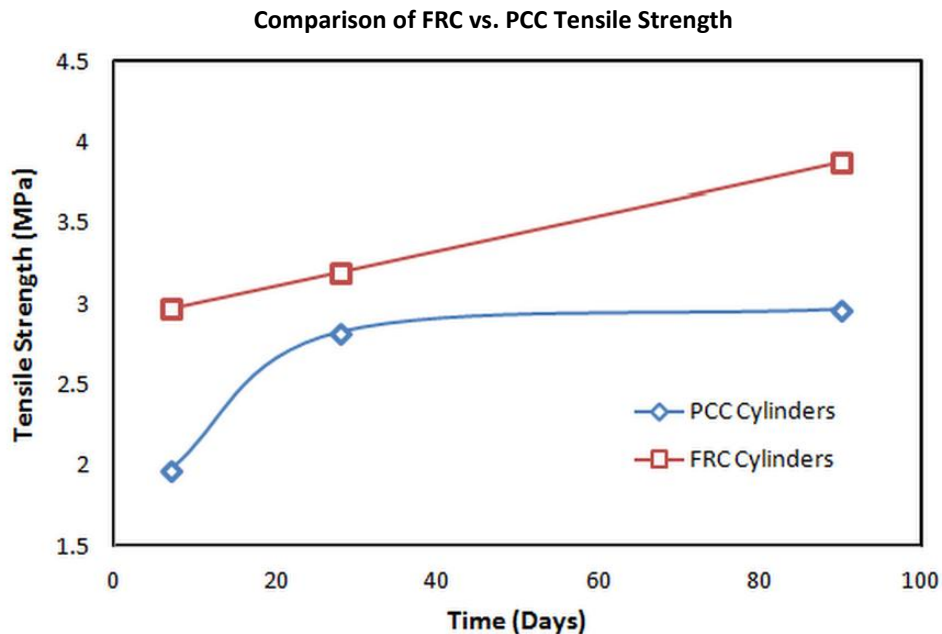
There is a marked difference in the behavior of PCC and FRC in terms of splitting tensile strength at same duration of curing. The introduction of fibers in the concrete matrix enhances the tensile strength. A keen look at the above graph shows the following key features:

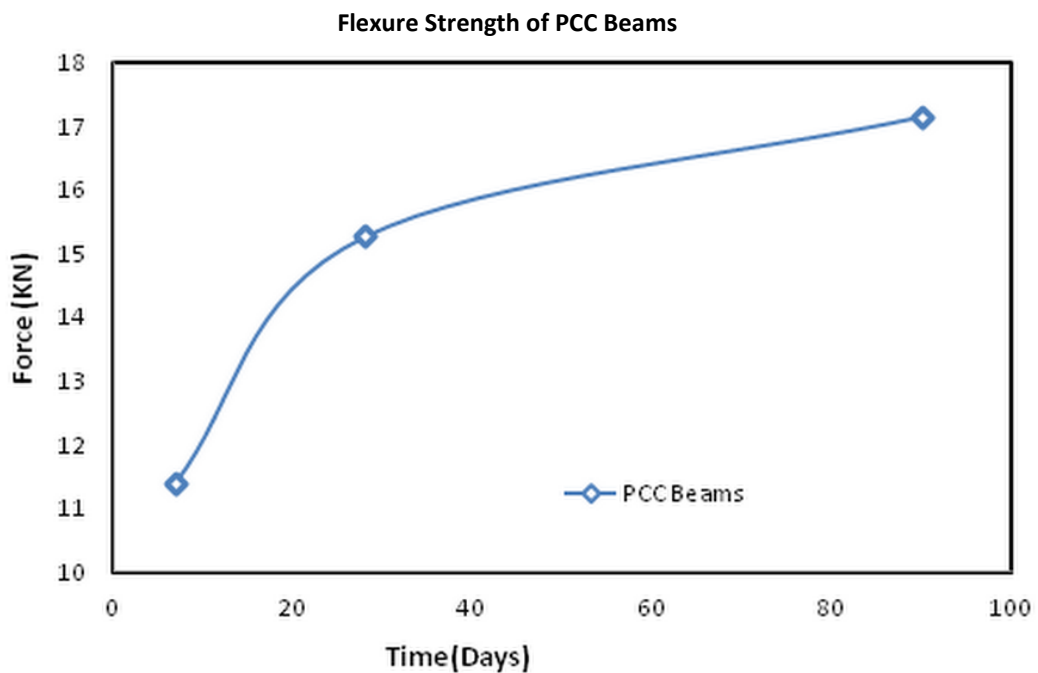
Below is a graphical representation of the results achieved by testing PCC beams in flexure.

The usual trend of increase of flexural strength with increase of compressive strength was achieved. The steep slope of the graph till 30 days shows that there is significant change in flexure strength with increasing curing duration. A gentle slope after 30 days of curing explains that there is no marked increase in flexural strength.

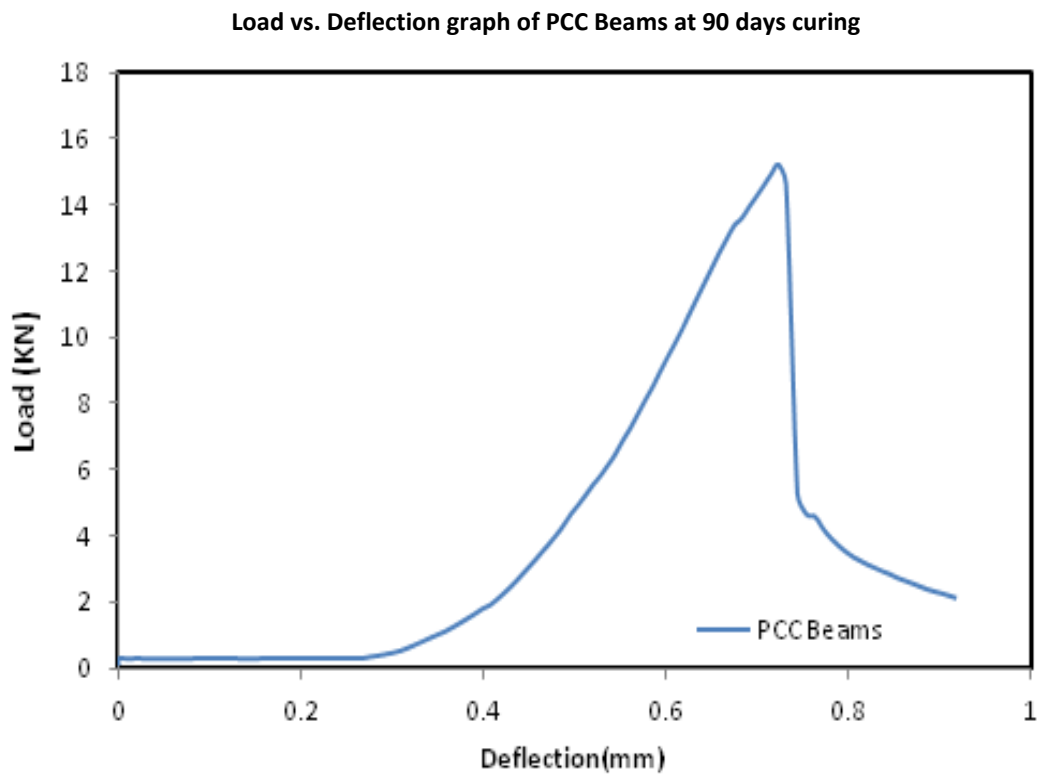
The following graph represents the deflection against the amount of load applied on the beam cured at 90 days.

The graph shows a very brittle failure of the PCC beam at maximum load. The beam is taking a lot of load while showing no significant deflection. After the failure, there is no post cracking ductility of the PCC samples which is shown by abrupt drop in the graph after the maximum load is attained.

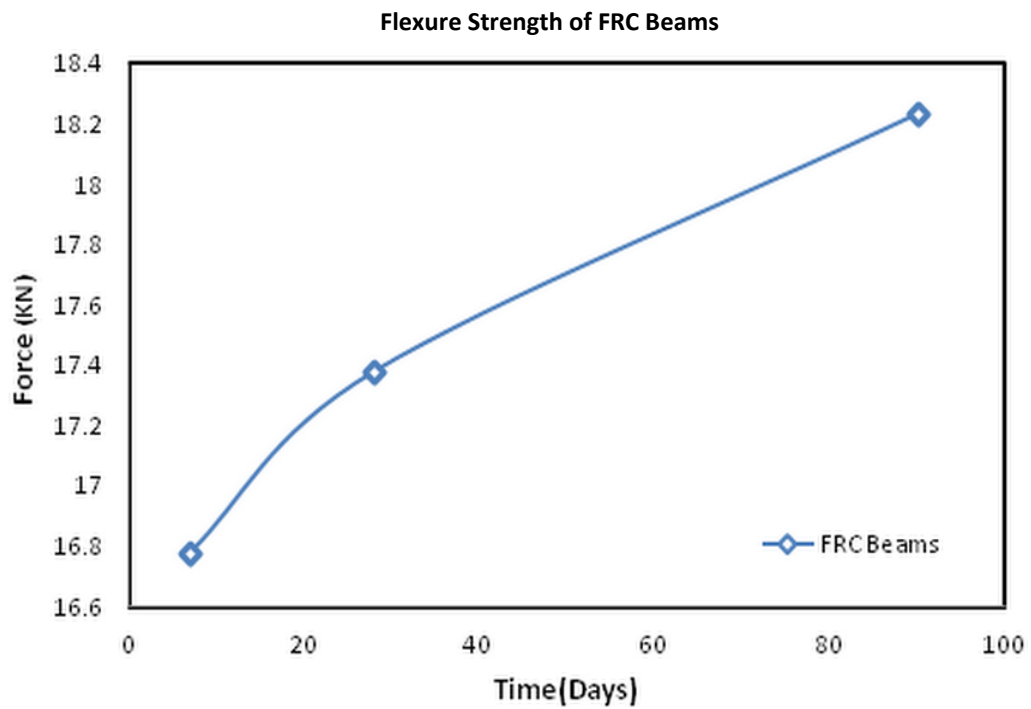
Below is a graphical representation of the results achieved by testing FRC beams in flexure. The usual trend of increase of flexural strength with increase of curing duration was achieved.

A marked rate of increase in the strength of Fiber reinforced beams was noted in the results achieved. The reinforcing properties of fibers proved to be excellent in improving the flexural load carrying capacity throughout the curing period. Further shown is a graph of load vs. deflection of a FRC beam cured at 90 days.

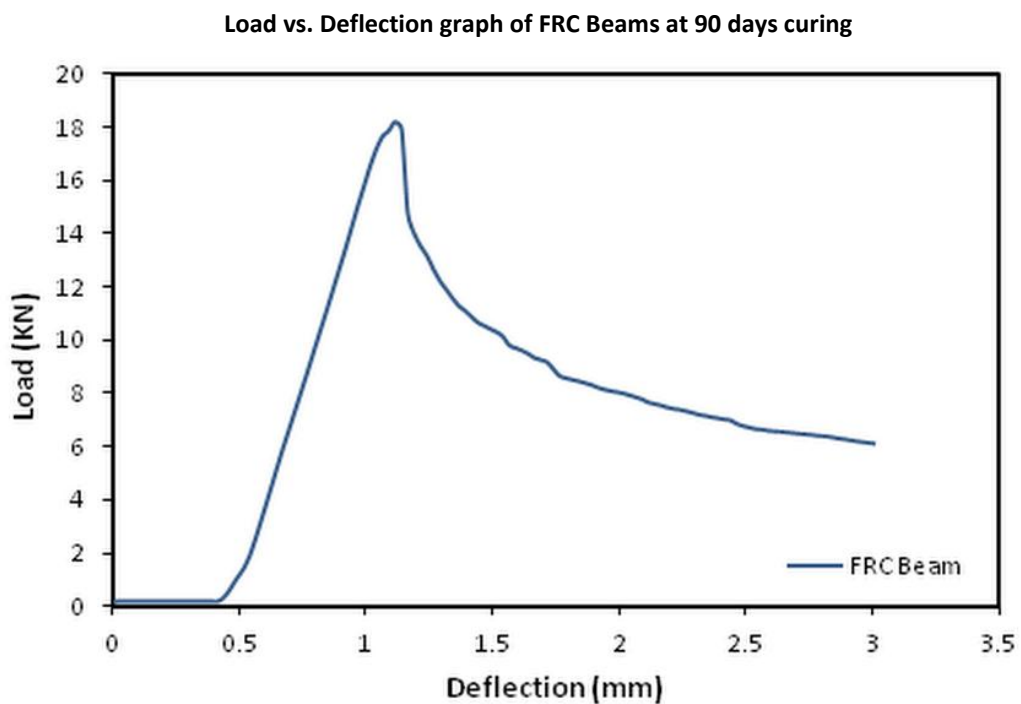
The above graph shows a very good ductile behavior of FRC beam against load applied. A gentle slope at the start shows that the beam is taking load and is allowing deflection as well. After failure, the beam showed good post cracking ductility. The beam was able to take higher load with ductile behavior even after the failure. This property, as studied from the literature, was practically proven through this experiment.

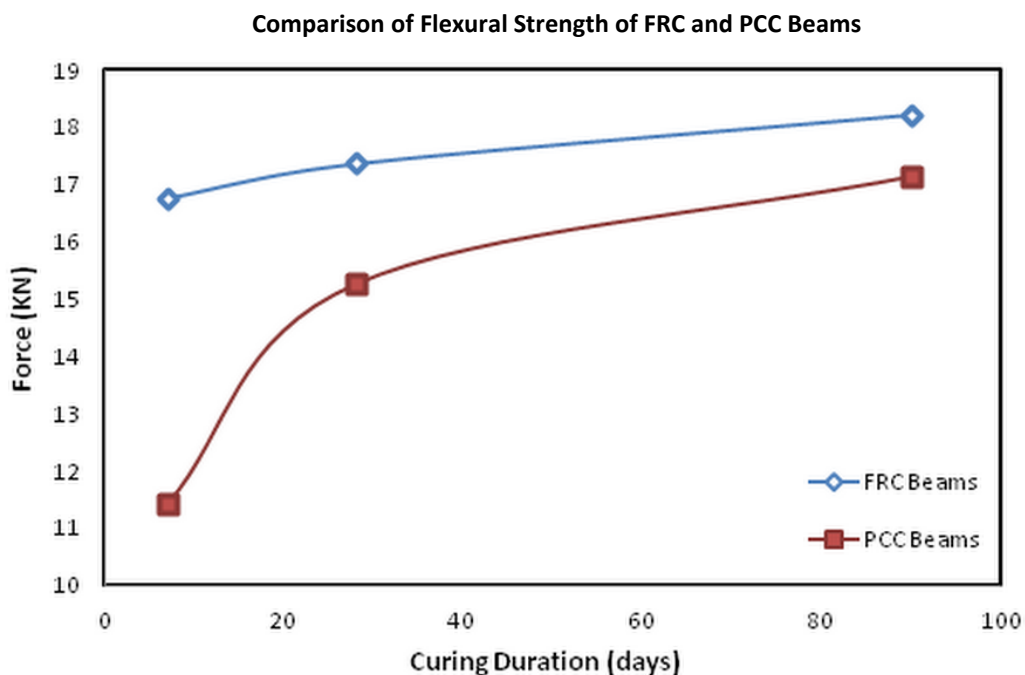
The comparison of maximum flexural load sustained by PCC and FRC is shown in the below graph.

It is clear that introduction of Fibers in the concrete mix enhanced the early strength of the beams. There is also a considerable change in the final flexural strength of the beam samples. The same attribute of reinforcing properties of fibers is the cause of the difference in the flexural strengths of PCC and FRC beams at same curing days. Addition of fibers increases the flexural toughness and enhances the flexural strength of the concrete. The gain in strength of PCC beam was high till 30 days of curing shown by steep slope of graph. After curing of 30 days the increase in flexural strength was not considerably high. While in case of FRC there was almost linear increase in strength throughout curing period.

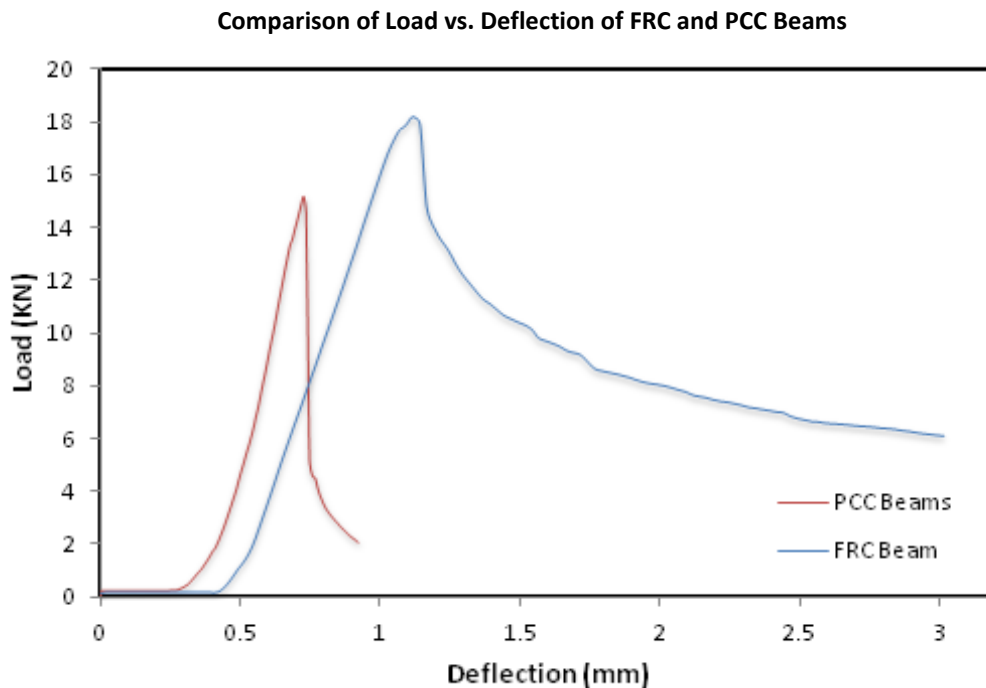
The graph shown below of load vs. deflection draws a comparison between PCC and FRC beams.

When the load deflection curves of the samples of both FRC and PCC cured at 90 days are compared, there is a remarkable difference in the load carrying capacity and post cracking behavior. The increase in the flexural strength is due to enhanced flexural toughness of the beam caused by the addition of the fibers. The steep slope of the PCC curve shows the brittle behavior of the beam. On the other hand a gentle slope of FRC curve shows a more ductile response. In addition to the strength enhancement, fibers add to the post cracking ductility of the ordinary plain concrete matrix. Even after failure the FRC beam was able to withstand appreciable load. The bridging of cracks due to fibers enhanced post-cracking ductility. The comparison of both the curves at and after the failure shows that FRC beams are capable of improving ductile properties before and after failure.

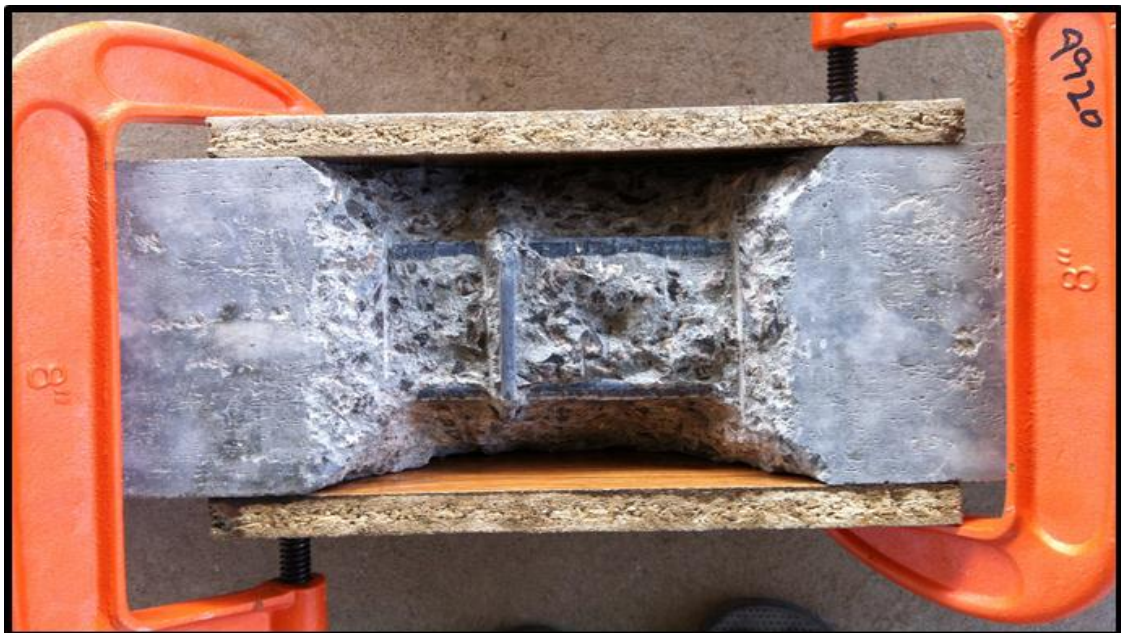
A 50 mm deep cut was made on the tension side of the beam specimens running from one side to the other at a distance of 75 mm right and 75 mm left from the mid of the beam, with the help of concrete cutter. The concrete between the cuts was then scrapped off from the tension side with gentle blows of wedge and hammer up to the depth of 25mm in order to expose the reinforcement. Care was taken to avoid crack propagation deep into the specimen and up to the best of our efforts the damage induced was kept same in all beam specimens.

**Fig. 3.1 A damage induced Beam with formwork**

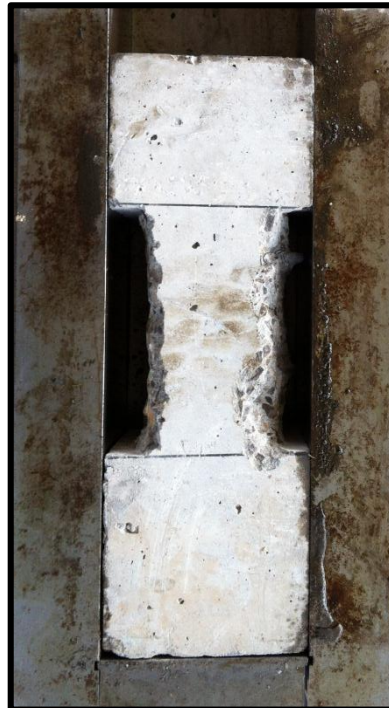
Similarly a cut of 50 mm was made at 75 mm towards top and 75 mm towards bottom of the mid-height of each column. This process was done on two opposite faces of the column. The concrete between cuts was scrapped off with gentle blows of wedge and hammer exposing the reinforcement.

**Fig. 3.2 A damage induced Column with formwork**

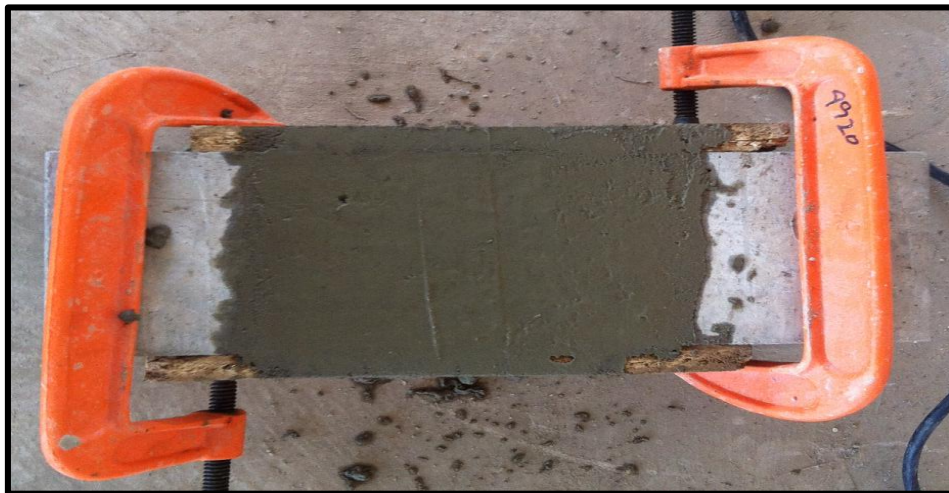
Same composition of repair mixes were applied to both beam and column repairs. True slump was maintained in order to rule out the problem of surface cracking due to drying shrinkage. Once the damaged was done, the damaged surface was washed with splash of water and brushed to remove loose concrete pieces and dust. Two boards of plywood were clamped against the sides of each beam and column specimen to be repaired. The prepared PCC and FRC mixes were added and compacted with help of vibratory compactor. Surface of the sample was made smooth and was left for 24 hours. After this, the specimen was put into the curing tank for 28 days to allow the repair mix to gain strength.

**Fig. 3.3 A PCC repaired Column with formwork**

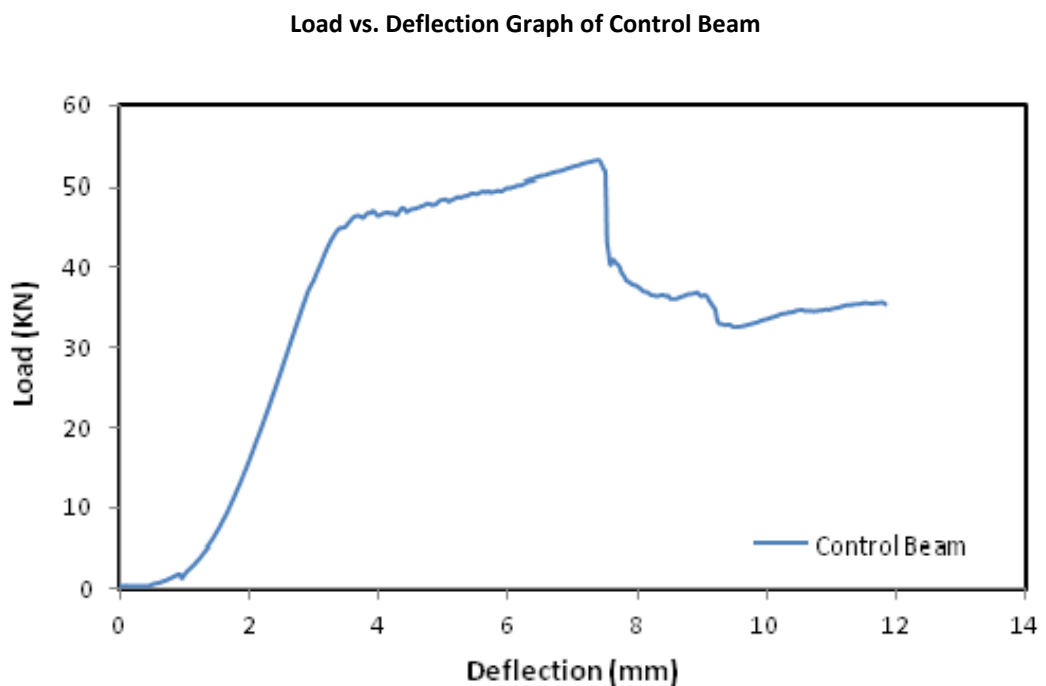
The graph below shows Load vs. Deflection behavior of the control beam.

The behavior of the control beam was quite irregular and the graph shows two major peaks. The first peak in the curve corresponds to the start of crack development under the point of application of load. Once the crack development has started, slope of the graph changes. This is due to the fact that the method of application of load was controlled by deflection and to keep the rate of deflection constant once the crack development started, the machine had to reduce the rate of application of load to reach the failure point Peak 2.

<b>Peak</b>	<b>Load (KN)</b>	<b>Deflection (mm)</b>
First Peak	48	4.3
Second Peak	52	7.2

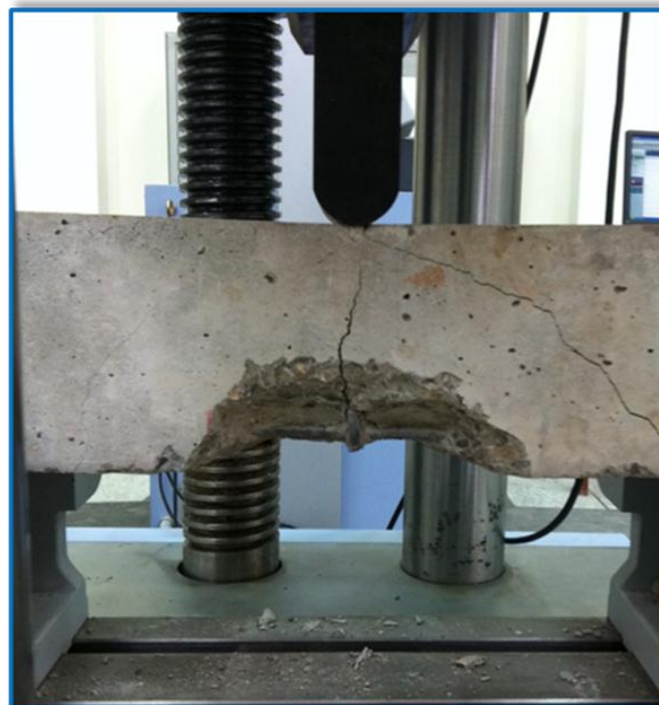
**Fig.3.4 A failed Control Beam**

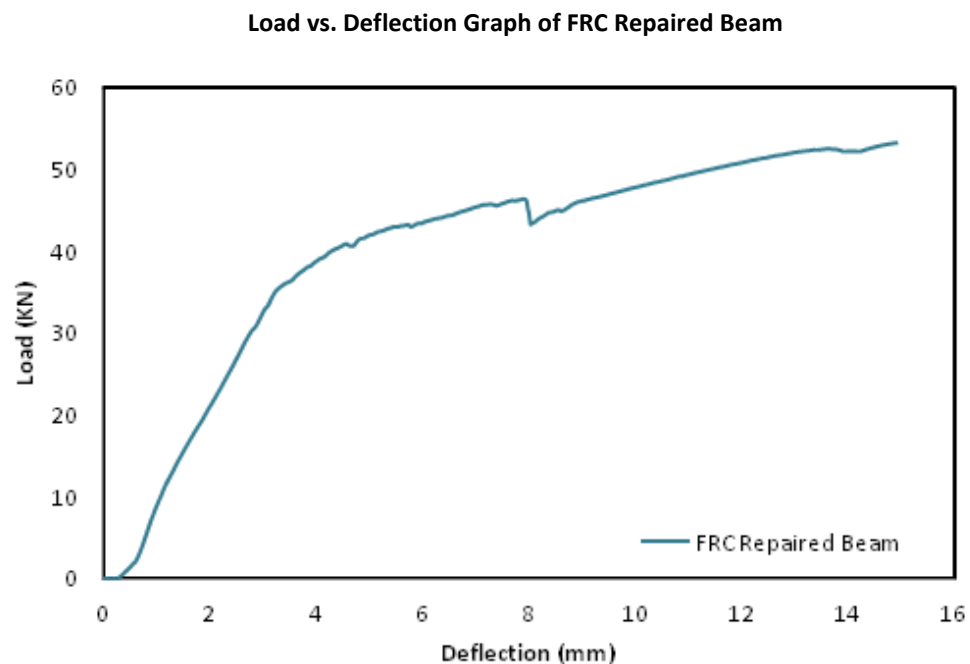
Flexural Strength test on the beam sample repaired with FRC showed the following behavior:

The initial part of the curve is straight showing regular deflection increment with the increase in load. From the graph, we cannot define a failure point clearly. The change in slope of the curve at the edge of straight part of the curve corresponds to the crack initiation. The deflection keeps on increasing with the load and there is no sudden drop in the curve. However, after a large amount of deflection, a minute break in the curve is observed corresponding to a deflection of 8 mm. This drop is due to flexure crack development in the repaired FRC mix portion directly under the application of load. Since fibers resist propagation of the cracks, the beam was able to withstand significant amount of deflection and load.

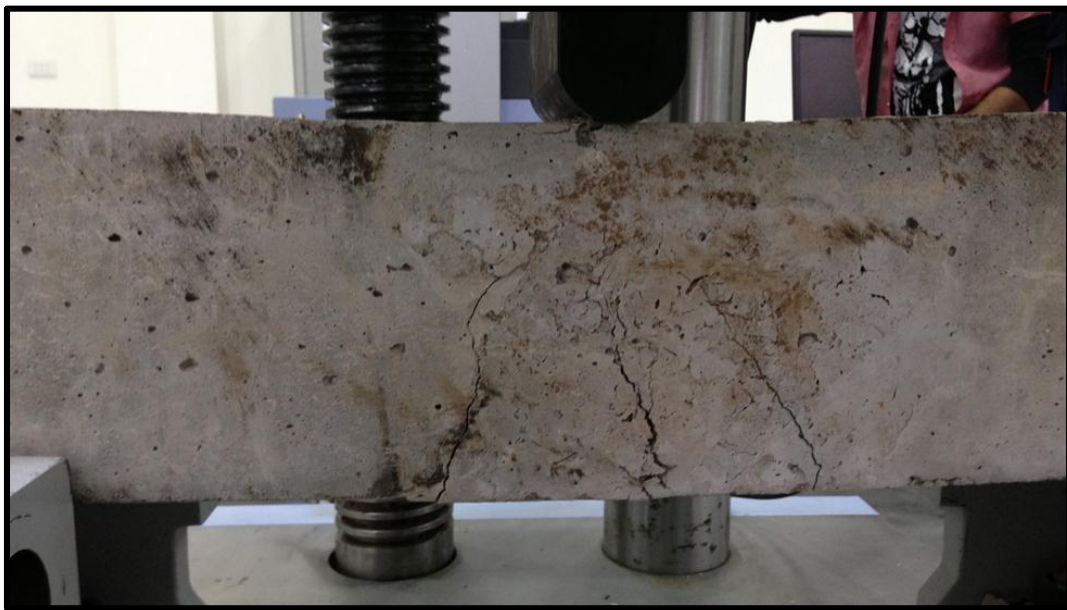
**Fig.3.5 A failed FRC Repaired Beam**

This behavior represents excellent property of post cracking ductility. This desirable feature required in most of the structural repairs is favorable in case of the large deflections due to earthquakes, settlements etc. So the objective of achieving post cracking ductility with use of steel fibers in repairs was achieved.

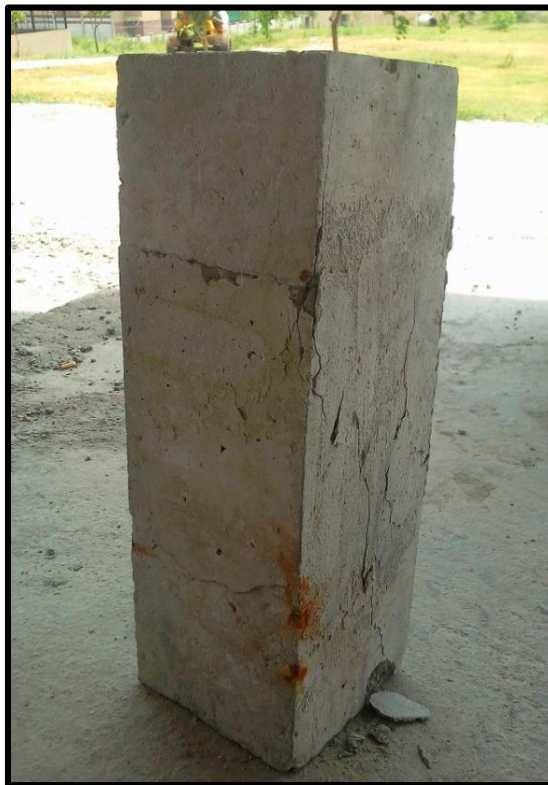
The application of PCC repair on column specimen improved resistance against surface cracking, delayed the appearance of surface cracks, reduced the crack opening and increases a small amount of load carrying capacity.

Fig.3.6 A PCC Repaired Column after failure

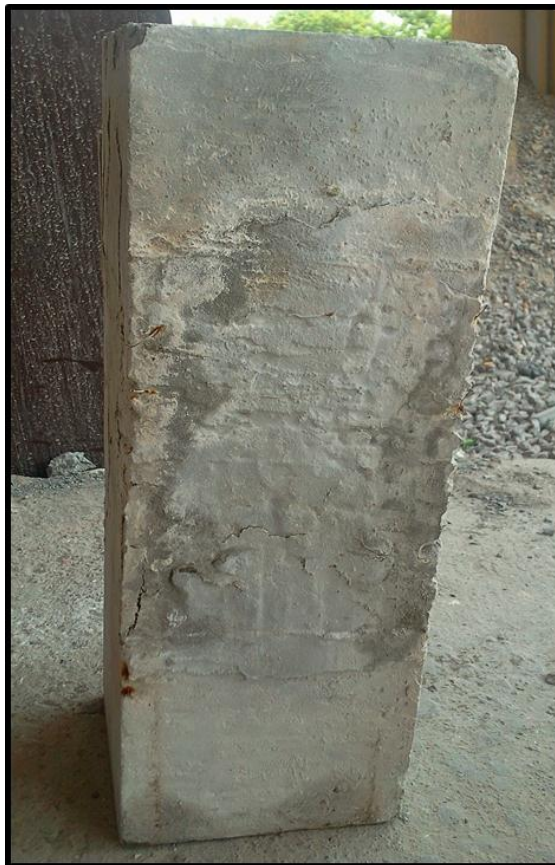
Appreciable enhancement in the reduction of surface spalling, crack widths, delayed appearance of the surface cracks, no spalling off of the surface concrete, good bonding with the existence concrete surface. These properties represent excellent repair potential of beam-column joints subjected to surface spalling, strengthening of columns showing spalling, columns exposed to the external atmosphere, rehabilitation of columns in earthquake and flood affected areas.

Fig. 3.7 A FRC Repaired Column after failure

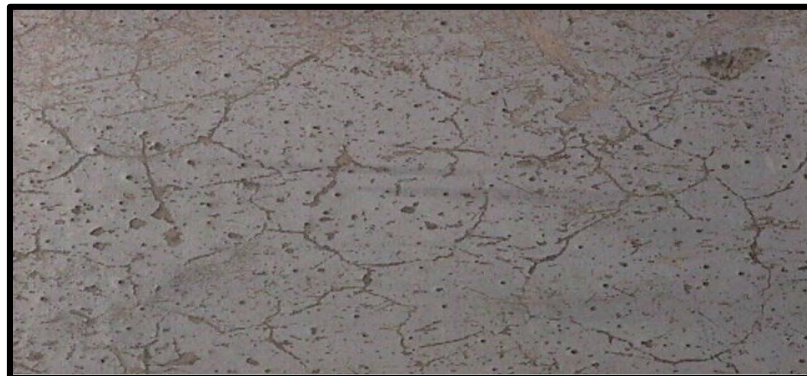
Fig.4.1 A concrete slab showing cracks due to excessive water in mix [5]

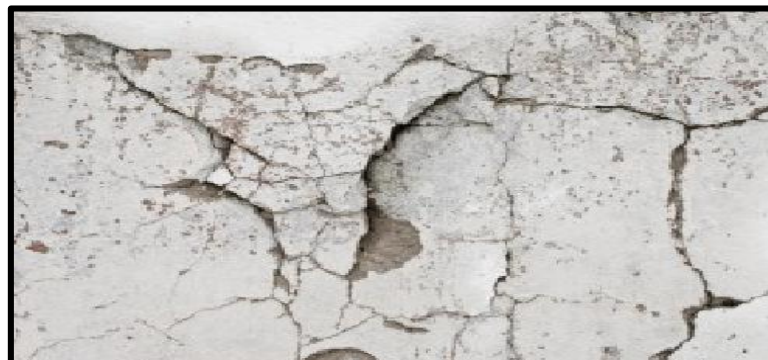
Fig. 4.2 A Concrete member showing cracks due to freezing and thawing [6]

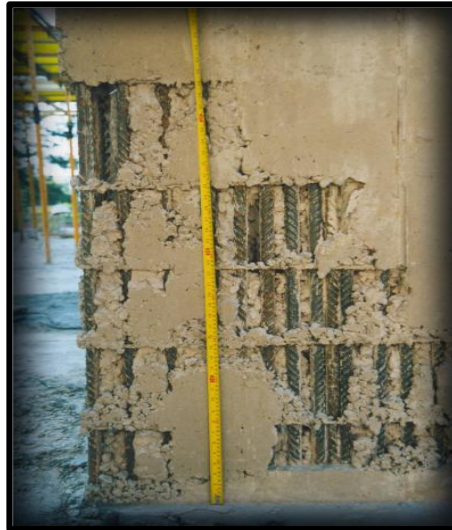
**Fig. 4.3 A Concrete Column with inadequate cover and exposed reinforcement [5]**

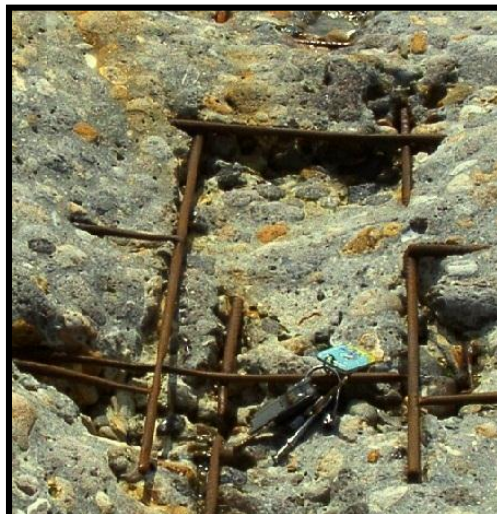
**Fig. 4.4 A Concrete member erosion with exposed reinforcement [9]**

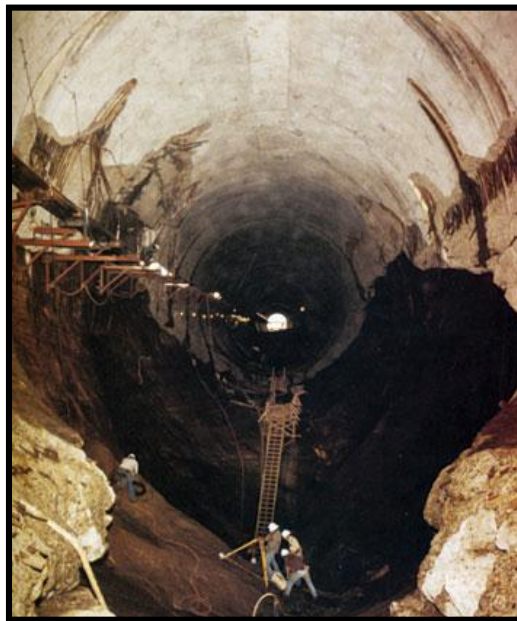
Fig. 4.5 Cavitation in spillway of Glen Canyon Dam [8]

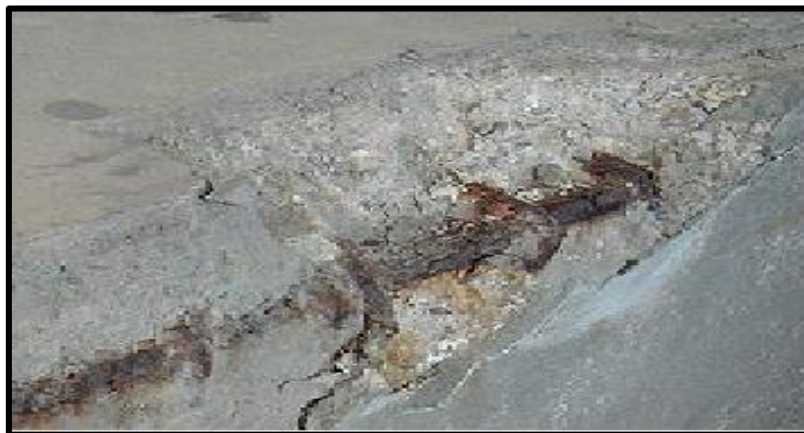
Fig. 4.6 A concrete member damaged due to acid attack [7]

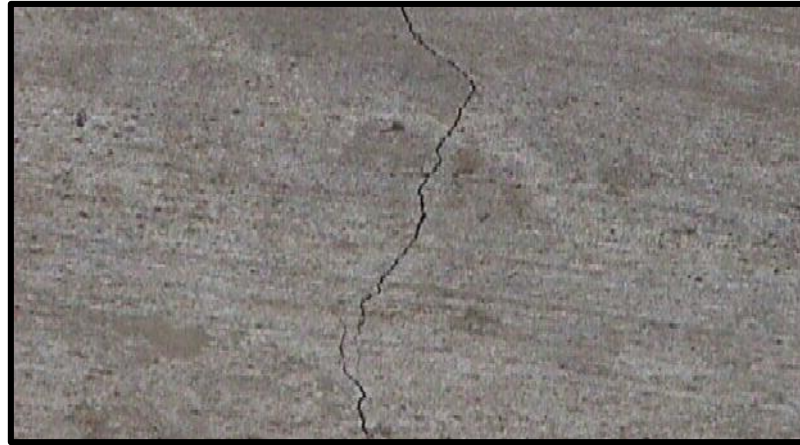
**Fig. 4.7 A Crack in a concrete member due to structural overload [5]**

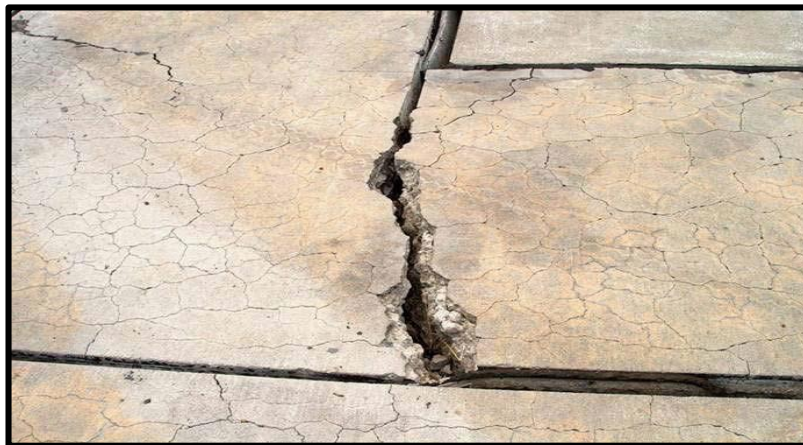
**Fig. 4.8 A Crack in a concrete member due to High impact loads [5]**
