Develop Database on Code Compliant & Non-Compliant RC Structures

FINAL YEAR PROJECT – UG BATCH 2018

NUST Institute of Civil Engineering (NICE)

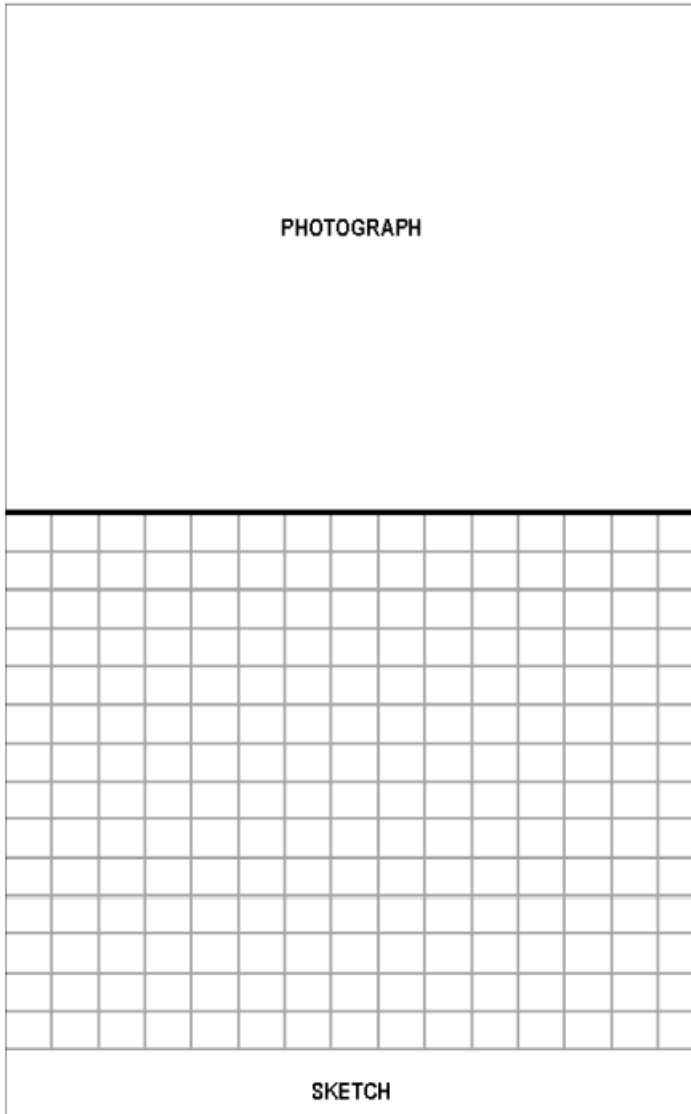
Figure 6: Building Visuals

Photos of site are placed in the form as shown. We used to take at the least 1 image for every site.

Sufficient distance is provided for large buildings to accommodate the frame of the camera.

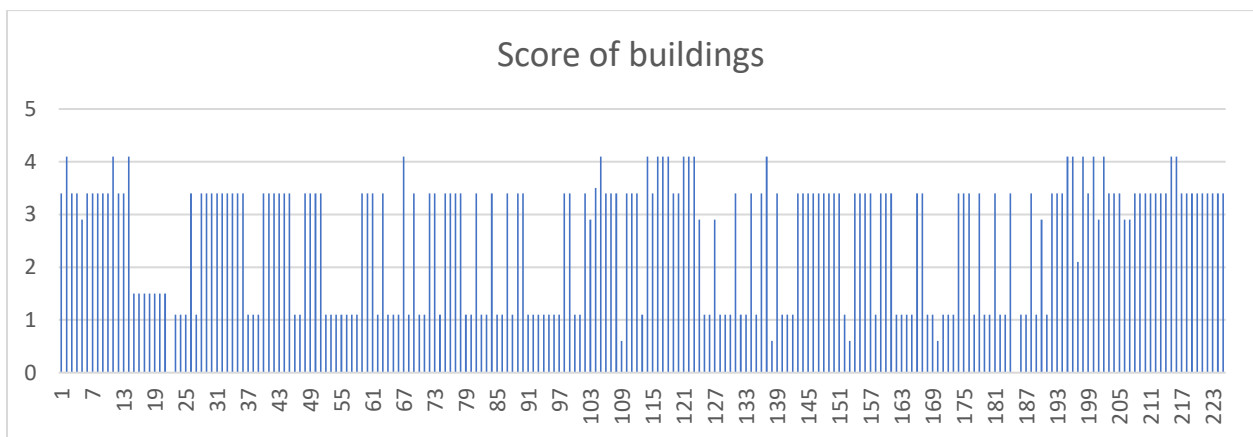
Figure 19: Score wise distribution of the buildings

The above fig shows that buildings that were surveyed had score ranges from 1 to 4.

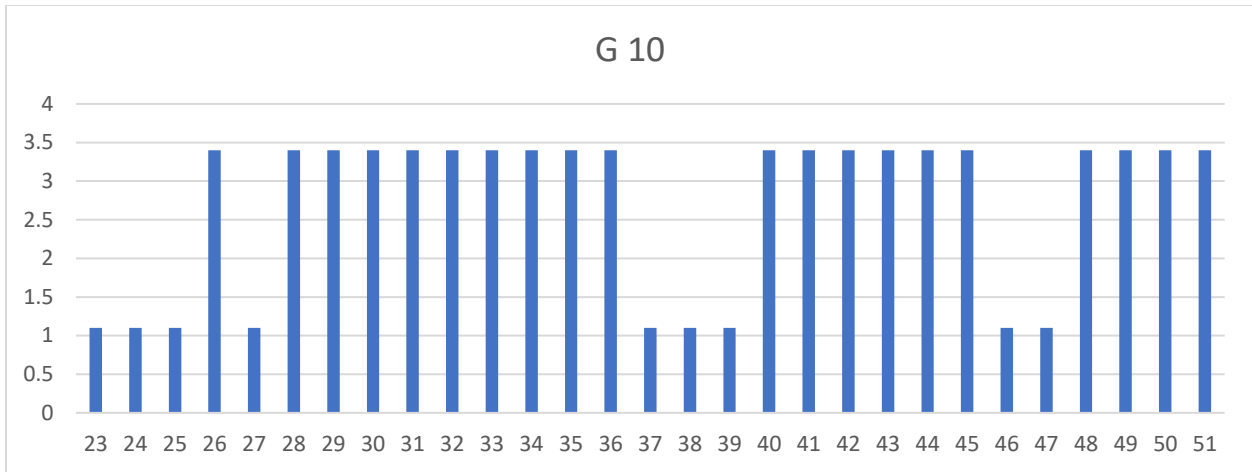
Figure 23: Pre/Post code distribution of buildings in G-10

Similarly the graph ranges from 1.1 to 3.4 . Buildings having score less than 2 are referred to further indepth analysis.

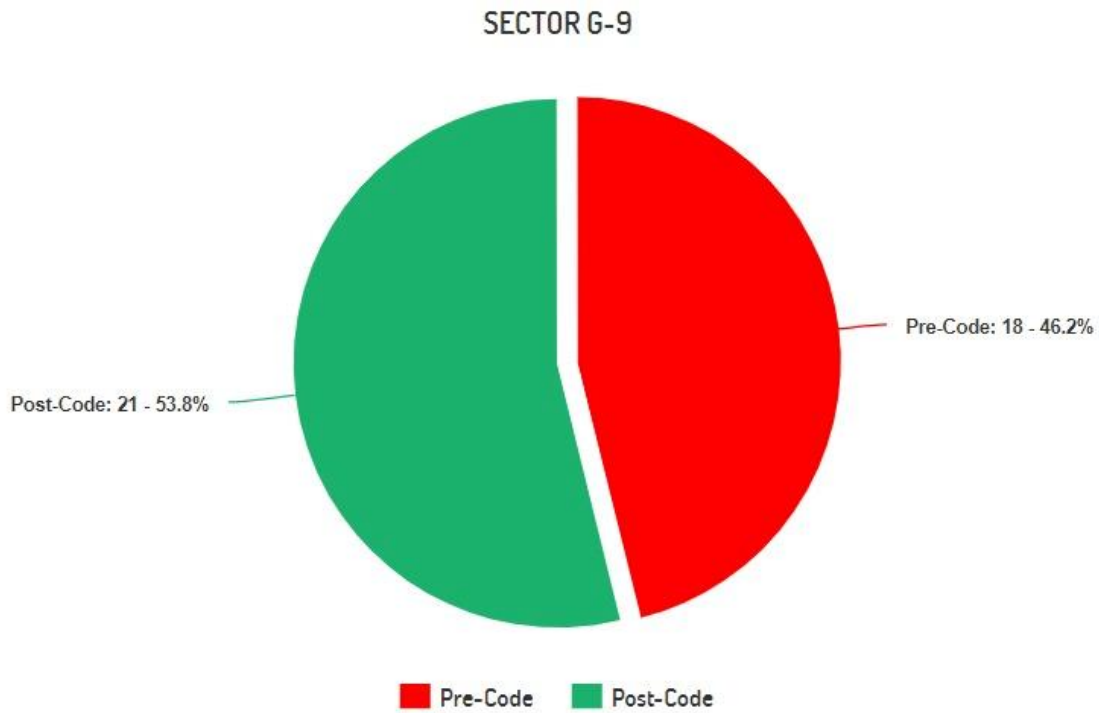
Figure 25: Pre/Post code distribution of buildings in G-9

From this data we can analyze that the G-9 sector have most of the buildings under 2 score and thus they are mostly pre code. They are referred to further indepth analysis. These buildings are

either too old or do not have proper maintenance in their life span. Thus they are prone to seismic activity.

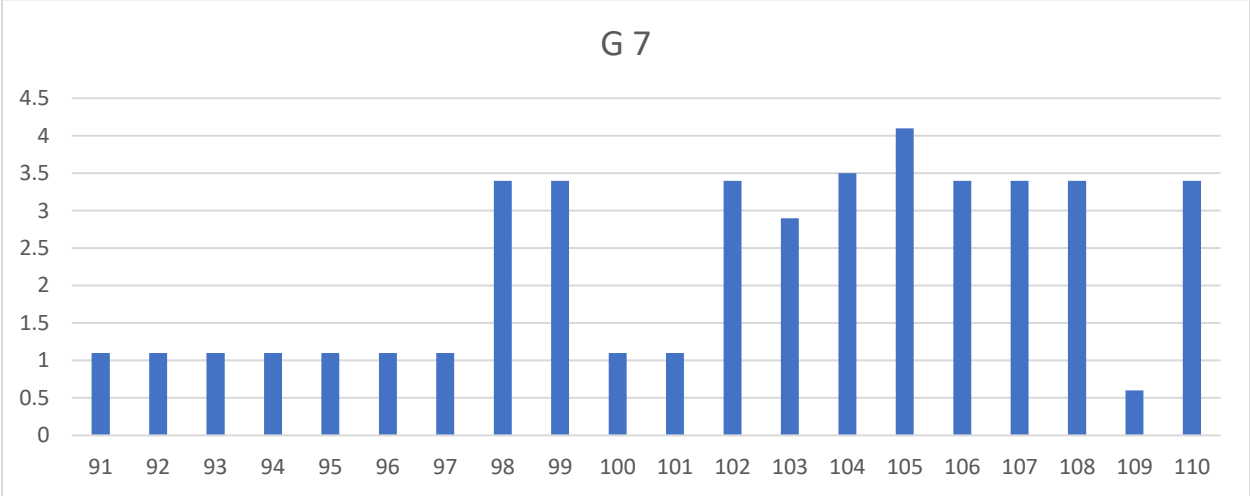
Figure 27: Pre/Post code distribution of buildings in G-7

G-7 sector have equal distribution of precode and postcode buildings it have some buildings below 2 score and some above it.

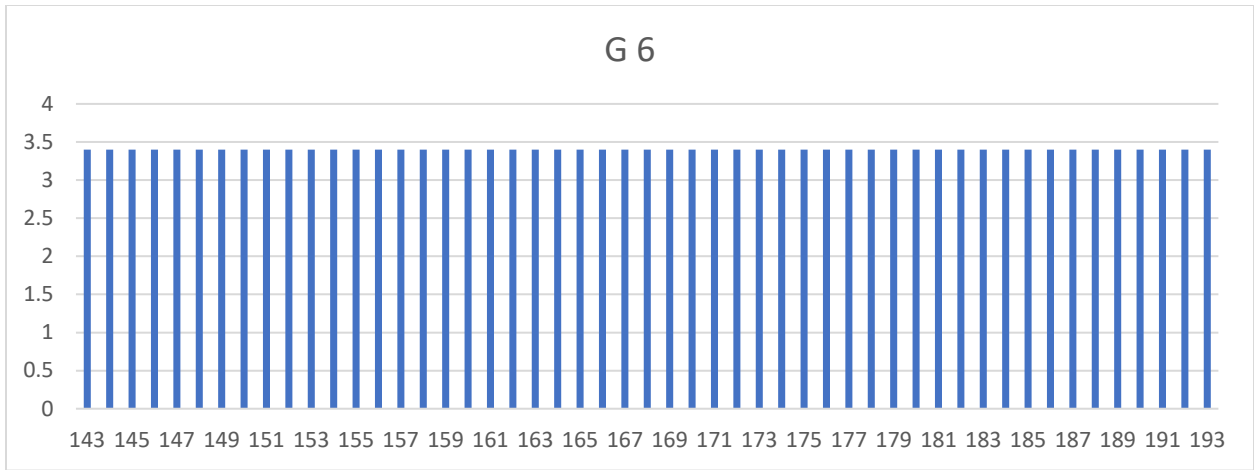
Figure 31: Pre/Post code distribution of buildings in G-6

In this figure we can conclude that all of the buildings in the sector G-6 are postcode and there is no need for further analysis of this sector. This sector is relatively strong in terms of seismic hazard analysis.

The avg score range of this sector is 3.4.

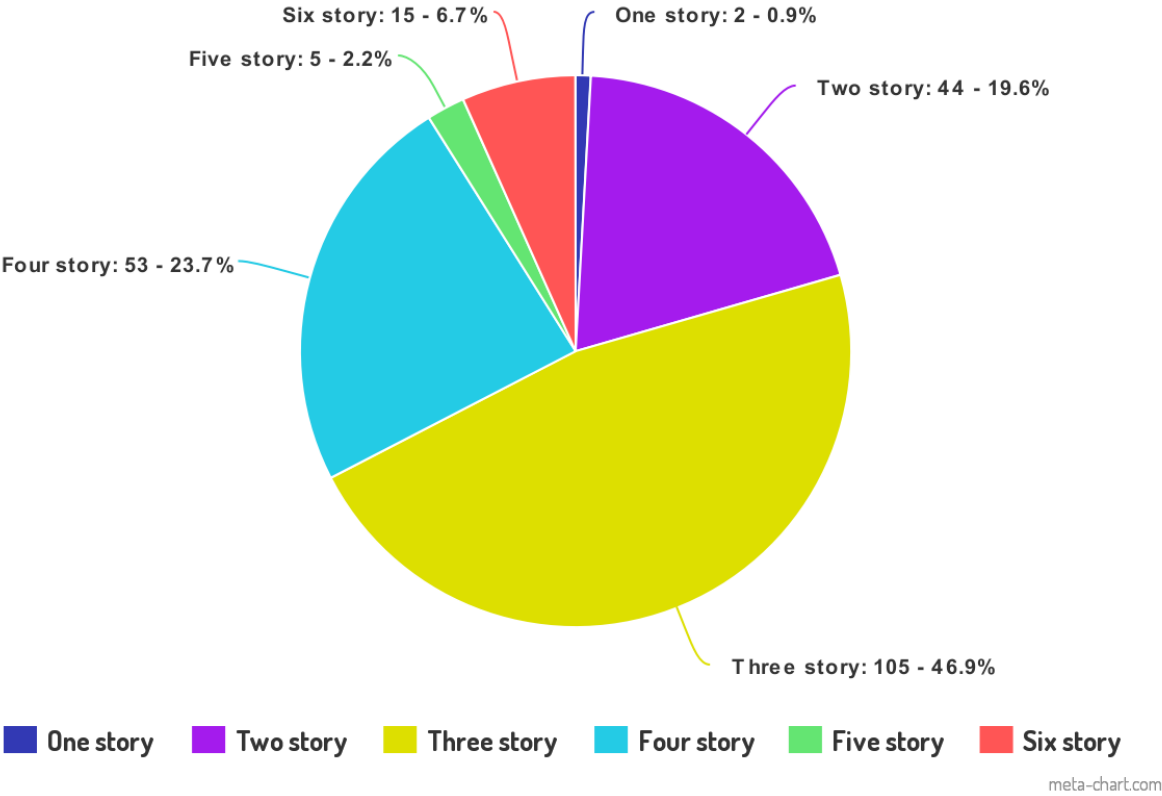
Figure 35:Score vs Number of stories

Another approach used to sort the data was no of stories and their relative score.

By this we were able to find the trends in no of stories of a building and its health after years.

By collection of data and its analysis it can be seen that there was no link between the building score and the building stories they both are independent of each other.

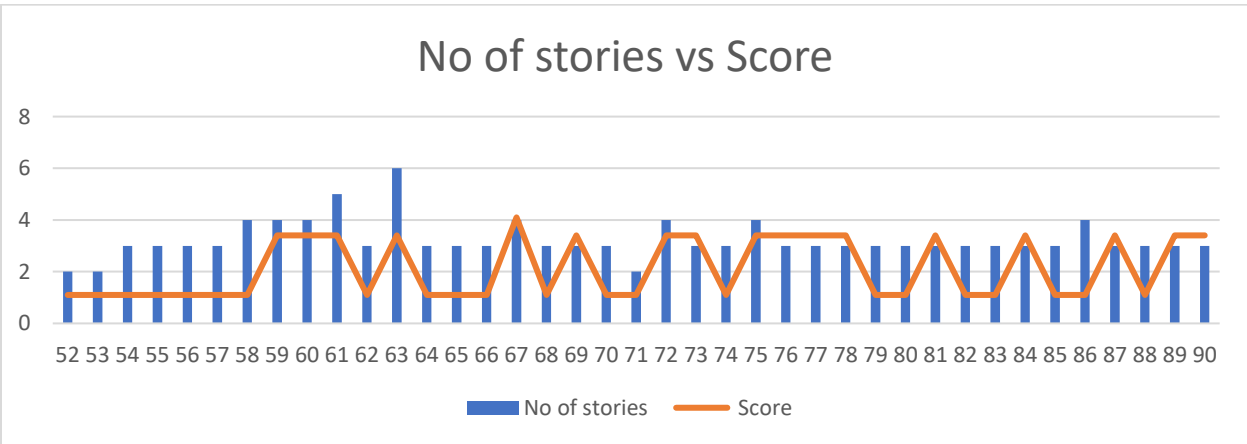
Figure 38: G-9 Stories vs score

This graph clearly shows that the building height or no of stories have no impact on the score the score varies with the physical condition of the building. The condition of the building depends upon when it was built rather than the height of the building.
