SEISMIC RISK MAPPING OF URBAN SECTORS OF ISLAMABAD

Final Year Project- UG Batch 2019

NUST Institute of Civil Engineering (NICE)

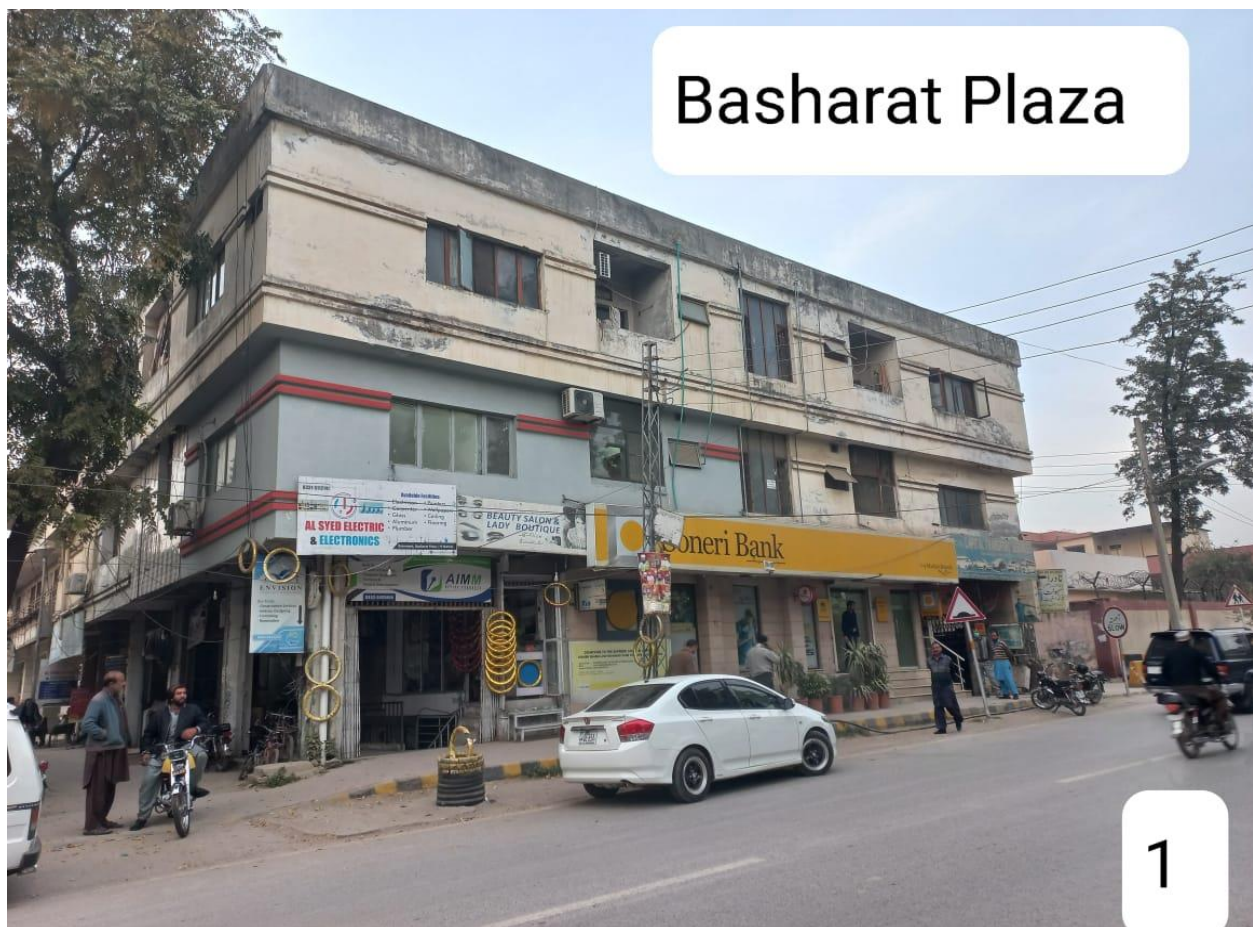
here is building named Basharat plaza located in I9 Markaz, we took all its details and filled it in such manner.

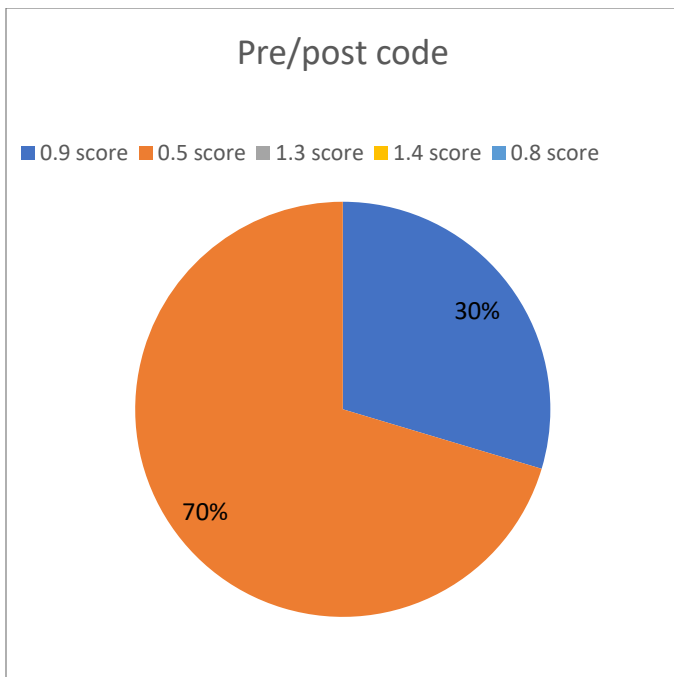
F-6:

S No	Co-ordinates	Basic High score	High seismicity RVS	Damage Grade
1	33.6838730,72.9874820	1.3	1.5	2
2	33.6838290,72.9885270	0.9	1.1	3
3	2.6831730,72.987862	0.9	1.1	3
4	33.6832290,72.9875350	0.9	1.1	3
5	33.683077,72.9874820	0.9	1.1	3
6	33.6840970,72.9861970	1.3	1.5	2
7	33.684440,72.981110	0.9	1.1	3
8	33.6875030,72.9859320	0.9	1.1	3
9	33.6827340,72.9804570	0.9	1.1	3
10	33.6826100,72.9800010	1.3	1.5	2
11	33.682591,72.9799270	0.8	1	3
12	33.682135,72.9801950	0.8	1	3
13	33.683573,72.9761920	0.8	1	3
14	33.682404,72.980261	0.8	1	3
15	33.6825030,72.9801660	1.3	1.5	2
16	33.73057,73.077521	1.3	1.5	2
17	33.6847580,72.989048	1.4	1.6	2
18	33.6844060,72.9889560	1.4	1.6	2
19	33.6832870,72.9887420	1.4	1.6	2
20	33.6832450,72.9893580	1.4	1.6	2
21	33.6834210,72.9887920	0.8	1	3
22	33.6831890,72.9887000	0.8	1	3
23	33.682990,72.980193	0.8	1	3
24	33.6823930,72.9803860	1.4	1.6	2
25	33.682230,72.980521	1.4	1.6	2
26	33.682911,72.980698	1.4	1.6	2

27	33.6823930,72.980782	1.4	1.6	2
28	33.682523,72.980468	1.4	1.6	2

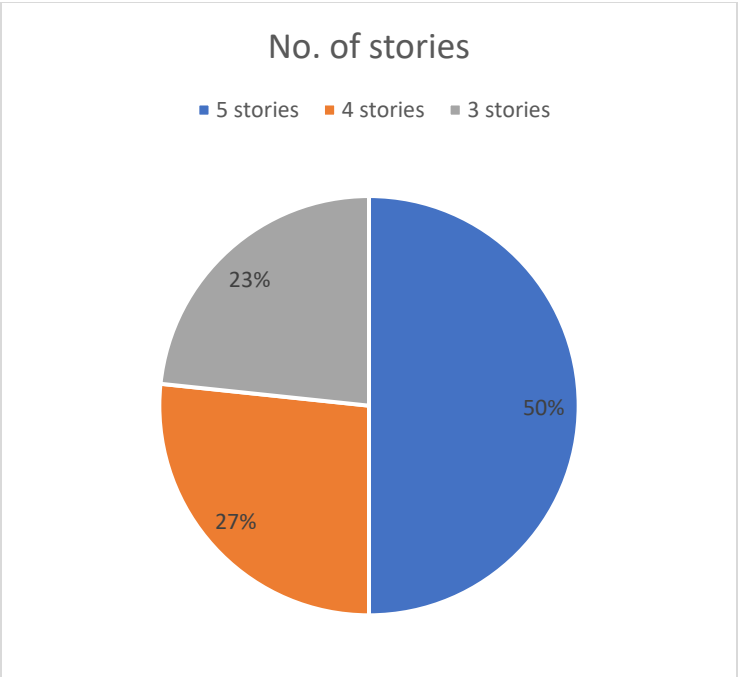
F-8:

S.No	Co-ordinates	Basic High score	High Seismicity RVS	Damage Grade
1	33.71006, 73.03965	0.5	0.7	3
2	33.71118, 73.0146	0.5	0.7	3
3	33.71106, 73.04135	0.5	0.7	3
4	33.71101, 73.04107	0.5	0.7	3
5	33.71115, 73.04089	0.5	0.7	3
6	33.711146, 73.04107	0.5	0.7	3
7	33.7134, 73.04127	0.5	0.7	3
8	33.71183, 73.04105	0.5	0.7	3
9	33.71175, 73.04086	0.5	0.7	3
10	33.71171, 73.04056	0.5	0.7	3
11	33.71246, 73.0403	0.9	1	3
12	33.7126, 73.04051	0.5	0.7	3
13	33.71245, 73. 03981	0.5	0.7	3
14	33.71269, 73. 03902	0.5	0.7	3
15	33.71224, 73. 03932	0.5	0.7	3
16	33.7124, 73. 03726	0.5	0.7	3
17	33.71212, 73. 03712	0.5	0.7	3
18	33.71193, 73. 03755	0.9	1.1	3
19	33.71164, 73. 0378	0.6	0.8	3
20	33.7113, 73. 0381	0.5	0.7	3
21	33.71178, 73. 03816	0.5	0.7	3
22	33.71207, 73. 03877	0.9	1	3
23	33.71222, 73. 03879	0.5	0.7	3
24	33.7124, 73. 03866	0.5	0.7	3
25	33.7173, 73. 0379	0.5	0.7	3
26	33.71095, 73. 03822	0.5	0.7	3
27	33.71066, 73. 03854	0.5	0.7	3
28	33.71046, 73. 03914	0.5	0.7	3

29	33.71095, 73. 03941	0.5	0.7	3
30	33.71081, 73. 03982	0.9	1.1	3

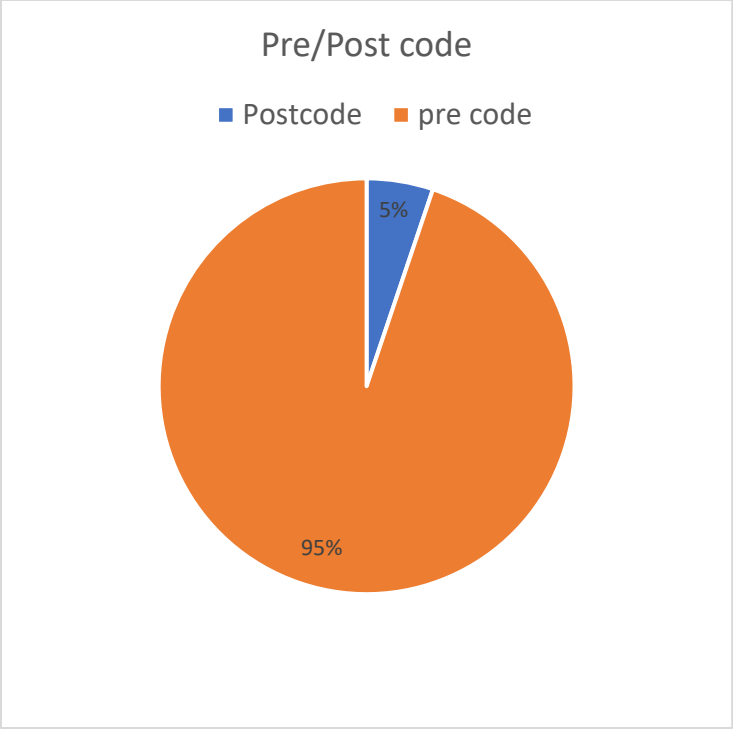
F-10

S.NO	Co-ordinates	Basic High score	High Seismicity RVS	Damage Grade
1	33.696104,73.013110	0.8	1	3
2	33.696212,73.012730	0.8	1	3
3	33.695698,73.012164	0.8	1	3
4	33.696025,73.012051	0.8	1	3
5	33.69612,73.0118	0.8	1	3
6	33.695962,73.011839	0.8	1	3
7	33.695507,73.012327	0.8	1	3
8	33.694935,73.012048	0.8	1	3
9	33.694766,73.012390	0.9	1.1	3
10	33.695599,73.013358	0.9	1.1	3
11	33.695431,73.013509	0.8	1	3
12	33.6957722,73.013551	0.9	1.1	3
13	33.695214,73.013775	0.8	1	3
14	33.695078,73.013762	0.8	1	3
15	33.694452,73.013417	0.8	1	3
16	33.694675,73.012489	0.8	1	3
17	33.69414,73.01292	0.8	1	3
18	33.69451,73.01382	1.5	1.6	2
19	33.69463,73.01395	0.8	1	3
20	33.69472,73.01401	0.8	1	3
21	33.69471,73.01413	0.8	1	3
22	33.69467,73.0143	0.8	1	3
23	33.69401,73.01434	0.8	1	3
24	33.6945,73.01441	0.8	1	3
25	33.69427,73.01453	0.8	1	3
26	33.69404,73.01473	0.8	1	3
27	33.69384,73.01444	0.8	1	3
28	33.69369,73.01409	0.8	1	3
29	33.69368,73.01410	0.8	1	3

39	33.69299,73.01488	0.8
40	33.6932,73.01518	0.8
41	33.6970951,73.0107162	0.5
42	33.6974707,73.0106079	0.8
43	33.6975721,73.0107635	0.8
44	33.6975721,73.0107635	0.8
45	33.6977465, 73.0110589	0.8
46	33.6978853, 73.0114061	0.5
47	33.6974576 ,73.0116362	0.5
48	33.6966798, 73.0118174	0.8
49	33.6966986, 73.0113831	0.8
50	33.6966986, 73.0113831	0.8
51	33.6964071, 73.0115739	0.8
52	33.6963771, 73.0118509	0.8
53	33.6963802, 73.0118486	0.8
54	33.6965483, 73.0122363	0.8
55	33.6965577, 73.0122362	0.8
56	33.6965576, 73.0122360	0.8
57	33.6963755, 73.0126935	0.5
58	33.6962866, 73.0128439	0.8

1	3
1	3
0.7	3
1	3
1	3
1	3
0.7	3
0.7	3
1	3
1	3
1	3
1	3
1	3
1	3
1	3
1	3
1	3
1	3
0.7	3
1	3

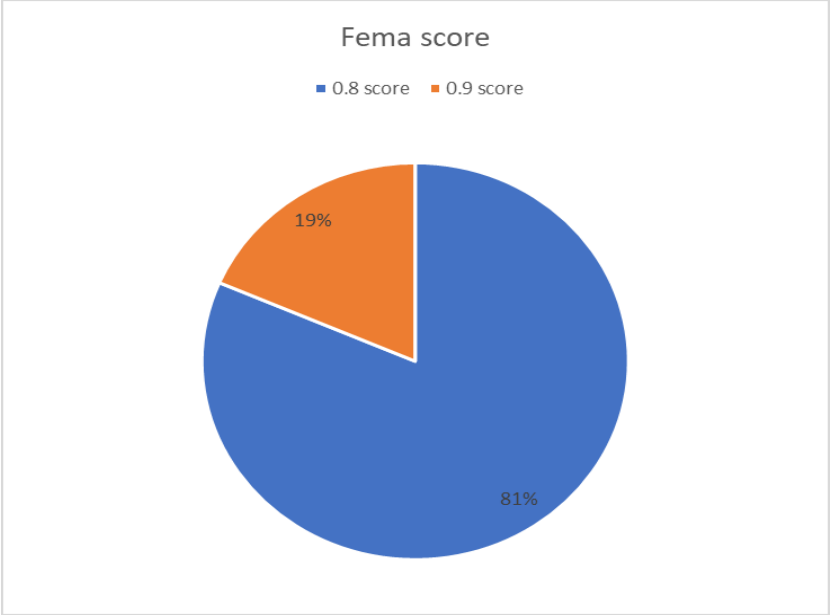
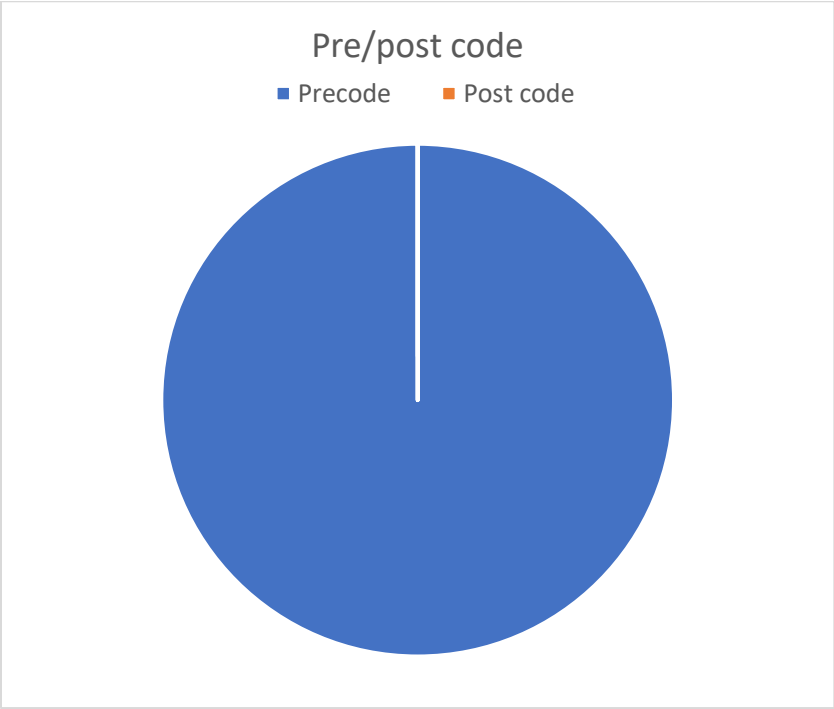
I-10:

S.No	Co-ordinates	Basic High score	High Seismicity RVS	Damage Grade
1	33.643789,73.031174	0.8	1	3
2	33.643514,73.031239	0.8	1	3
3	33.643871,73.031393	0.9	1.1	3
4	33.64401,73.031590	0.8	1	3
5	33.643960,73.031943	0.8	1	3
6	33.644095,73.031912	0.8	1	3
7	33.64568,73.03525	0.8	1	3
8	33.646067,73.035411	0.8	1	3
9	33.645803,73.035596	0.8	1	3
10	33.646216,73.035763	0.8	1	3
11	33.646036,73.035924	0.8	1	3
12	33.646293,73.036028	0.8	1	3
13	33.646430,73.036276	0.9	1.1	3
14	33.646477,73.036494	0.8	1	3
15	33.646714,73.036823	0.8	1	3
16	33.646714,73.036823	0.8	1	3
17	33.646744,73.037282	0.9	1.1	3
18	33.647679,73.038607	0.8	1	3
19	33.648311,73.039888	0.8	1	3
20	33.648434,73.040474	0.9	1.1	3
21	33.648651,73.040603	0.8	1	3
22	33.648525,73.040658	0.8	1	3
23	33.65003,73.04305	0.8	1	3
24	33.650021,73.04325	0.9	1.1	3
25	33.650389,73.043684	0.8	1	3
26	33.650238,73.043911	0.8	1	3
27	33.650810,73.044527	0.8	1	3

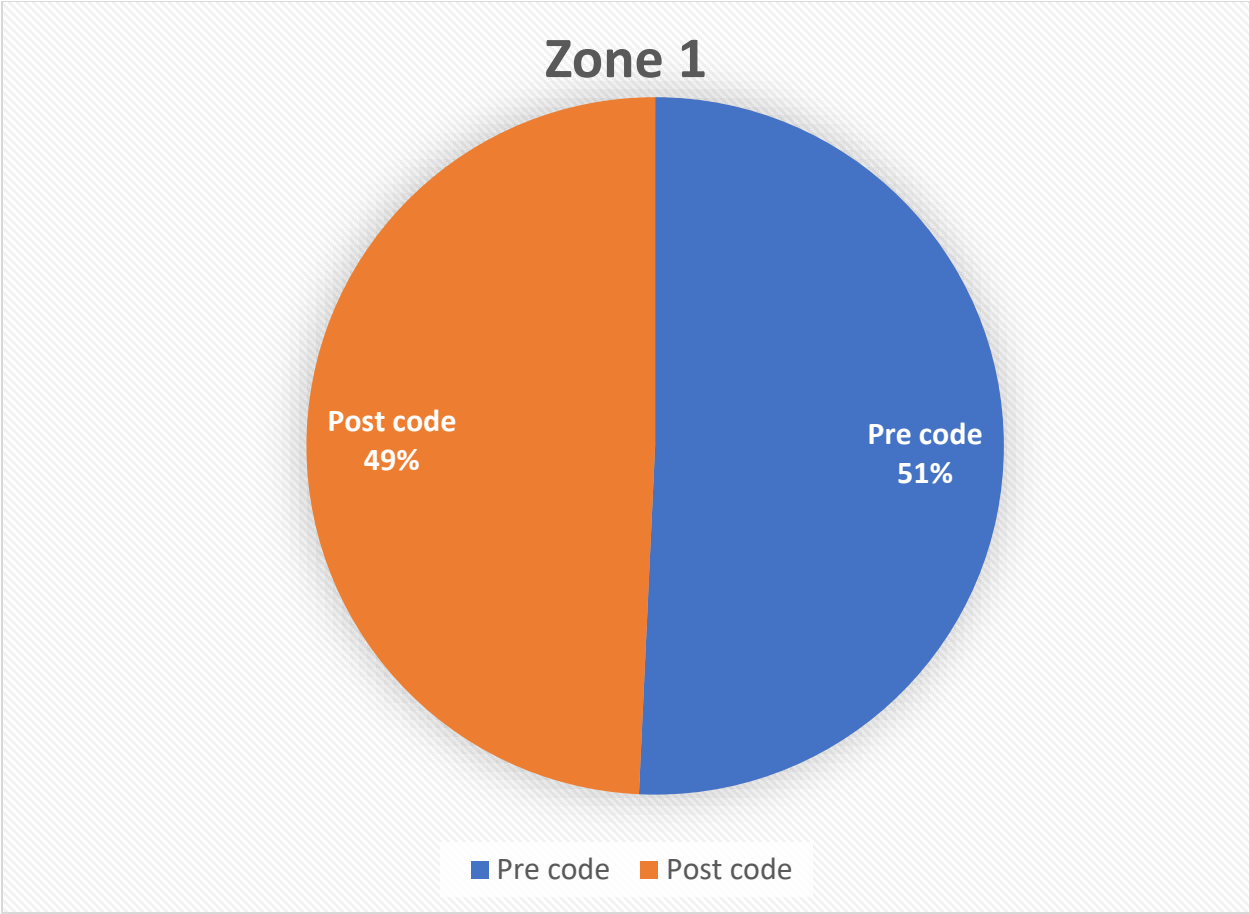
Figure B

Code compliant and non-code compliant RC structures:

Here are all the buildings categorized as post code and pre code. They are almost the same. Here we have assumed that all the buildings built after the BCP-2007 are code compliant.
