Corrosion Analysis & Preventive Measures Against H₂S in Regeneration Gas Heating & Cooling System

School of Chemical and Materials Engineering
National University of Sciences and Technology

2023

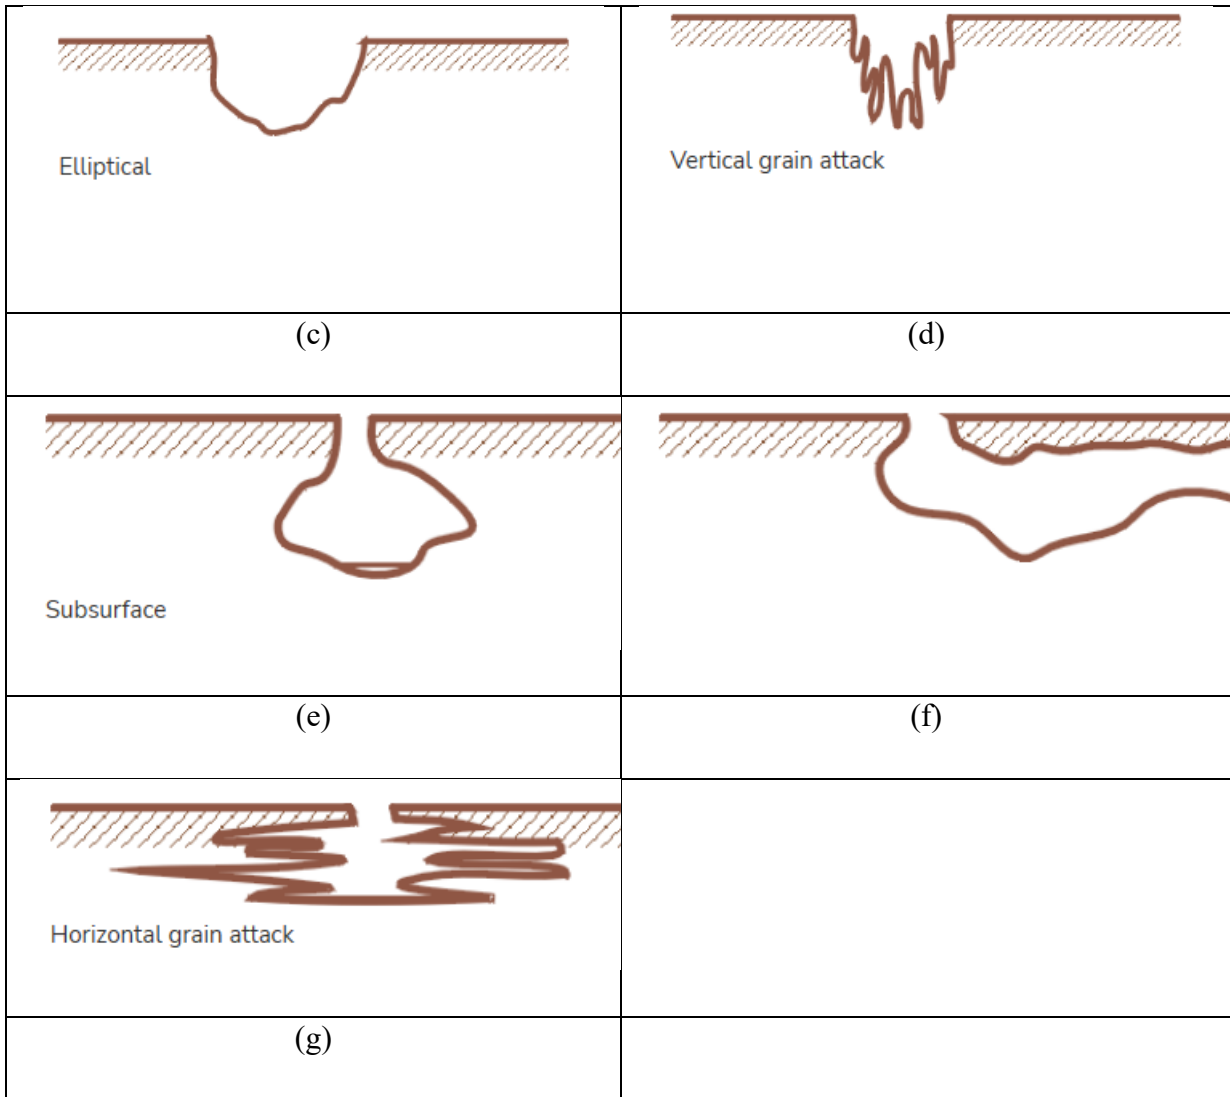
Figure 11. (a) Narrow, deep pit (b) Shallow, wide pit (c) Elliptical pit (d) Vertical grain attack (e) Sideway / Subsurface pit (f) Undercut pit / sub surface (g) Horizontal grain attack [18]

The formation of a pit can be triggered by the presence of an unusual cathodic site within a normal surface, where a previous pit has corroded, or by an abnormal anodic site surrounded by a normal surface that acts as a cathode. In such cases, a localized electrochemical cell is formed, leading to the initiation of a pit.

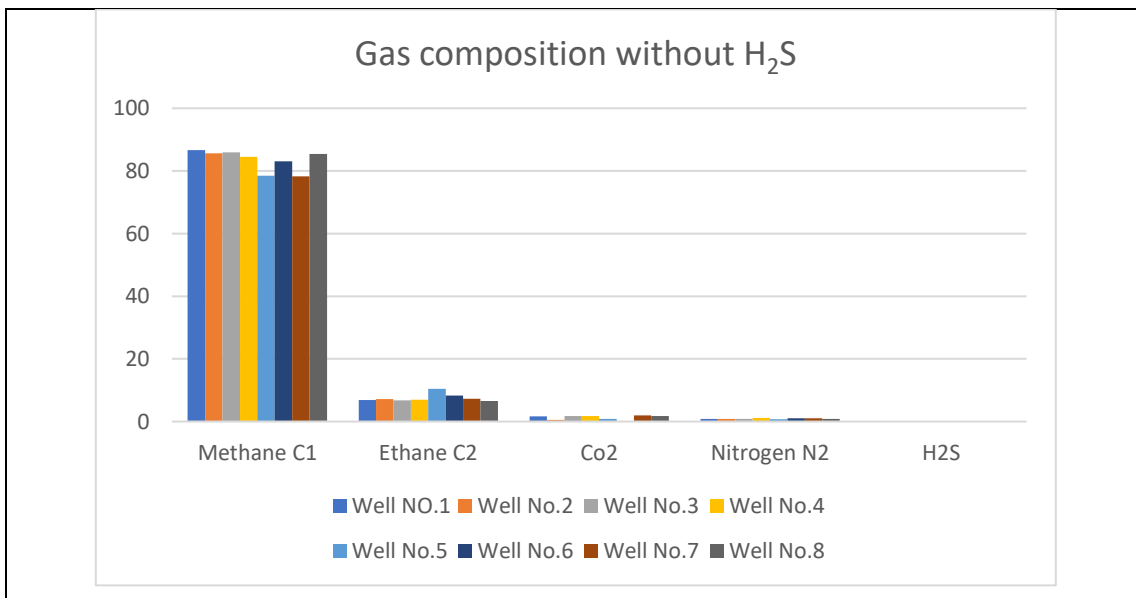
Figure 12. Gas composition without H₂S production

A re-generation gas heating and cooling system has been installed at the Gas and LPG (liquefied petroleum gas) facility of a reputable E& P (Exploration and processing) firm. The graph shown in Figure 13 reflects the gas composition without H₂S in oil and gas commingled flow and figure 14 show the parts per million of H₂S in upstream of regeneration gas cooling and heating system. [21] Due to the unexpected formation of H₂S from the reservoir (H₂S being heavier than oil), the presence of H₂S was deducted and was through tube method. Production of H₂S is detailed with comparison in the graph below.

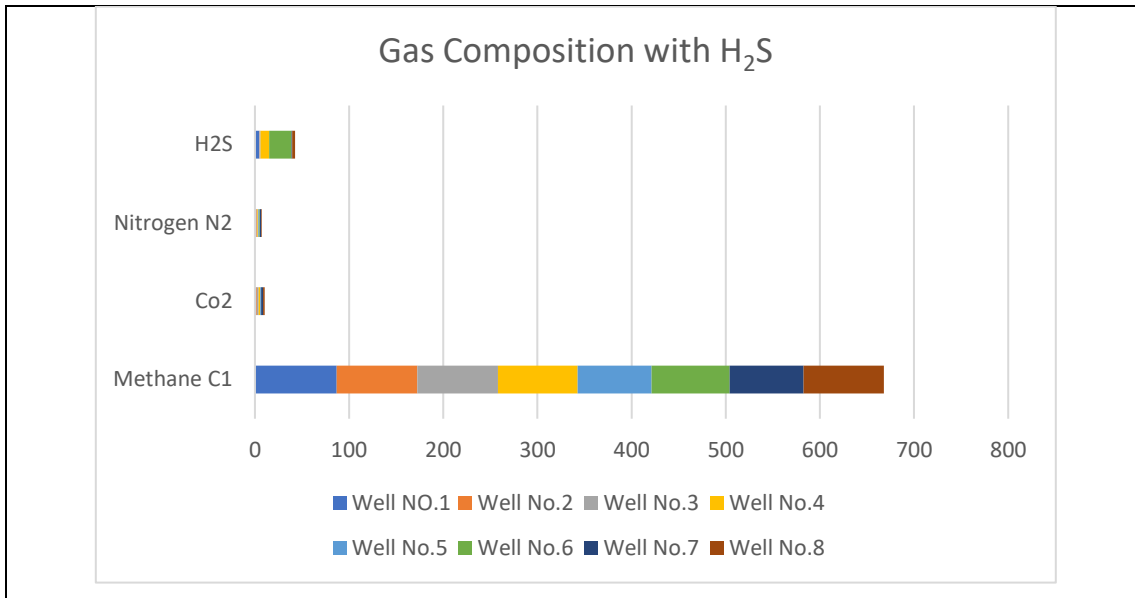
Figure 13. Gas composition with H₂S production

During periodic lab test, it was observed that H₂S is being produced from reservoir and lab test revealed the presence of H₂S.

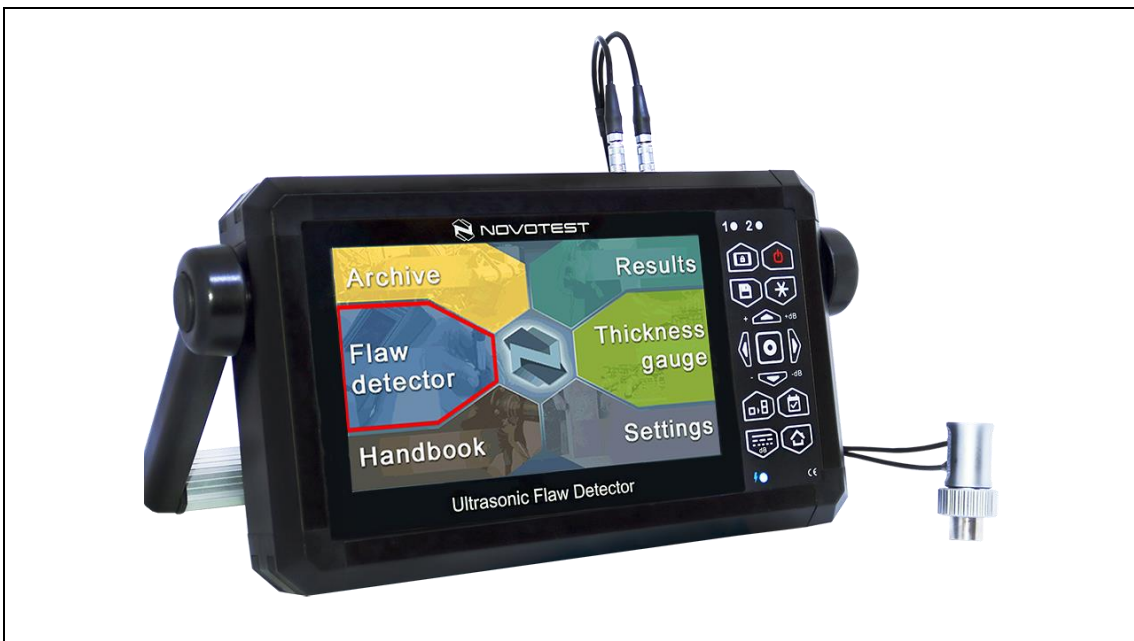
Figure 15. Ultrasonic flaw detection device

All the welding joints and Heat affected Zones (HAZ) and Tee joints of the equipment is to be made clean through the wire brush paint / coat was removed to make the surface exposed with the flaw detector. The probe of the ultrasonic flaw detector is to be placed as per procedure provided by the OEMs to investigate the flaws in the surface, weld joints and T joints. Data is collected and stored in the inbuilt storage capacity of the ultrasonic flaw detector for further analysis.

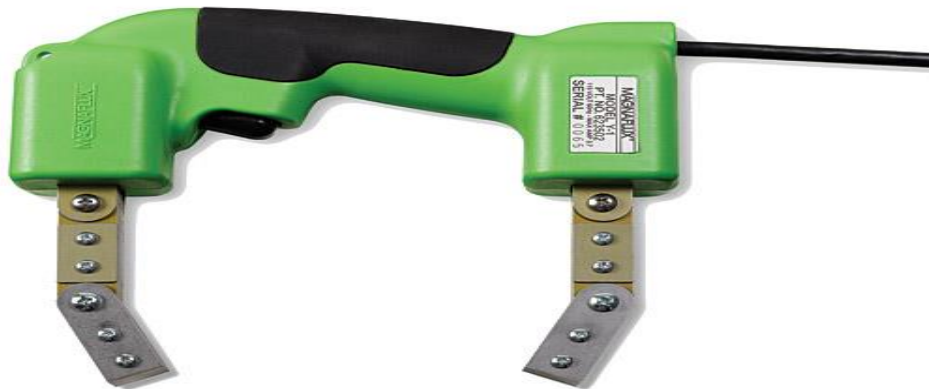
Figure 16. Magnetic particle inspection device

- i. Magnetization: The object or component to be inspected is magnetized. This can be achieved by either applying a magnetic field through direct magnetization (using a magnetic yoke or permanent magnets) or by using an electromagnetic coil to induce a magnetic field.
- ii. Application of Magnetic Particles: Small iron or iron oxide particles are applied to the surface of the magnetized object. These particles can be in dry form or suspended in a liquid carrier such as oil or water.
- iii. Flaw Detection: flaw detection is conducted when these magnetic particles are drawn to the areas of magnetic flux leakage caused by surface or near-surface defects, such as cracks, voids, or discontinuities. The shape and location of the flaw is highlighted as these particles accumulate and make a visible indication.

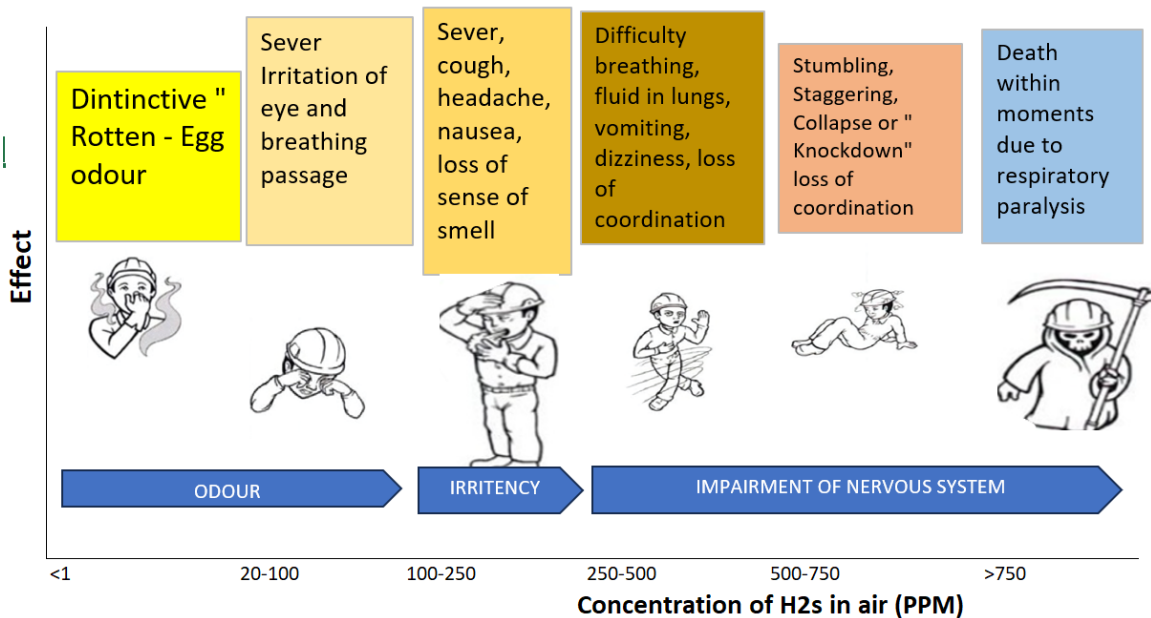
Figure 18. Concentration of H₂S in air PPM & its short term & immediate danger to human life

- I. 5 ppm STEL (Short term exposure limit) as per NIOSH
- II. 10 ppm REL (Recommended exposure limit) as per NIOSH/OSHA Permissible Exposure Limit (PEL) Limit
- III. 30 ppm criteria for Muster Point
- IV. 76 ppm AEGL -3 (10 minutes) AEGL guidelines for population outside, Acute exposure guideline levels (AEGLs) provide information about how harmful airborne chemicals can be to humans in a situation where they are exposed to them only once in their lifetime or on rare occasions.
- V. 100 ppm (IDLH) “Immediately Dangerous to Life or Health value as per NIOSH
- VI. 700 ppm Death within 40-minute s as per NIOSH/OSHA guidelines

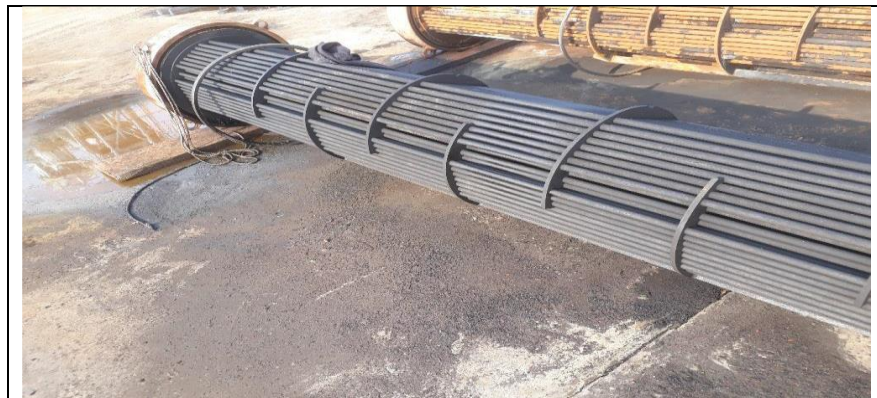
Figure 19. Flushing for removal of dirt through water jetting

The material of tube was SA-179 with outer diameter of 19.05mm, wall thickness recorded was 2.11 mm, length of each tube was 4000 mm, with total no of tube 256 and 102 no of tubes were inspection. The model of tool used for the inspection was M-5800 with serial no: 819536-01 and probe type was single exciter. The calibration of the probe was conducted prior to inspection of tube bundles to ensure the accuracy of the testing. Internal and external cleaning of tube bundle was conducted through the water flashing and after the confirmation of cleaning procedure, marking of each tube in the tube bundle is marked to ensure and confirm the back tracing of inspection report. [23]

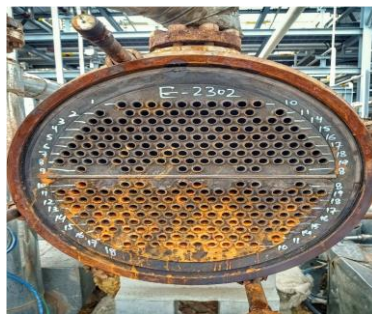
Figure 20. Inspection of tube through RFT and numbering of tubes

Remote field-testing equipment consists of a wire like tube connected with a device. The wire of RFT tool was inserted in each tube of the equipment and a low frequency pulsed magnetic field was generated to inspect and evaluate each of the tubes to access any metal loss. It makes use of transmitter coils to produce a magnetic field that passes through and out of the tube wall before returning to the tube to strike the reception coil. Equal detection sensitivity at the inner and outer surfaces of the tube is possible with this technique. While tube thinning can be detected using the absolute mode, the differential mode of Remote Field Testing provides for more accurate fault detection (corrosion, erosion) The generation and decay of eddy current is reliant on the thickness of the material and the position of opposite edge (black wall) and these factors strongly influence the decay and generation function of eddy current. Figure 22 & Figure 21 above show the tube bundles and the evidence of numbering tubes inside the bundles. Average thickness of the material was measured from the strength of the eddy current, and the time taken for each variation. Specific algorithm and calculations for lift off and wall thickness available in the attached software was used to calculate the average wall thickness with the help of absolute mode of RET equipment. Corrosion and erosion detection in the tube was also inspected with the help of available RFT equipment. [13]

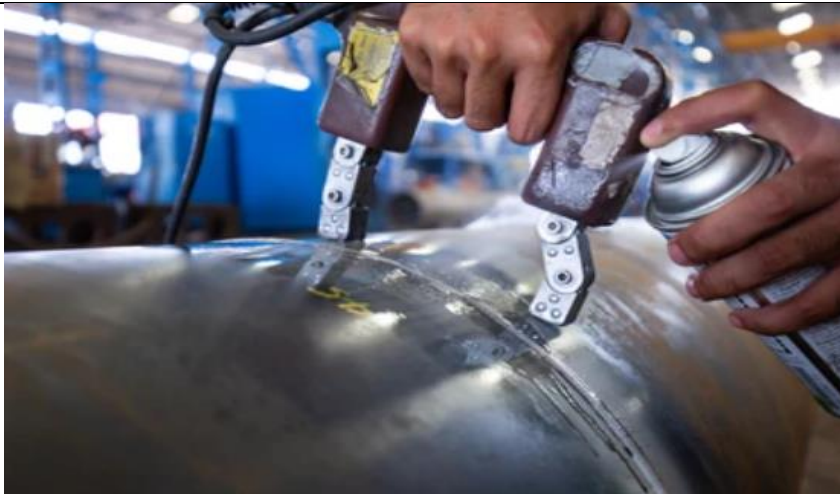
Figure 22. MPI inspection

MPI was conducted as a non-destructive testing technique to identify any potential threat at the surface and near surface of nozzles and Tee joints of the regeneration gas cooling and heating system. Magnetic particle inspection was conducted under the guidance of ASME section V and acceptance criteria ASME Sec VIII Div I, components that were inspected through this technique are inspection including nozzles and Tee joints to detect any surface anomalies in the weld joints and Tee joints.

Surface of regeneration gas cooling and heating system was cleaned, and magnetic particles were removed with the help of cleaners and wire brush.

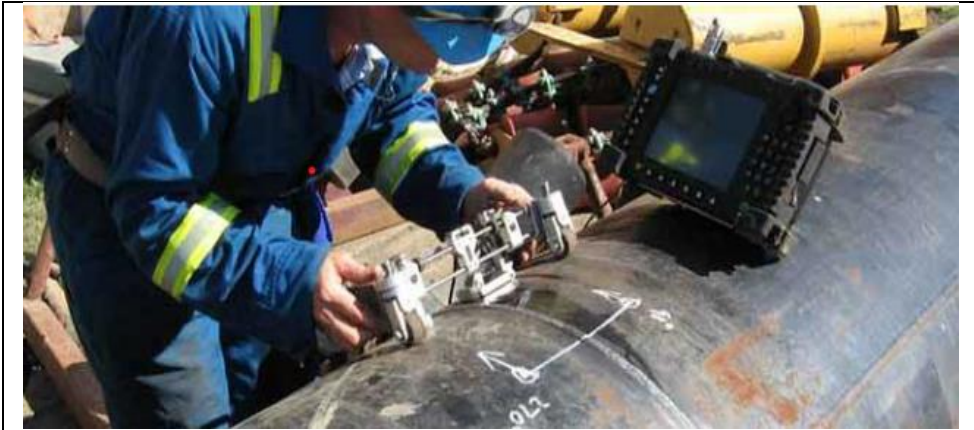
Figure 23. Application of Ultrasonic flow detection

Scanning of the weld joints was conducted with the help of instrument probe at different angles to detect any flaw, defect, or any anomalies in the weld joints, base metal and the area which is affected by heat during welding. Transducer was placed on the surface of the weld joints, base metal and heat affected zone to scan for the defects. During the scanning process of the above-mentioned areas, the indications such as echo, back- reflections and change in amplitude were carefully observed. Such kinds of indications come from any available defects on the inspected area. The indications observed during inspection were carefully analyzed and their nature, size, and location of any detected flaws or discontinuities were finalized. [6]

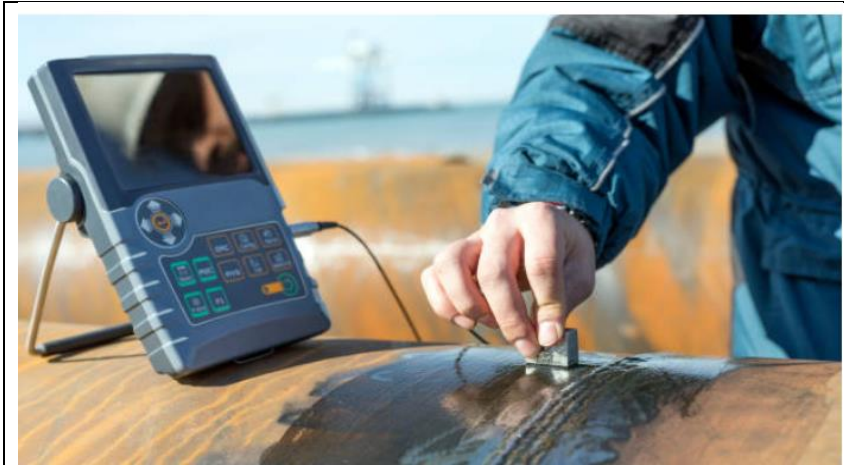
Figure 24. Application of Thickness gauging by applying gel as Couplant

Active ultrasonic thickness meter and after selecting the appropriate setting of meter (Density, sound velocity and probe frequency), the probe was placed perpendicular to the surface of equipment making sure that the contact between the probe and surface is accurate and thickness reading was noted down. For every TMLs / CMLs, four reading at o clock positions were taken and recorded in the UT meter which were then retrieved from the meter through data cable. [3]

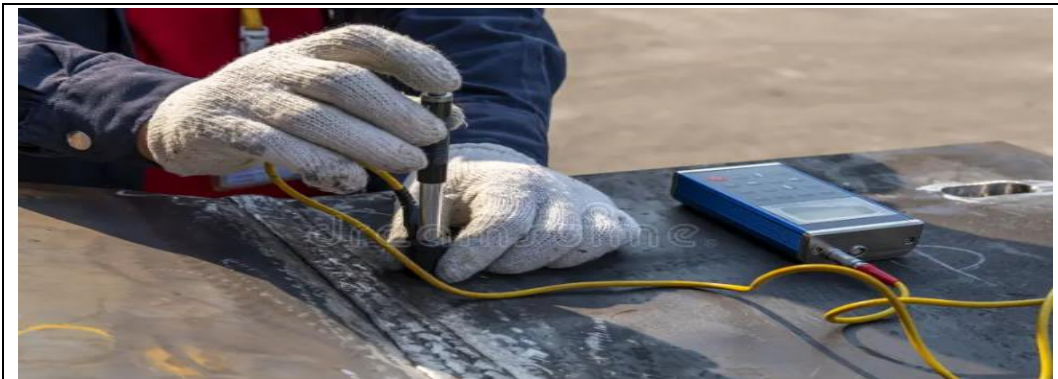
Figure 25. Application of hardness testing through portable hardness tester

After calibration of hardness tester and setup of the hardness testing equipment, tester was placed perpendicularly at the already selected condition monitoring locations the base metal, weld joints and HAZ and reading was noted and recorded in the available memory of tester equipment.
