Combine UAV and 2D ERT Approach for Identification of Water Leakage Zones in Gul Dheri Dam, Akora Khattak, Nowshera

A thesis submitted to the National University of Sciences and Technology, Islamabad,

Bachelors in Civil Engineering

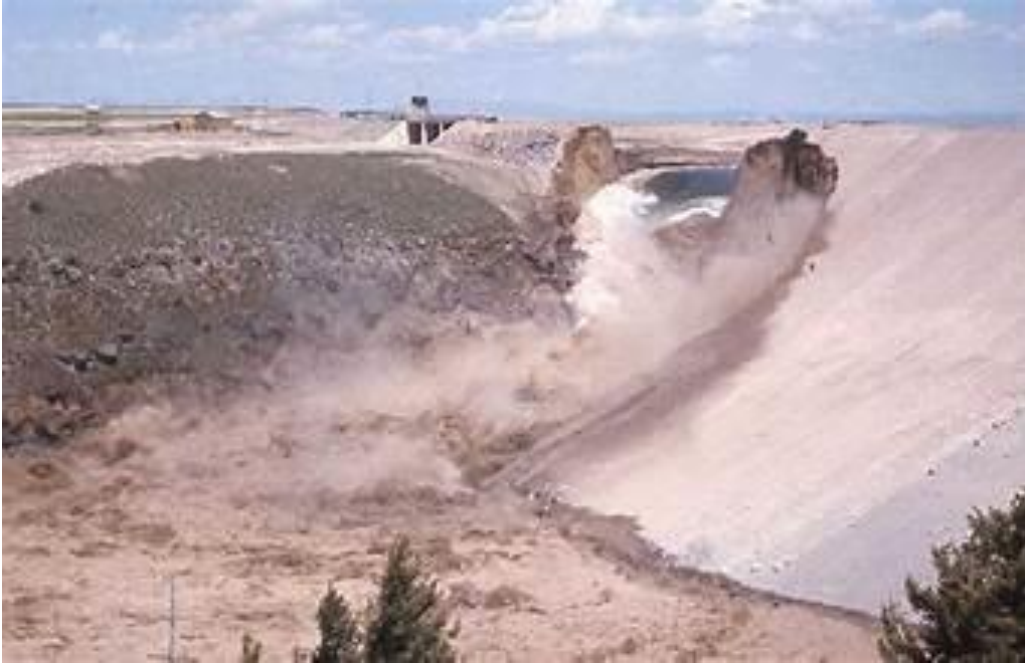
Figure 1:Teton Dam Failure

One notable example of a dam disaster attributed to seepage is the failure of the Teton Dam in Idaho, USA, in 1976. The Teton Dam was an earthen dam constructed on the Teton River for irrigation and flood control. The disaster occurred on June 5, 1976, just a few months after the dam's completion. The primary cause of the failure was identified as seepage through the dam's foundation and abutments.

During the initial filling of the reservoir, seepage was observed at the base of the dam. Despite efforts to address the seepage, it intensified, leading to the disintegration of the dam structure. Ultimately, the dam breached, releasing an immense volume of water downstream. The catastrophic failure resulted in the loss of 11 lives, the destruction of numerous homes, and significant damage to agricultural land and infrastructure.

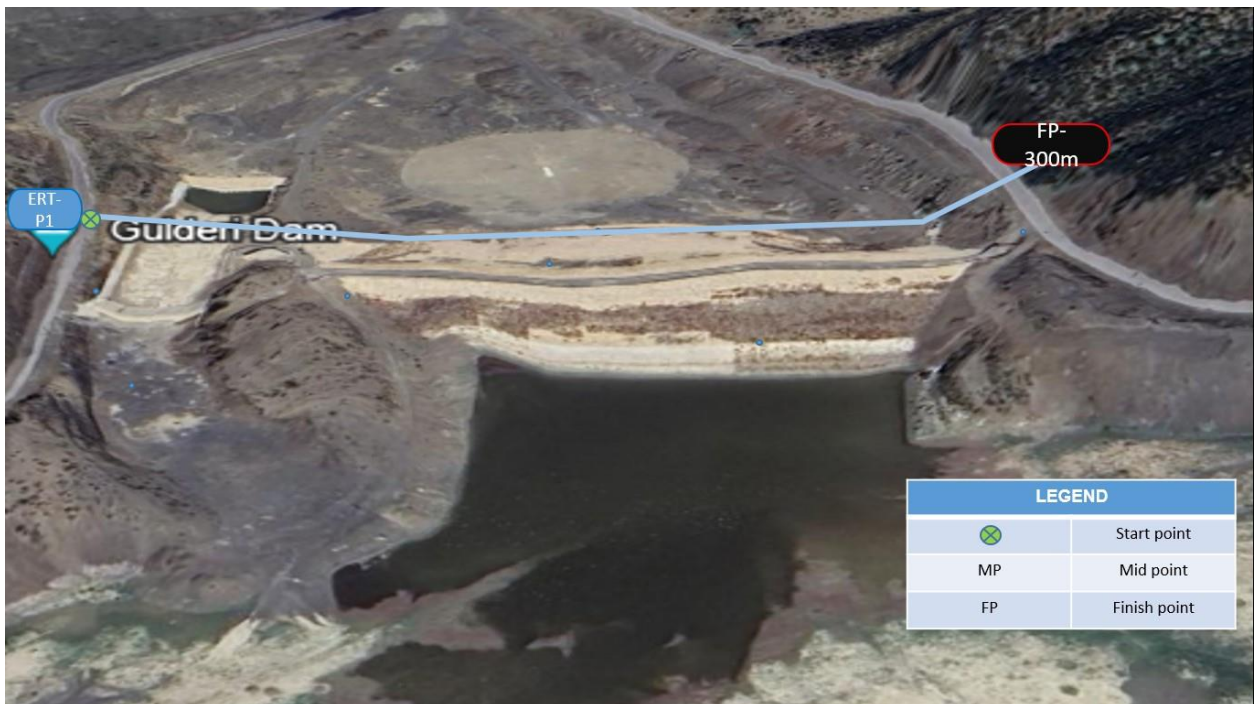
Figure 3:ERT P-1

ERT-P1 was acquired in the Down Stream area (as shown in Figure 5). The profile was orientated in the East-West direction, the midpoint of the ERT-P1 profile was lined up as per

the geotechnical diagram especially the installed piezometer borehole. The maximum profile length was 300 meters with a 5-meter takeout interval. The starting point (1st electrode) was placed in the eastern part and extended toward the western part. All electrodes were installed in the natural subsurface ground and planted electrodes were wetted with salty water to ensure good contact with the underlying soil and to reduce the noise. Figure 4 shows the inverted ERT-P1 geo-electrical cross-section (COVERING EAST-WEST NALA SECTION & SEGMENT OF SPILLWAY), which can be divided into three principal distinguished blocks horizontally.

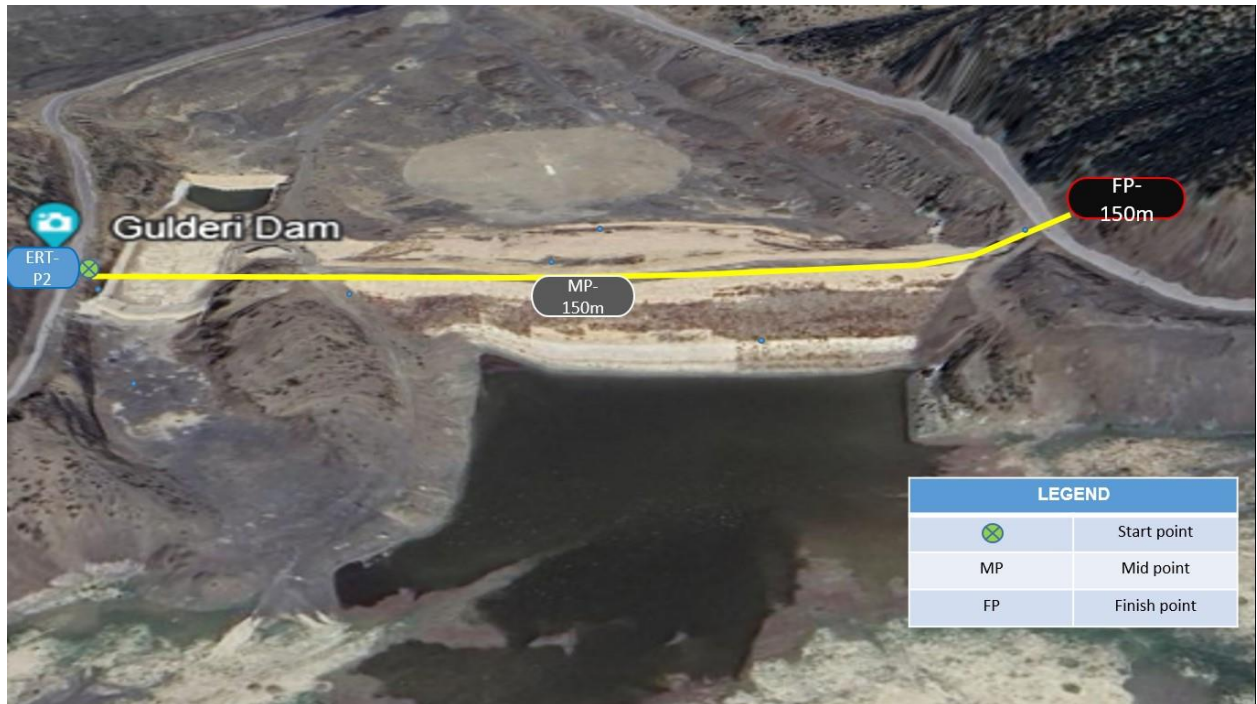
Figure 6: ERT P-2

ERT-P2 was acquired on the Dam Axis (as shown in Figure). The profile was orientated in the East-West direction. The maximum profile length was 300 meters with a 5-meter takeout interval. The starting point (1st electrode) was placed in the eastern part (Left) and extended toward the Western part (Right Abutment); this profile provides the East-West cross-sectional area of the dam axis and small portion of spillway and right abutment. All electrodes were installed in the natural subsurface ground and planted electrodes were wetted with salty water to ensure good contact with the underlying soil and to reduce the noise.

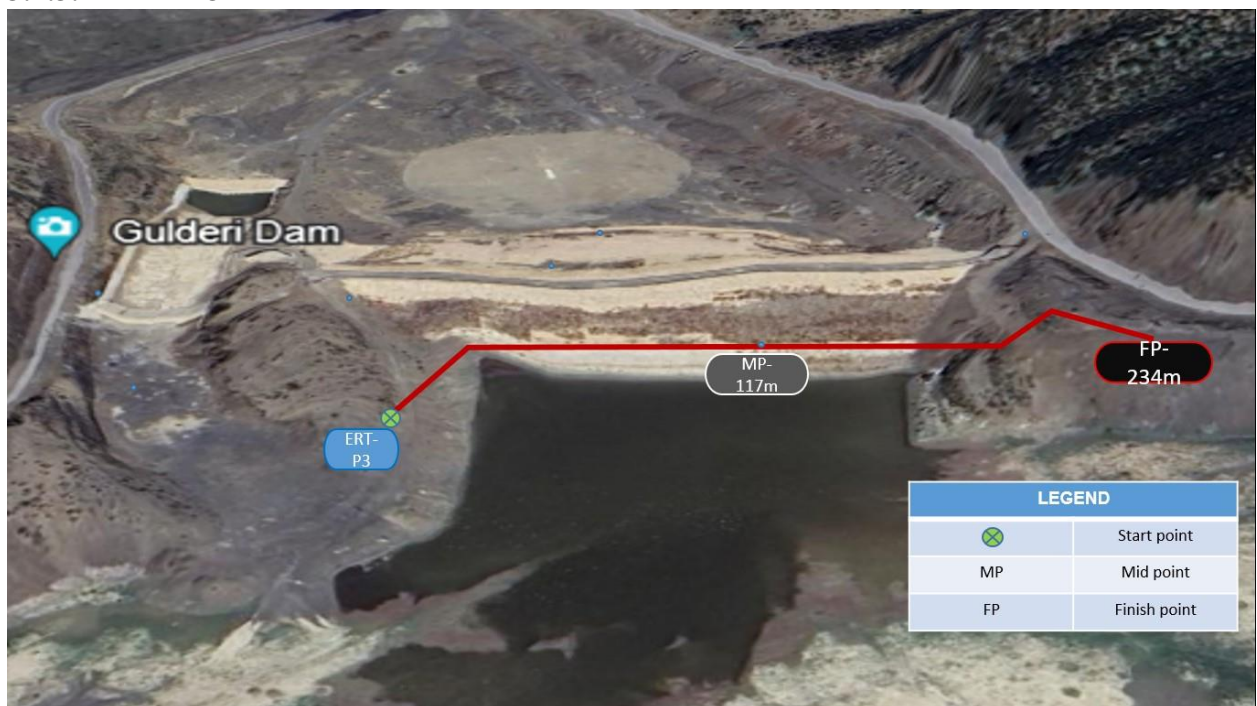
Figure 9: ERT P-3

ERT-P3 was acquired which covers the Upstream Toe. The profile was orientated in the East-West direction. The maximum profile length was 300 meters with a 5-meter takeout interval. The starting point (1st electrode) was placed in the eastern part and extended toward the western part (Right Abutment). All electrodes were installed in the natural subsurface ground

and planted electrodes were wetted with salty water to ensure good contact with the underlying soil and to reduce the noise.

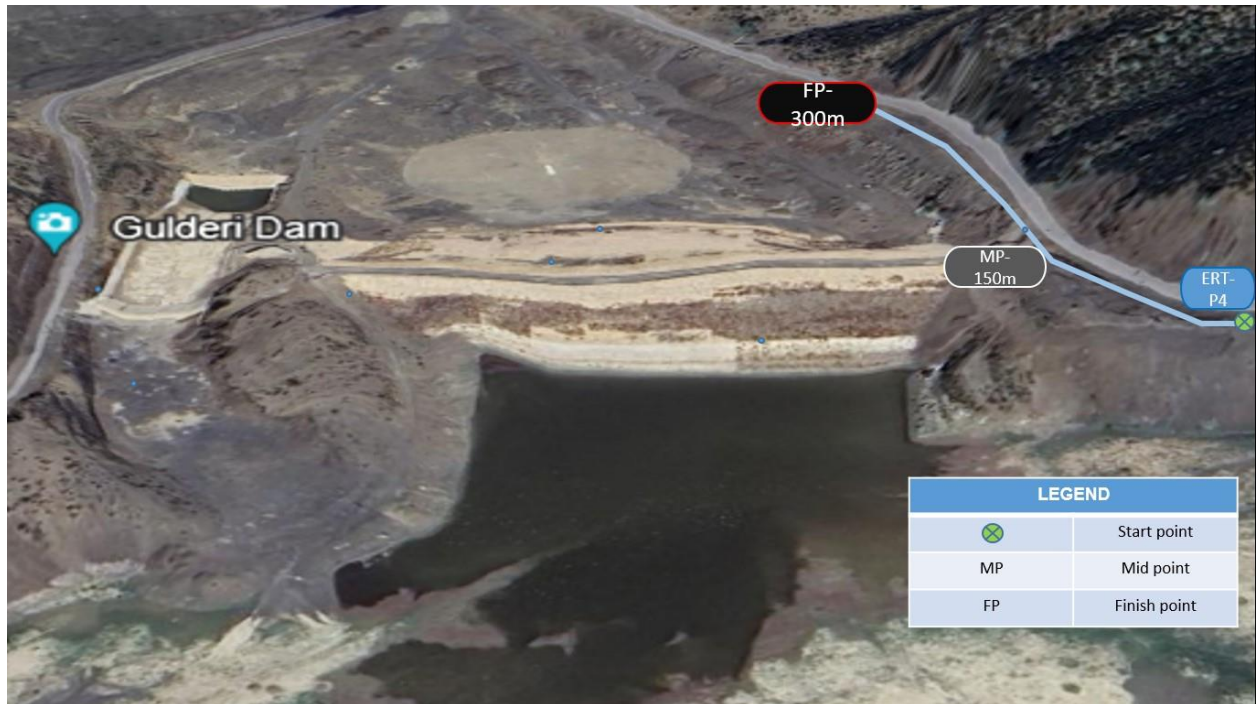
Figure 12: ERT P-4

ERT-P4 was acquired in RIGHT ABUTMENT. The profile was orientated in the North-South direction. The maximum profile length was 300 meters with a 5-meter takeout interval. The starting point (1st electrode) was placed upstream and extended toward downstream area (this profile was acquired along the road side). All electrodes were installed in the natural subsurface ground and planted electrodes were wetted with salty water to ensure good contact with the underlying soil and to reduce the noise.

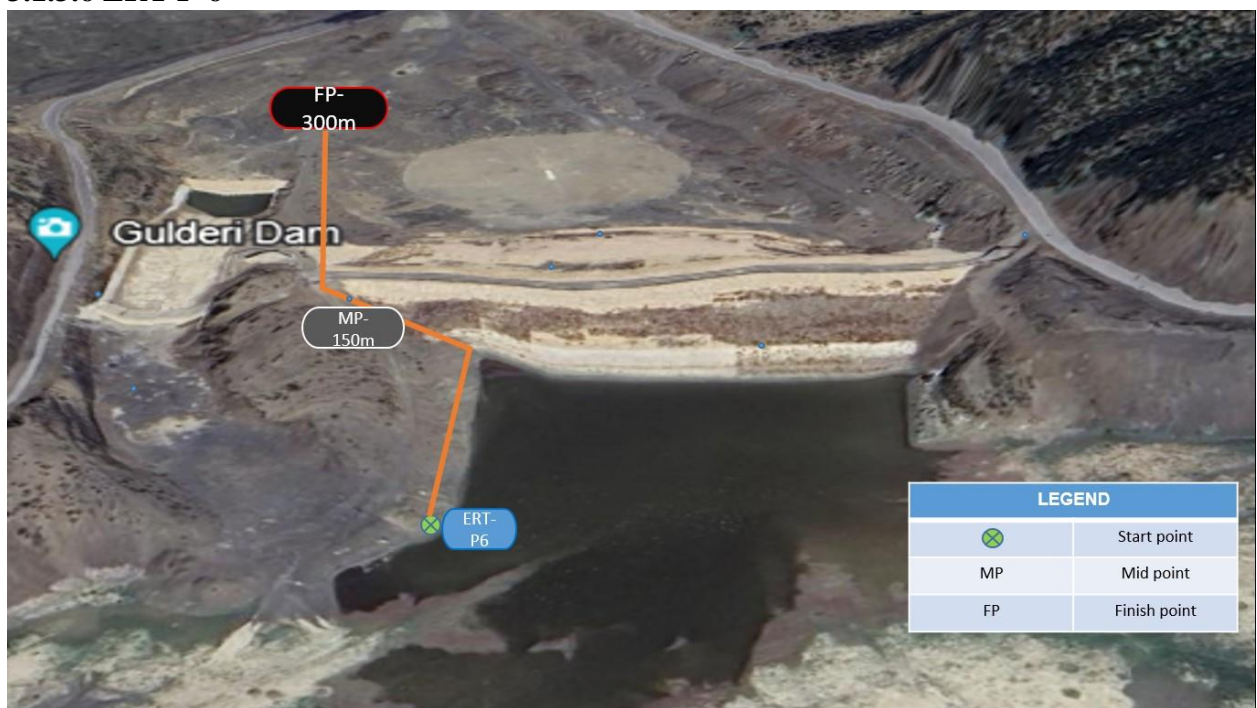
Figure 18: ERT P-6

ERT-P6 was acquired in LEFT ABUTMENT. The profile was orientated in the North-South direction. The maximum profile length was 300 meters with a 5-meter takeout interval. The starting point (1st electrode) was placed upstream and extended toward downstream area (this profile was acquired on the left abutment. All electrodes were installed in the natural subsurface ground and planted electrodes were wetted with salty water to ensure good contact with the underlying soil and to reduce the noise.

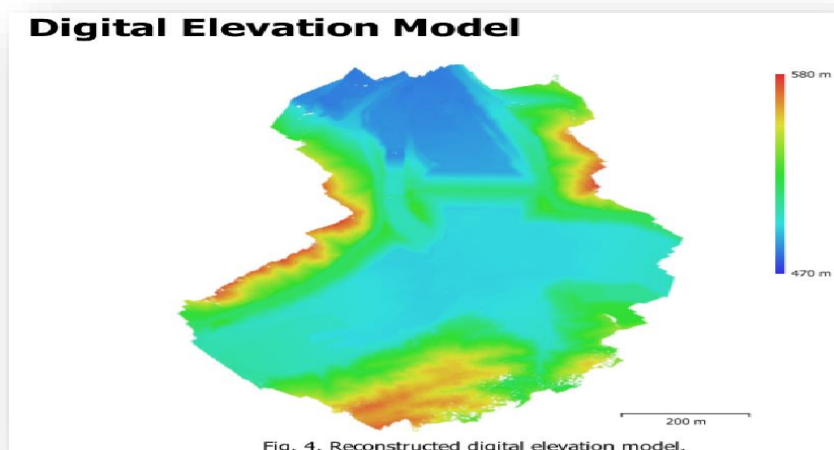
Figure 34: Digital Elevation Model

The above model shows the elevation of the selected terrain on a heat map, with red being the highest and blue being the lowest / deepest areas.
