A DESIGN STUDY ON REINFORCED CONCRETE SILOS FOR REHABILITATION AND RETROFITTING

FINAL YEAR DESIGN PROJECT UG 2020

The Silo that is taken as the case study for this project is owned by Pakistan's 2nd largest cement manufacturer Bestway Cement Limited and is located at its operating plant site at Kallar Kahar setup in 2014. Said Silo is a Controlled Flow (CF) Silo that stores Raw Meal and has a total height of around 81 meters. The Silo has two levels, level 1 is of a height of 32 meters and is not used for storage rather it is a housing compartment for the associated plant and level 2, which starts above 32 meters and lasts till 81 meters and is used for Storage of bulk material. Cracking phenomenon was observed at the upper 1/3rd portions of silo above the slab level at level 2. The services of NUST institute of Civil Engineering (Structural Engineering Department) were hired for crack depth measurement of the CF silo. The Team mobilized for site testing on 2nd June, 2021 and around 11 cracks which were identified and examined using Ultrasonic Pulse Velocity Testing apparatus by following Bungey et al (2006) approach. PUNDIT (Ultrasonic Pulse

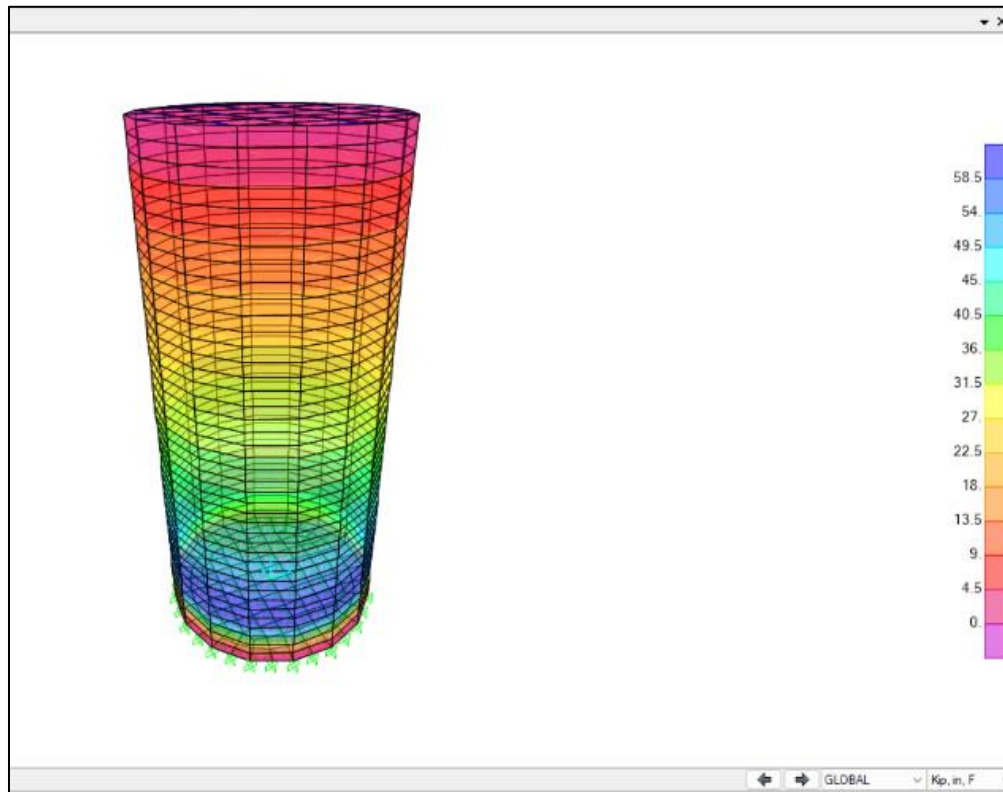
common program used for structural analysis. For the purposes of this project the Silo was modelled as a thick shelled element and the design was checked using the program's built-in structural checks.

Figure 1: The Kallar Kahar silo as modelled in SAP2000

Method	Area of Steel required (mm²/m)	Result
BS8110	2276	No Failure
ACI 313-16 (No thermal)	2189	No Failure
ACI 313-16 (Thermal)	2349	Failure
SAP2000	-	No Failure

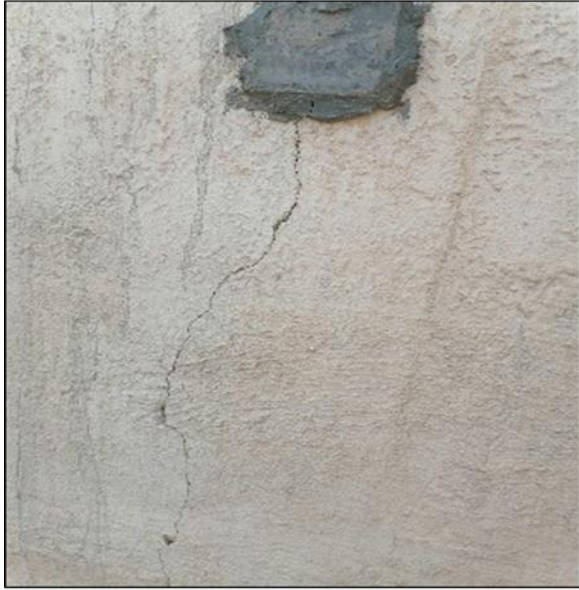
Figure 3: View of: (a) Cracking at Kallar Kahar; (b) Silo cracking after filling with hot material

From the comparison of the two figures shown above it can be concluded with reasonable certainty that the cause of the cracking in this case was due to thermal stresses.

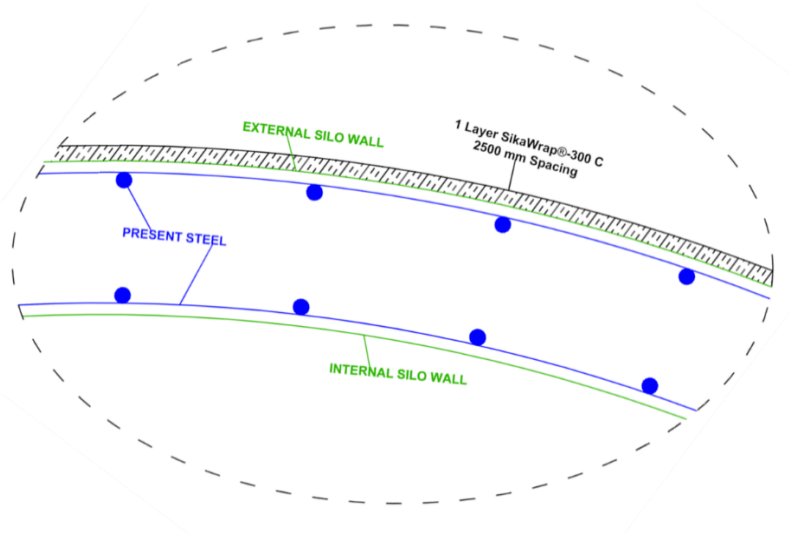
Figure 4: Segment of silo top view showcasing the retrofitted design

For the design of the CFRP retrofitting, the additional force beyond the capacity of the present steel reinforcement was used as the design value for the retrofitting specifically. For properties of CFRP the product range of the company Sika Pakistan was used as reference for a design that would be feasible to do within the country. The equation used for determining of CFRP area is as listed below:

Design Force	71 KN/m
Product	SikaWrap®-300 C
Design Tensile Strength	3200 N/mm ²
Nominal Thickness	0.167 mm
Strip Width	600 mm
Strip Spacing	2.5 m
Total Number of Strips	20
Weight of Retrofitting	269 Kg
