# **Rehabilitation of Buildings damaged due to Earth Quake**

**A Thesis**

**Bachelors of Engineering in Civil Engineering**

**NUST Institute of Civil Engineering**

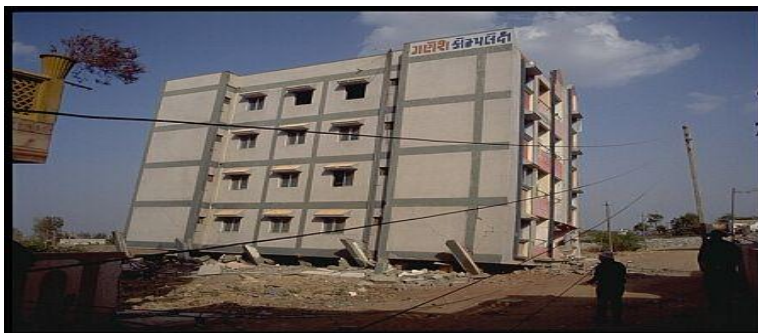
The story in the building that has substantially lesser strength is called Soft Story. Usual location of the soft story is the ground floor because the first floor is usually easily accessible so it has more openings.

**FIGURE 4-1 SOFT STORY**

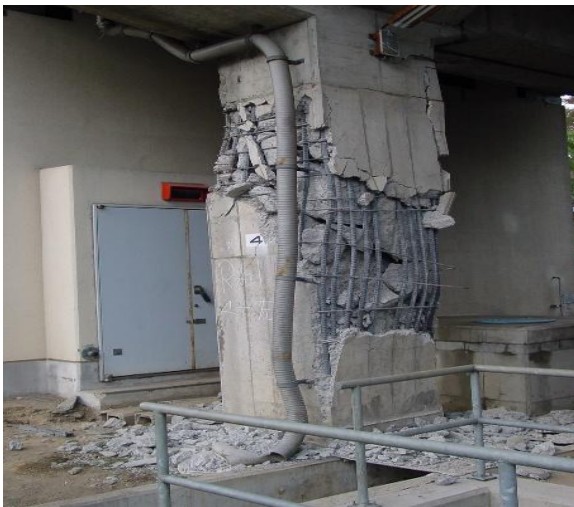
The buckling of longitudinal column reinforcement due to lack of stirrups is observed.

**FIGURE 4-2 BUCKLING OF COLUMN**

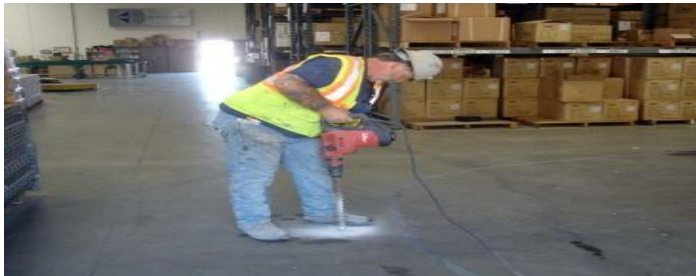
In the grout pouring technique the existing cracks from the slabs, resulted from the excessive loading, are enlarged in width and in depth until the existing reinforcement is exposed. Before the cement grout is poured into the enlarged extends the exposed reinforcement and concrete surfaces must be cleaned using a steel brush, compressed air and water jet. The grout used in the experiment was a non-shrink premixed high strength cement grout.

**FIGURE 5-1 CEMENT GROUTING**

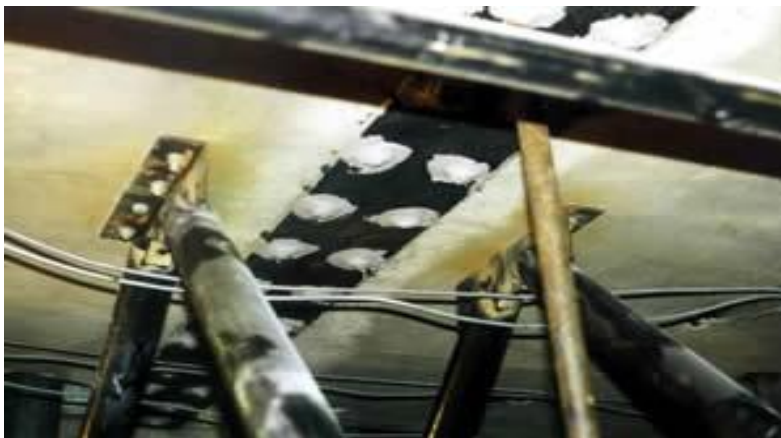
Design procedure is based on general principle concerning the concrete design of glued joints or glue-bolt and glue-dowel joints. The basic assumption is that the integrity of the plate and concrete adhesives interface is maintained and that structural integrity prevails up to the expected pick load.

**FIGURE 5-2 EXTERNAL PLATE BONDING**

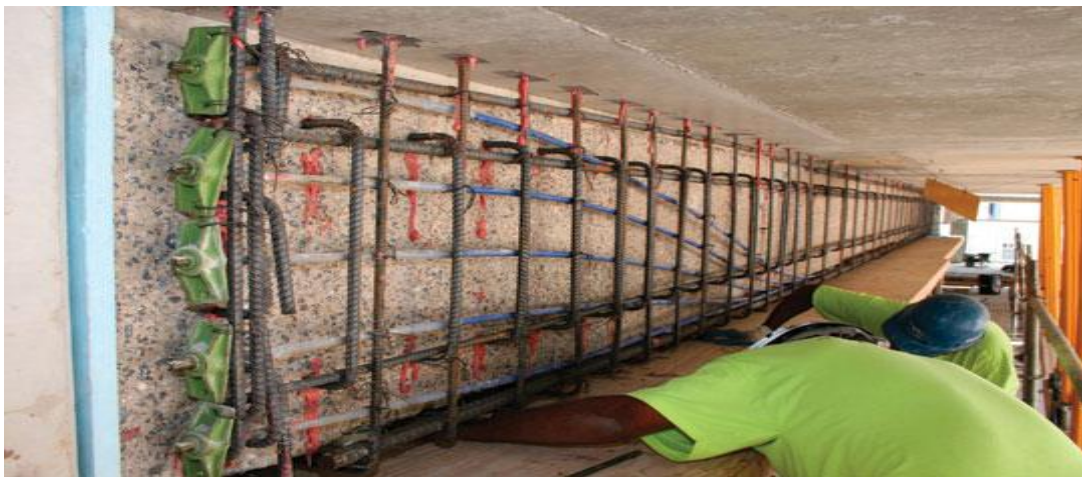
the ends of the member. End-anchors can be made of steel fixtures bolted to the structural member, or sometimes reinforced concrete blocks. The desired uplift force is provided by deviation blocks, fastened at the high or low points of the structural element. Before the strengthening technique can be applied necessary repairs to the structural members must be performed. The existing cracks must be repaired by means of epoxy injecting or other known methods. If there are existing spalls patching must be done, because this repair must ensure that the pre-stressing forces are distributed uniformly across the section of the member. T

**FIGURE 5-3 EXTERNAL PLATE TENSIONING**

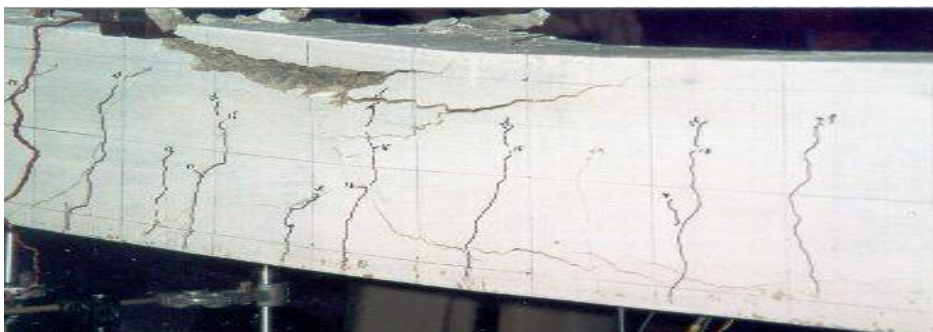
1. Concrete failure: Crushing of concrete
2. Steel failure: Yielding by steel
3. Concrete & steel combined failure

**FIGURE 5-4 FLEXURE CRACKS IN BEAM**

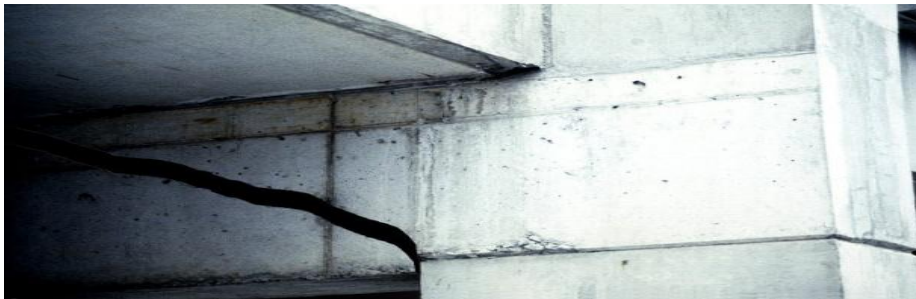
Flexure cracks can be identified as they are vertical. Shear cracks are at 45 degrees in the beam.

**FIGURE 5-5 SHEAR CRACK IN BEAM**

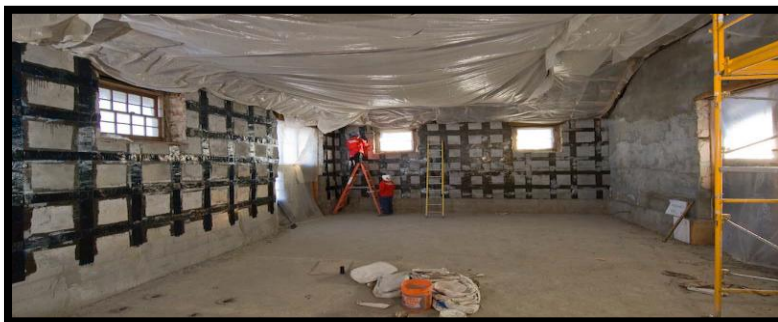
The repair of damaged reinforced concrete members by the bonding of CFRP laminates is becoming popular in the construction industry. CFRP has following attributes such as high strength, resistance to corrosion, light weight, and ease of handling. The application of the CFRP sheets without anchor system is worthless. For the strengthening of the low-rise walls, the use of the vertical CFRP sheets is more effective than that of horizontal CFRP sheets.

**FIGURE 5-13 CFRP RETROFIT ON PARTITION WALL**

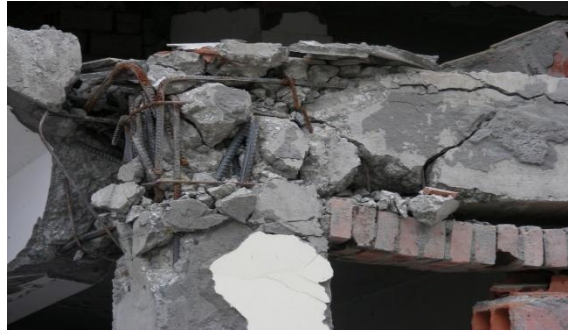
moments and forces induced due to loadings and due to transfer of forces, e.g. from beams to columns.

**FIGURE 5-14 JOINT FAILURE**

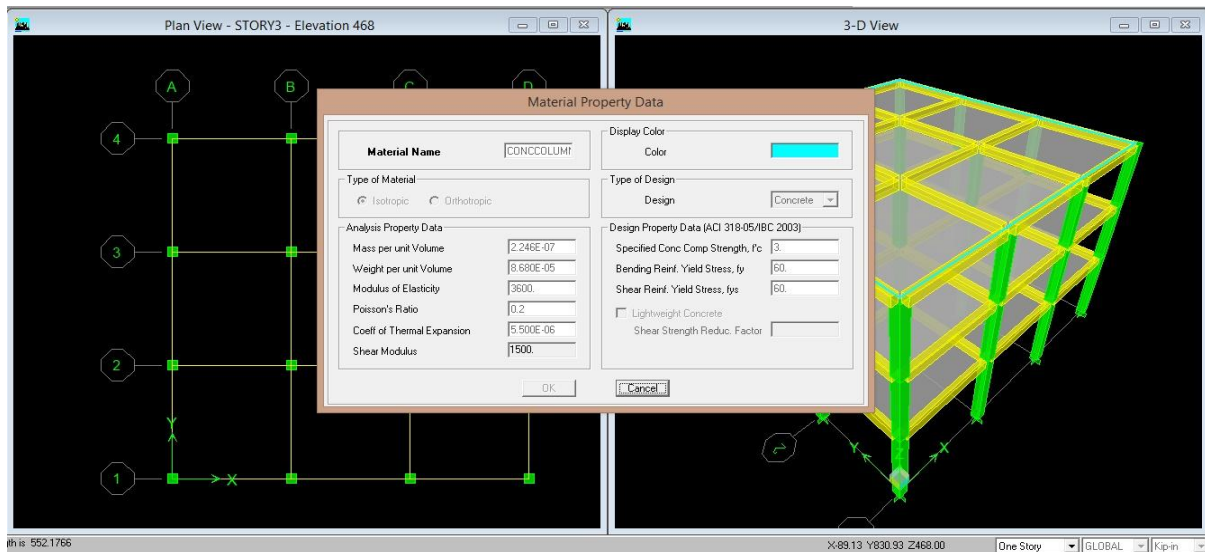
In this menu we defined the values of bending and shear reinforcement stresses of beams and columns. For columns, 3000 psi concrete and 60 ksi steel was defined. For the beams, 3000 psi concrete and 40 ksi steel was defined. As we can see in figures below.

FIGURE 7-2 MATERIAL PROPERTIES FOR COLUMN

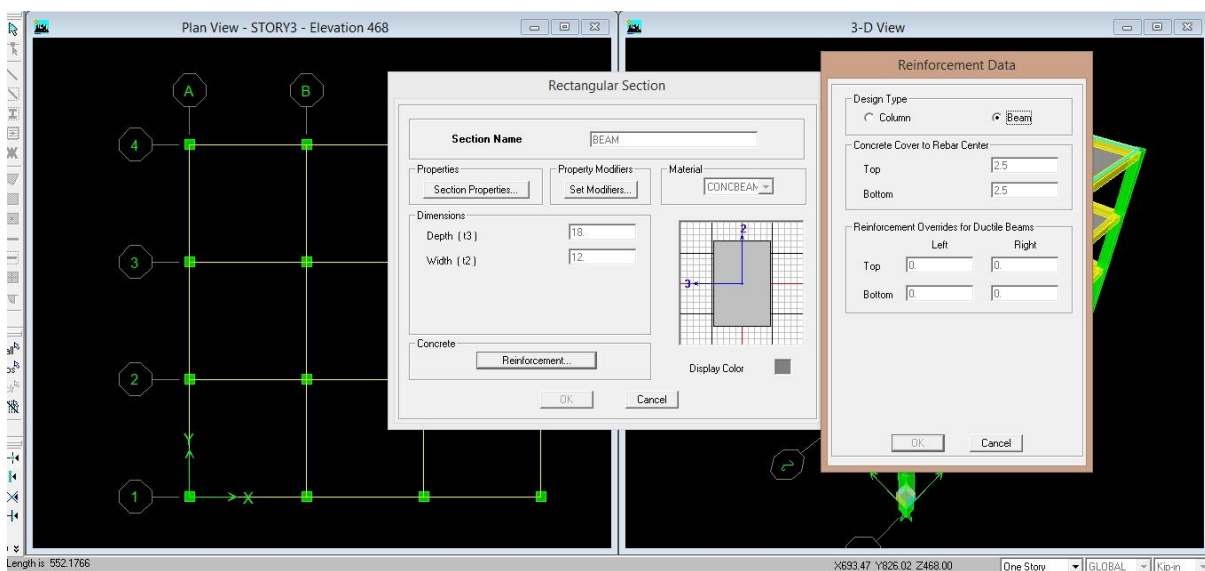
In this menu we defined the section properties of beams and columns. The reinforcement was also introduced in this menu. For the beams 12 X 18 was defined with inertia reduction factor as 0.35 and for columns 18X18 was defined with inertia reduction was equal to 0.7. Column was also given 16#8 bars and analysis option was set. In beam design was set. Although the beams have already been designed.

FIGURE 7-3 SECTION PROPERTIES OF BEAM

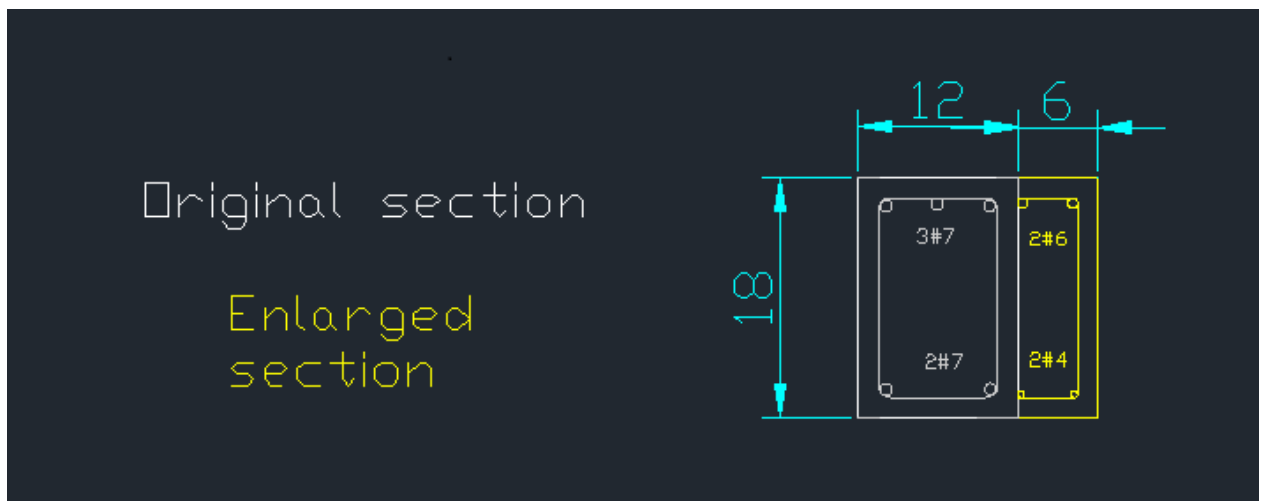
Originally the beams were of 12" X 18". After earth quake the strength of beams was reduced. We had original strength and we had reduced strength. Reduced strength was calculated by putting values of  $f_c = 1740$  psi and  $f_y = 32000$  psi. Total moment encountered during the earth quake minus total reduced strength or capacity of the beam was the moment needed to be restored. Now new section was added along the side of the beam which was 6 by 18 inch making beam 18 by 18 inch. New section added had capacity greater than restored moment of the beam.

**FIGURE 8-4 RETROFIT DESIGN OF BEAM**

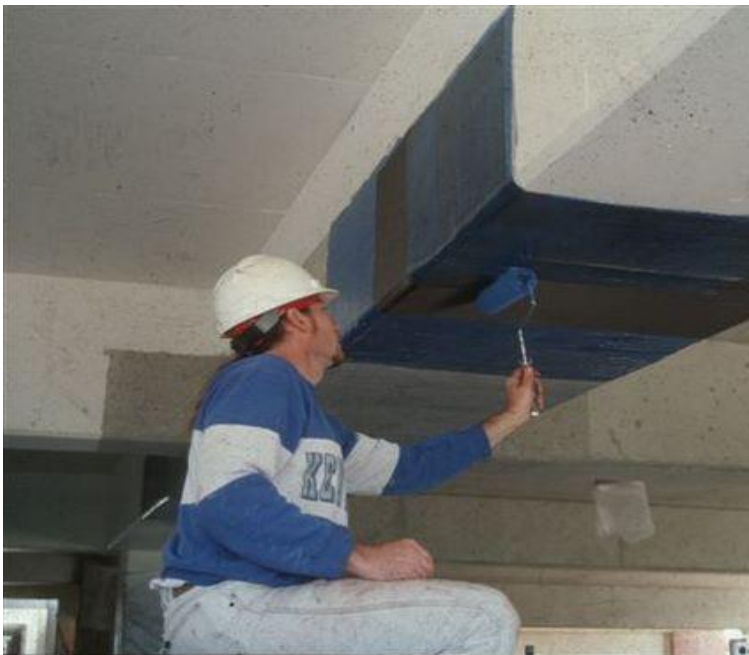
In this technique FRP belts are pre-stressed using a simple wrench. The technique is as follows: a carbon fibre belt is cut in a desirable length needed for wrapping around the cross section of the column and is impregnated with epoxy resin along only 100 mm lap joint of both cut ends, which is straightened to form a belt. When the belt is wrapped around the column, its ends can be clamped together by passing a solid rod between the eyes of the belt and putting bolts in between to lock them.

**FIGURE 8-5 WORKER APPLYING FRP BELT**
