# DEVELOPMENT OF CO<sub>2</sub> INHALING BIO-HEALABLE CONCRETE WITH ENHANCED IMMUNITY TO CORROSION

**Final Year Project UG 2015**

NUST Institute of Civil Engineering

National University of Sciences and Technology, Islamabad

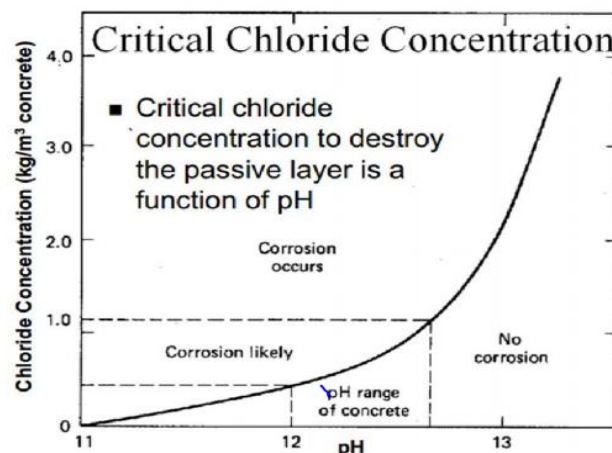
Figure 4: Relationship between  $Cl^-$  concentration and pH; Source: Steel corrosion in concrete by Bentur et al

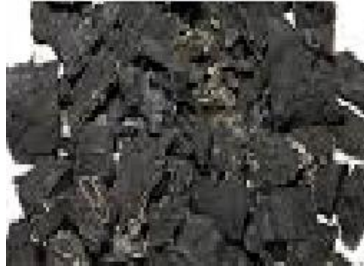
Figure 7: Raw pyrolyzed WT  
 $D_{50} = 1.27 \text{ mm}$

Later laser granulometry was performed on the obtained samples to obtain the optimum milling period for CWT. Examinations reveal that for 3

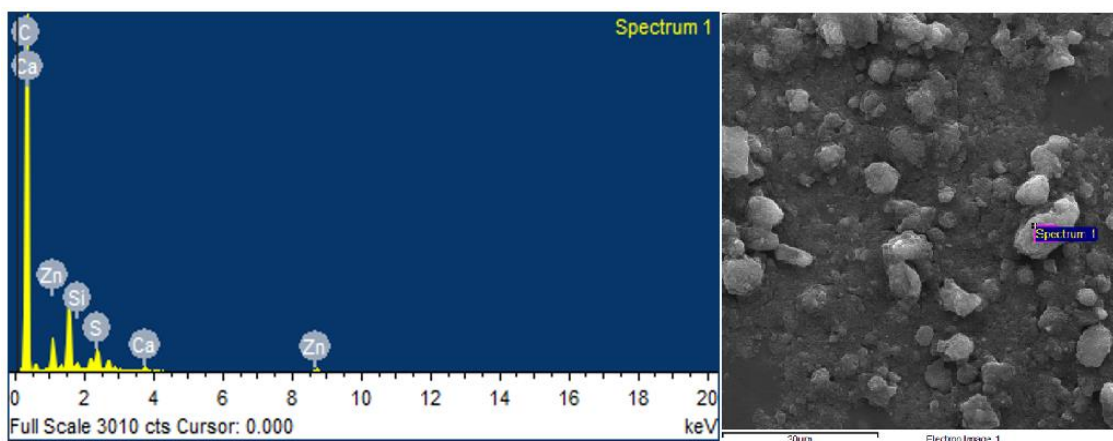
Energy dispersive spectroscopy (EDS) was performed for elemental characterization of carbonized waste tires shown in the figure and result summarized in the table below indicating the presence of 96.44% carbon within the CWT char.

Figure 10: EDS of CWT

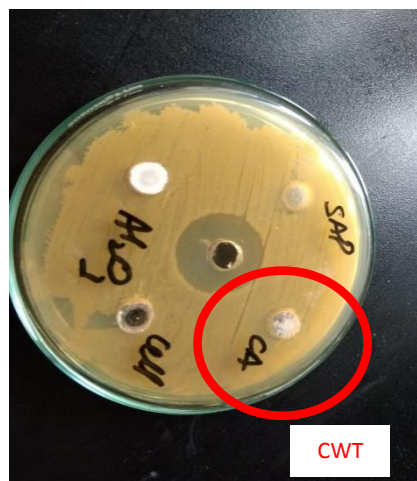
Since CWT would act as an adhering surface for bacterial specie its interaction with it was studied using optical microscopy. The following image shows the result of compatibility test from which it can be inferred that CWT does not kill bacteria whereas, cellulose kills bacteria as evident from dark well formed around it.

Figure 11: Result of bio-compatibility test

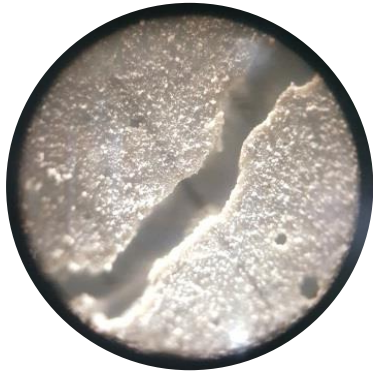
Figure 14: OM image of PCS

Figure 151: OM image of BCS

Figure 162: OM image of BCS 0.25

Figure 17: OM image of BCS 0.50

Figure 18: OM of BCS 0.75

The first and foremost deduction from the test result is no healing being observed in case of PCS samples, since no microbial species were introduced and also points out the fact that natural healing alone is insufficient for crack filling.

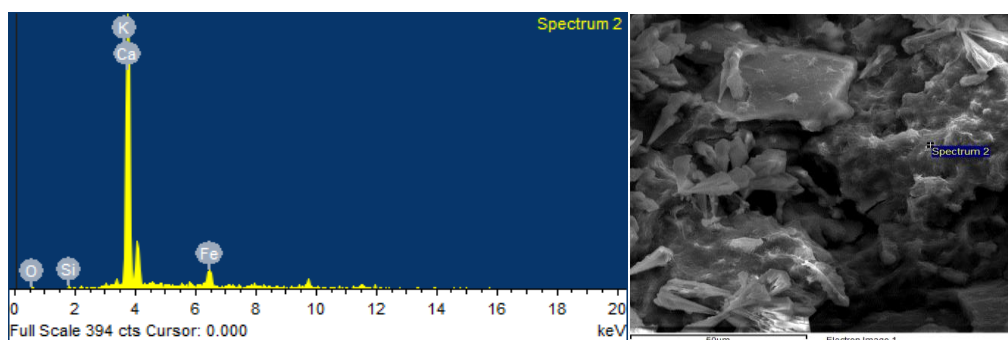
Figure 19: EDS of BCS at 50  $\mu\text{m}$

The following figures illustrate elemental compositions of the chips extracted from different concrete samples analyzed at multiple spectrums.

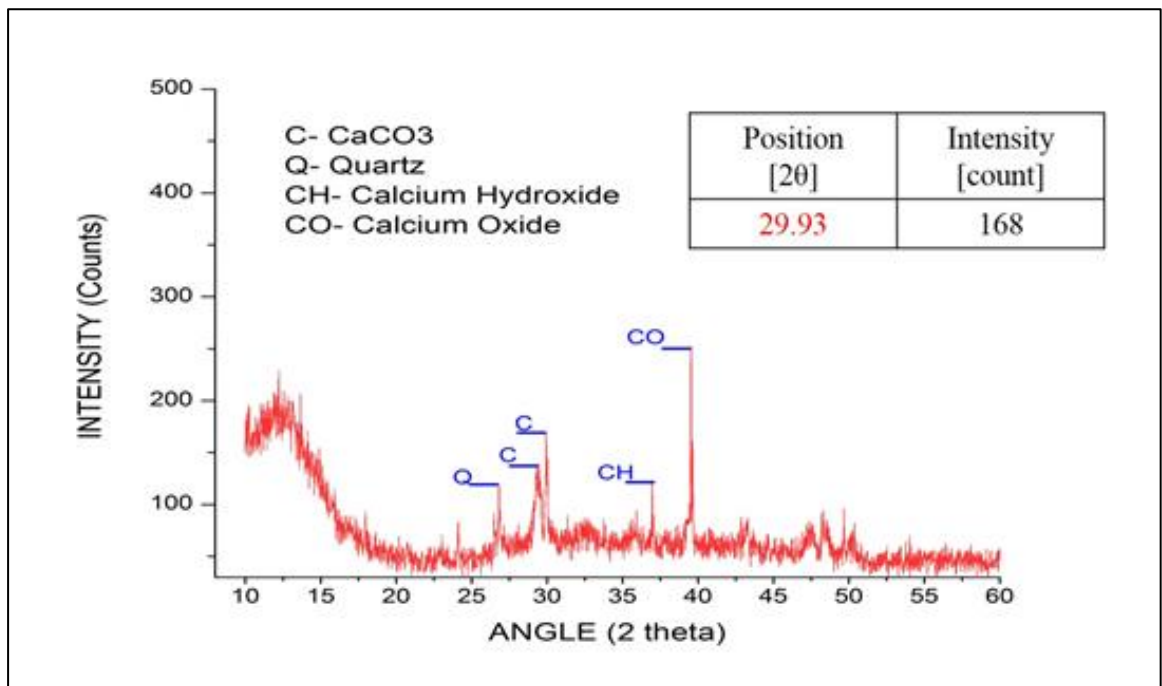
XRD analysis involves phase identification of crystalline material to distinguish elemental components in self-healable concrete. For this test, a core was extracted from healed samples and relative peaks corresponding to specific elements is obtained.

Figure 21: XRD of BCS 0.75

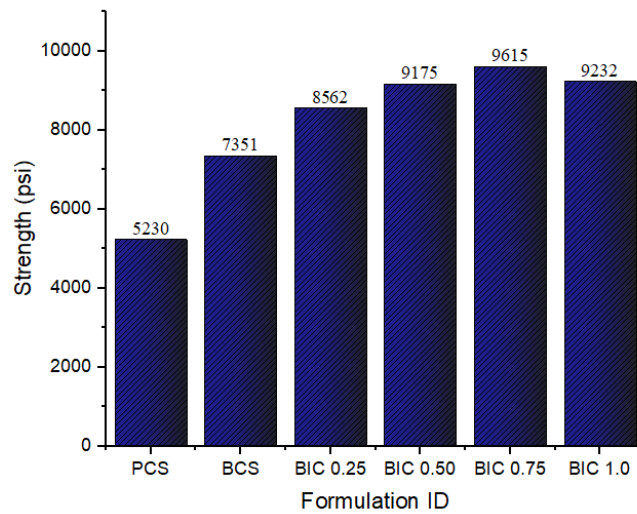
The graphs below show the initial compressive strengths of the concrete at curing periods of 3, 14 and 28 days respectively. It is observed that with introduction of bacterial immobilized char the healing efficiency has improved that results in densification of concrete matrix enabling it to withstand increased loads until BIC 0.75. There is drop in compressive strength for BIC 1.00 because of agglomeration of char particles which leads to formation of weak zones that causes decrease in ability to sustain load hence lower compressive strength.

Figure 22: Compressive strengths at (a) 3 days (b) 14 days (c) 28 days, of cured samples

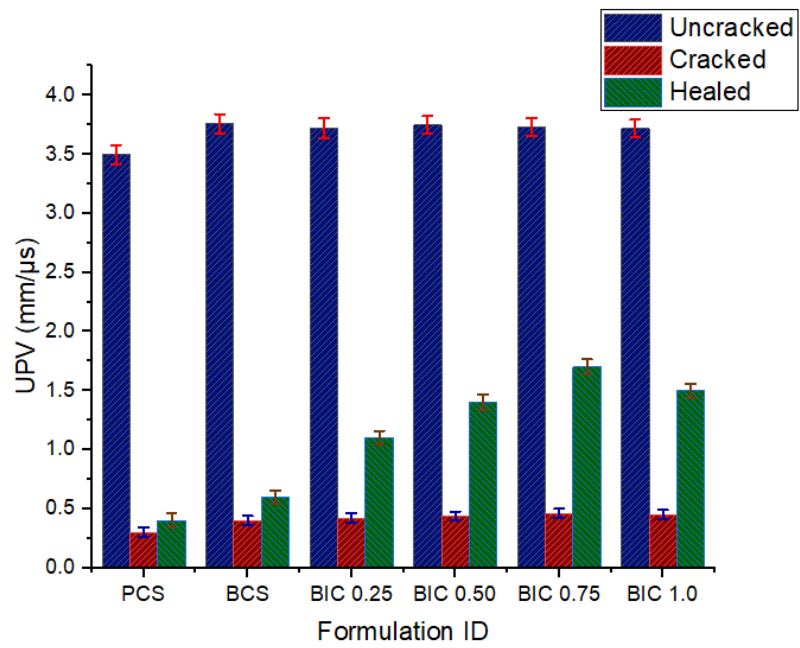
UPV test was carried to monitor the healing activity within the concrete samples cured at respective periods, for which the internal cracks were filled. In order to estimate the healing activity UPV was performed before cracked, then for pre-cracked and later for healed samples. Three methods were employed direct, semi-direct and indirect to investigate healing in different planes. Subsequent table depicts the velocities through concrete samples, in general the velocity increase with filling of cracks as there is no obstruction for waves to propagate.

Figure 243: UPV on (a) 3 days (b) 14 days (c) 28 days, uncracked, cracked and healed samples

The results of UPV compliment the previous test results for healing. It can be seen that with increase char content the healing efficiency has improved that results in crack repair therefore the speeds have increased through the transducers.

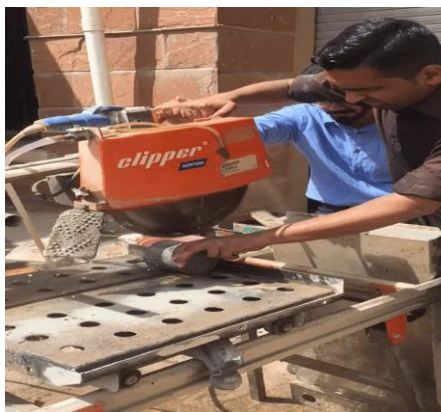
Figure 25: Sample preparation using diamond saw cutter

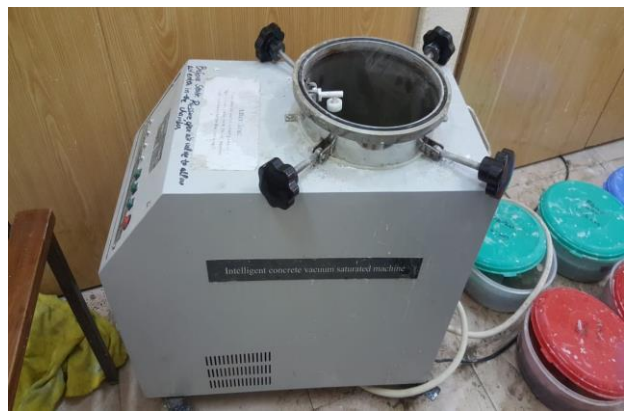
Figure 264: Sample isolation through vacuum chamber

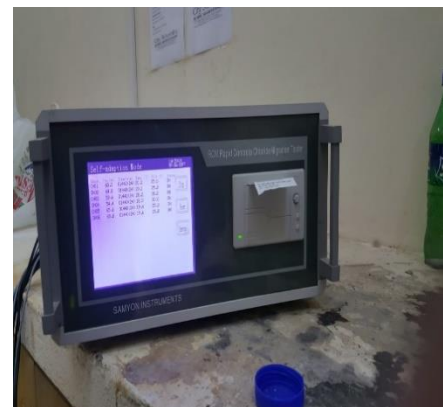
Figure 285: Voltage drop monitoring through potentiostat

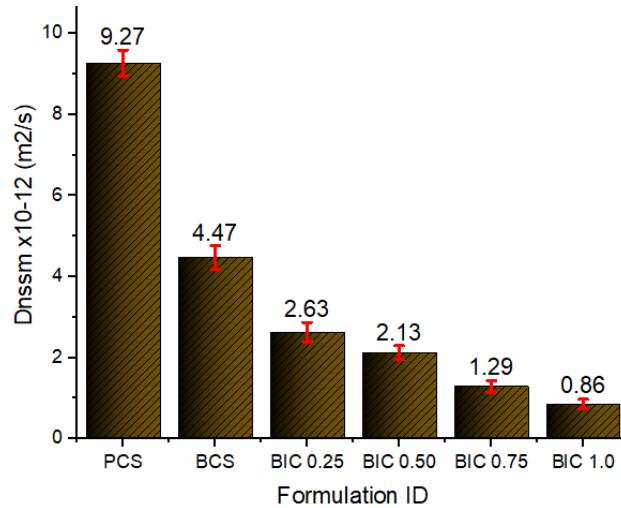
The graph below represents the migration coefficient values for various formulations. It can be implied that bacterial inspired concrete reduces the attack of aggressive agents like chloride ions by filling the pores whilst making the concrete impermeable. With increase in char content the healing activity increases that decreases the corrosion within the samples by 89%.

Figure 30: Migration coefficients for different formulations

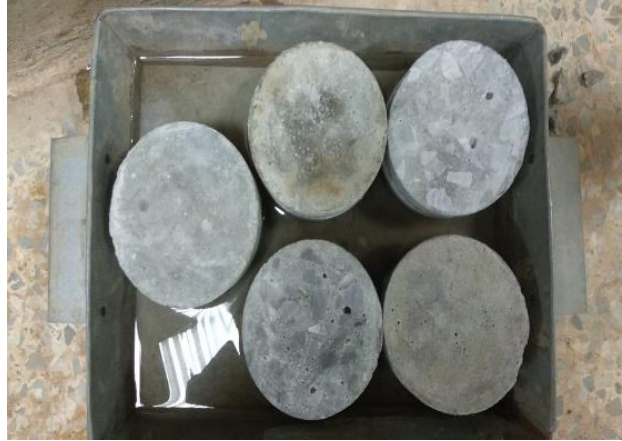
Figure 31: Concrete samples immersed in NaCl solution

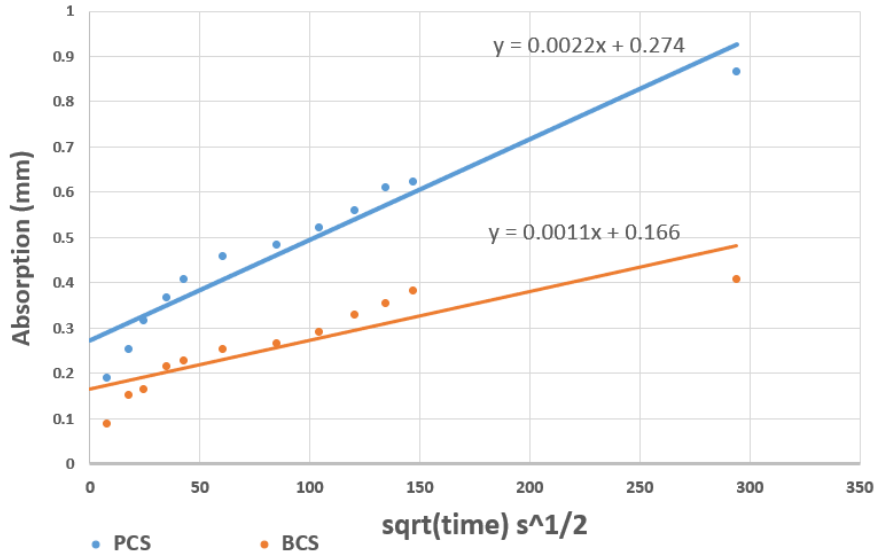
Initial rate of absorption ( $mm/\sqrt{s}$ ) was determined by drawing the line of best fit through linear regression equation for the plotted points as shown in the graph below.

Figure 32: Plot of best fit line for sorptivity

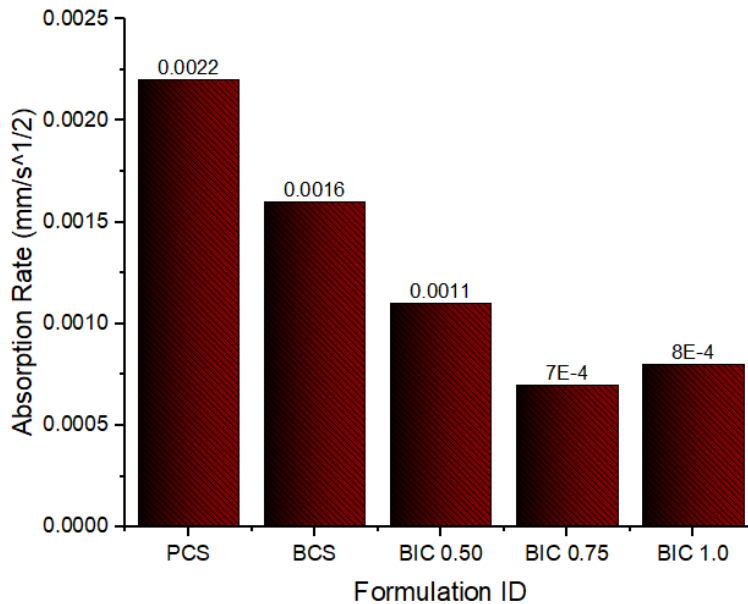
The bar chart shown in the figure below summarizes the absorption rates for different formulation, it can be observed that healing action reduces the permeability in the concrete hence the carbonation within concrete is prevented that ensures the reinforcement is preserved. The calculation reveals 68 % decrease in permeability for BIC 0.75 relative to PCS.

Figure 33: Absorption rate for different formulations

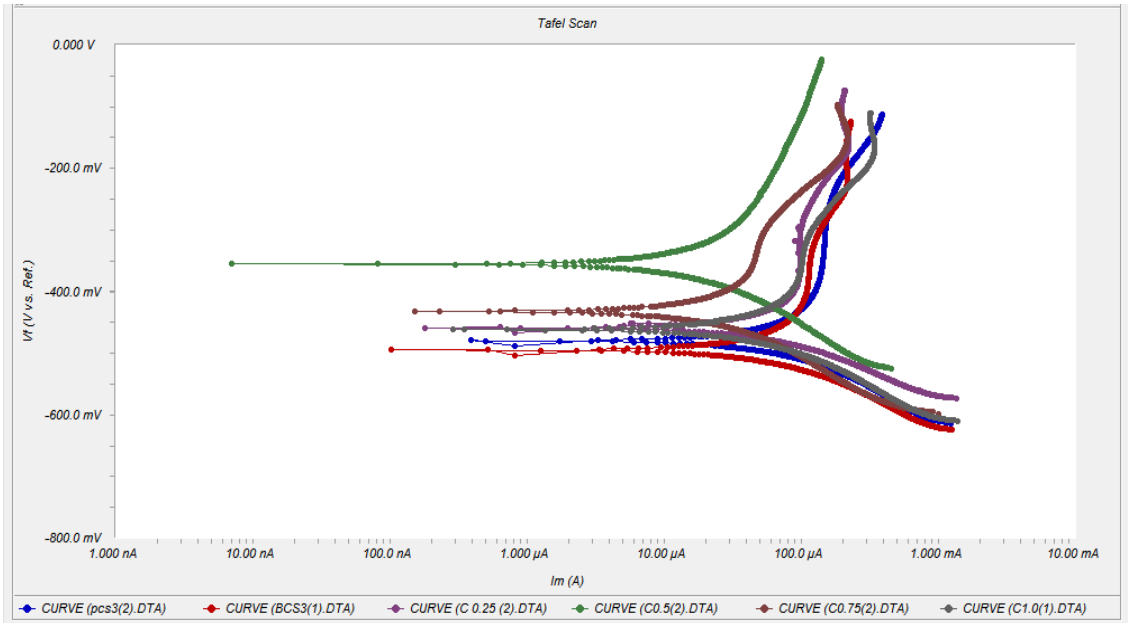
The general trend of different concrete formulations is shown in the graph followed by figure summarizing the test result.

Figure 36: Superimposed curves of tafel plot

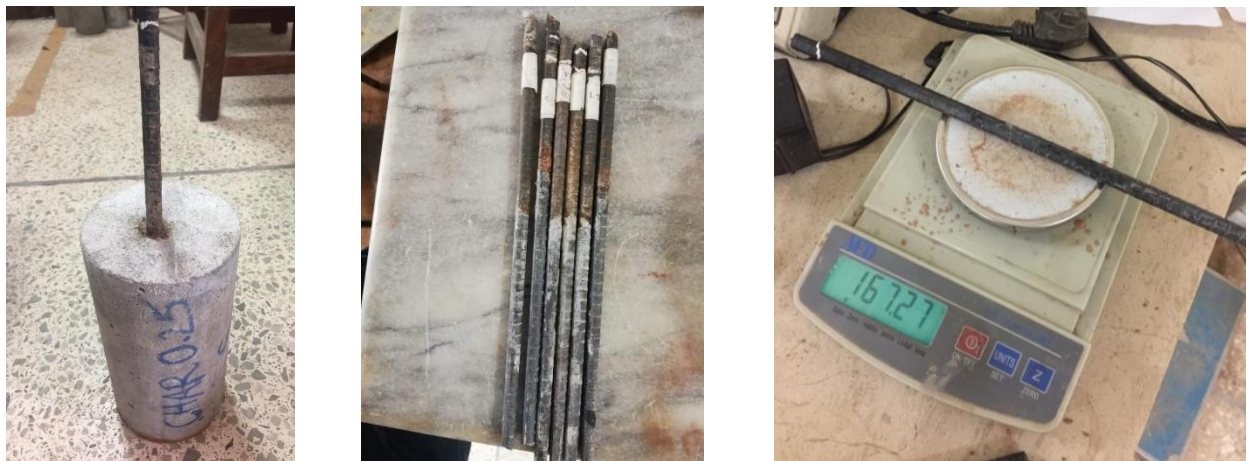
In mechanical method, the sponge was used to remove the corrosion products. In chemical method, the bars were immersed in 20 % w/w solution of NaOH with 2 % granulated zinc for 40 minutes at 85°C according to the standard ASTM G1-03.

Figure 38: Pictorial description of weight loss measurement test

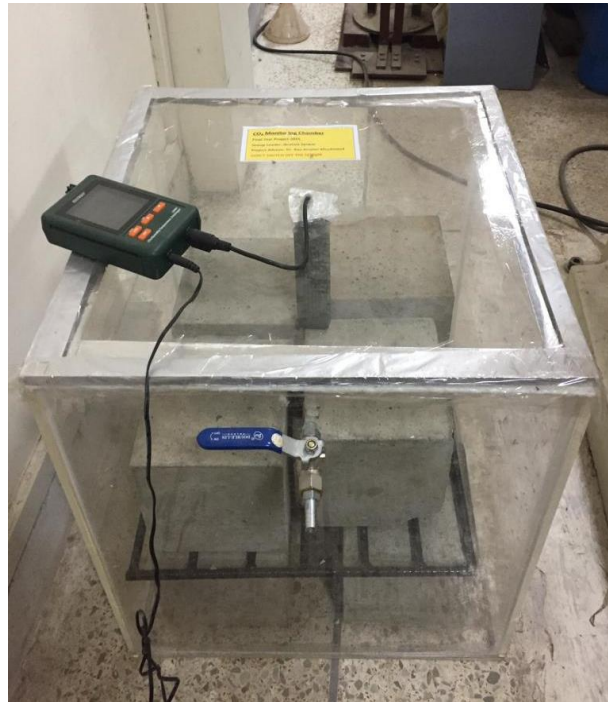
Figure 41: Real time CO<sub>2</sub> monitoring in the climate control chamber

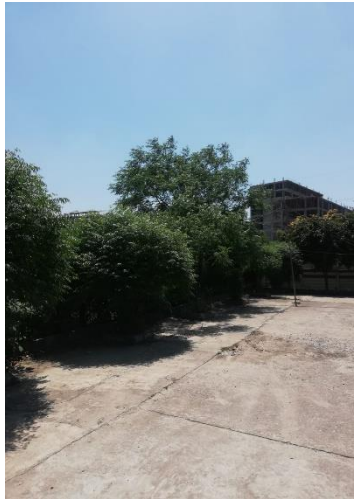
In order to draw comparison between bio-emulsion and epoxy grout, NIT (NUST) car parking, was selected as test site possessing macro cracks in its pavement as shown in the figure below.

Figure 46: Site selection NIT (NUST) car parking

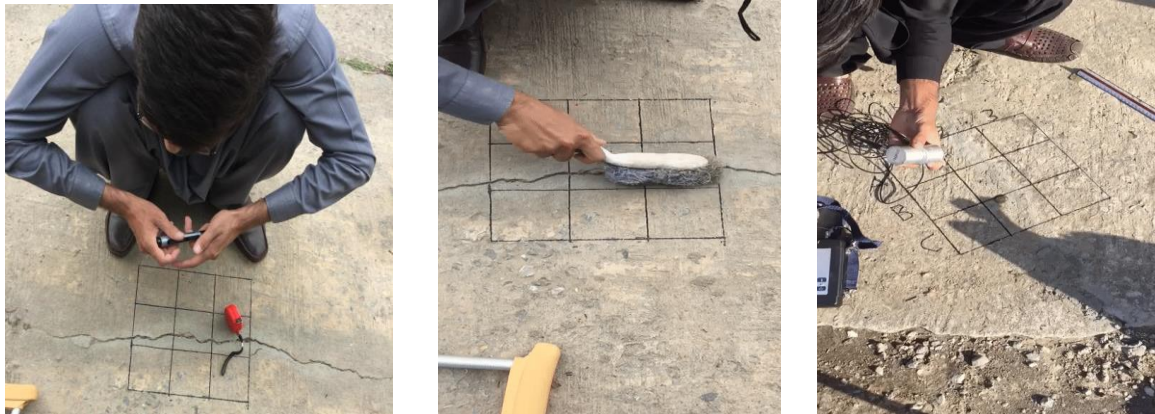
The crack was cured using jute bags for period of 7 days, afterwards UPV readings were taken at respective grid points.

Figure 47: Pictorial description of field trial

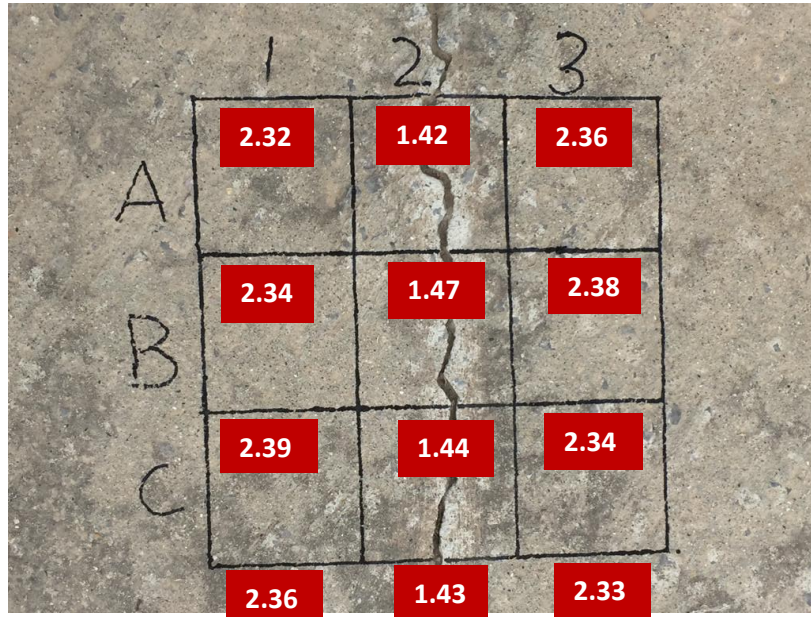
Figure 49: UPV results (a) before (b) after application of bio-emulsion

The figures below summarize the results of UPV readings converted into speeds.
